Photographic Log Base Map - November 30, 2011

# Technical Memo

**Date:** December 13, 2011

**Subject:** MEM-07 Monitoring Report – November 30, 2011 Field Reconnaissance

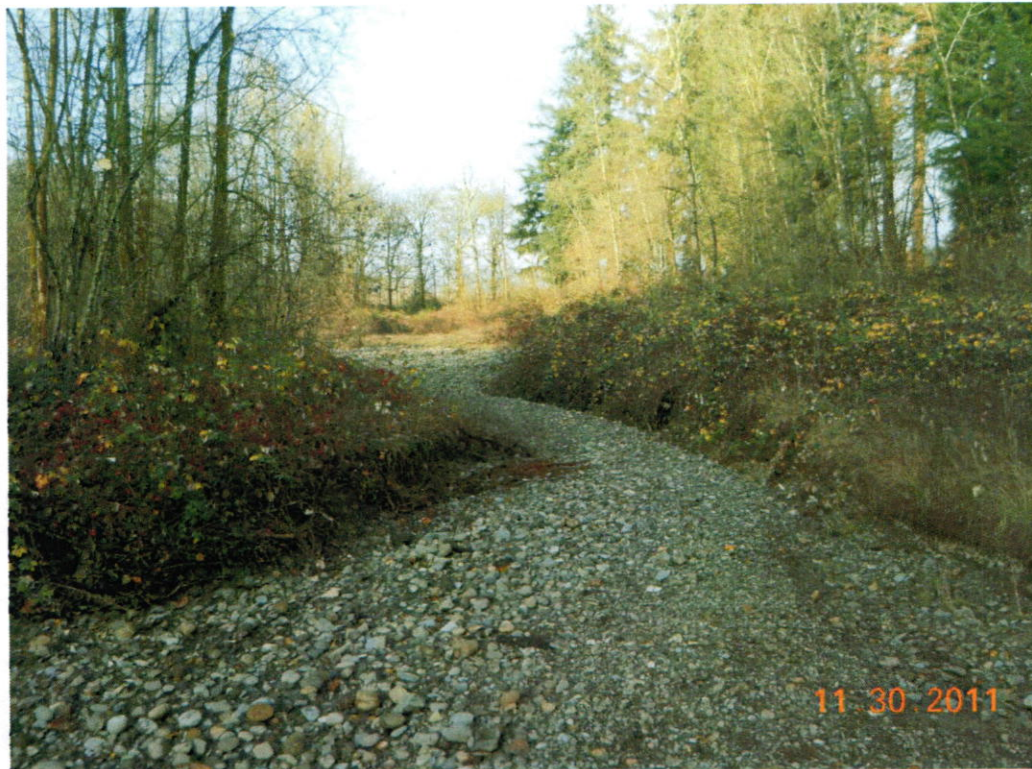
Photo 1. Looking northwest from Location #1 along secondary floodplain channel.

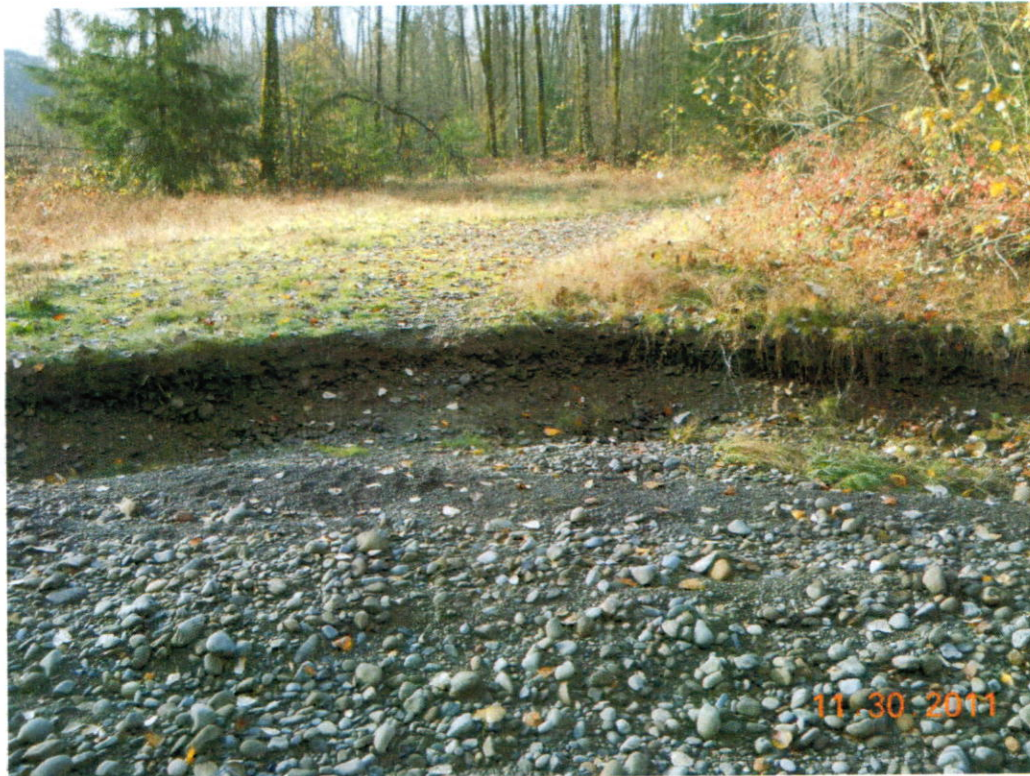
Photo 2. Looking southwest from Location #1 at headcut nick point located at upstream end of secondary floodplain channel.

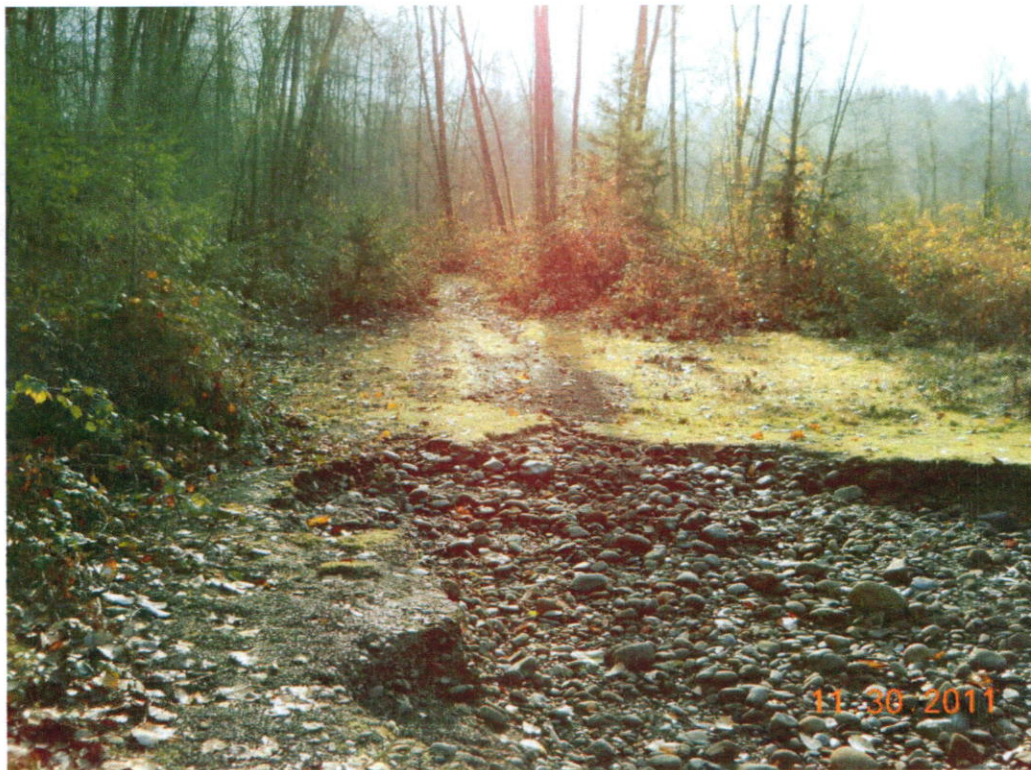
Photo 3. Looking south southeast from Location #1 toward County Pond #2.

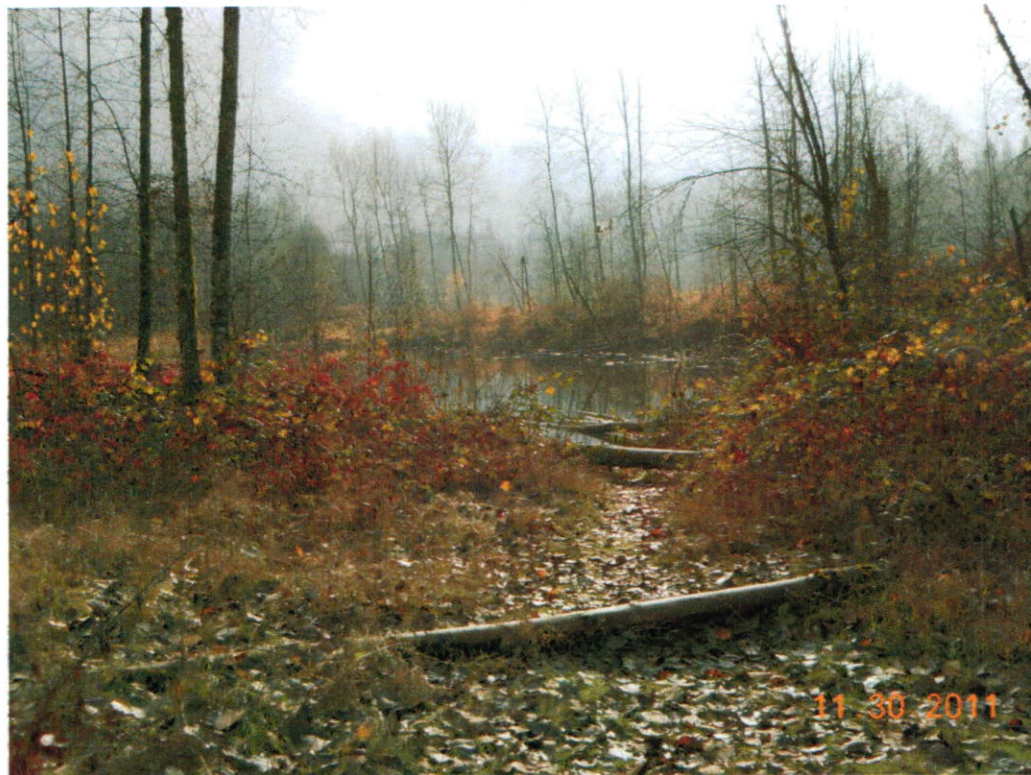
Photo 4. Looking southeast from Location #2 at overflow path from County Pond #2.

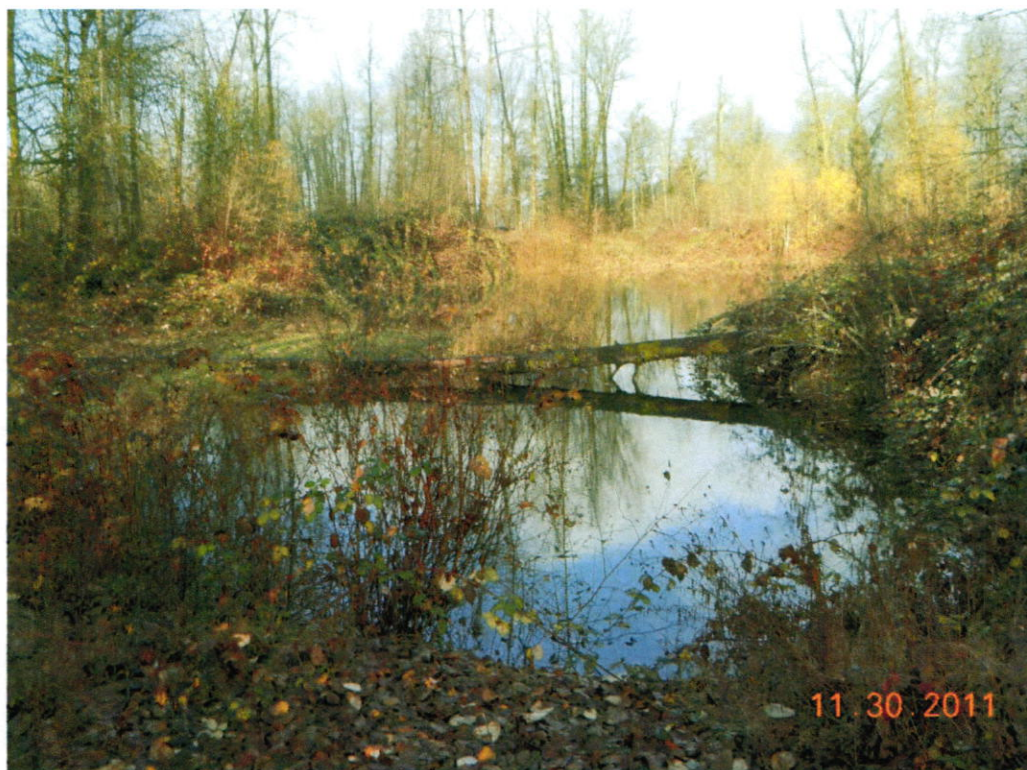
Photo 5. Looking northwest from Location #3 at overflow channel into County Pond #1.

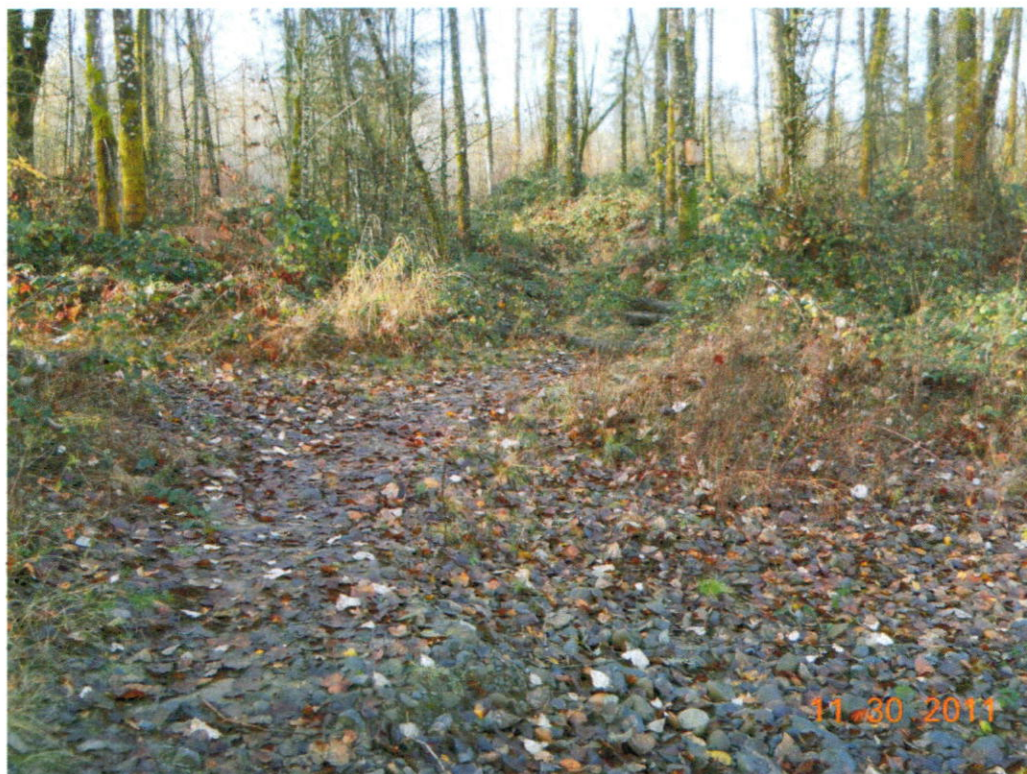
Photo 6. Looking southwest from Location #3 at headcut nick point located at upstream end of overflow channel into County Pond #1.

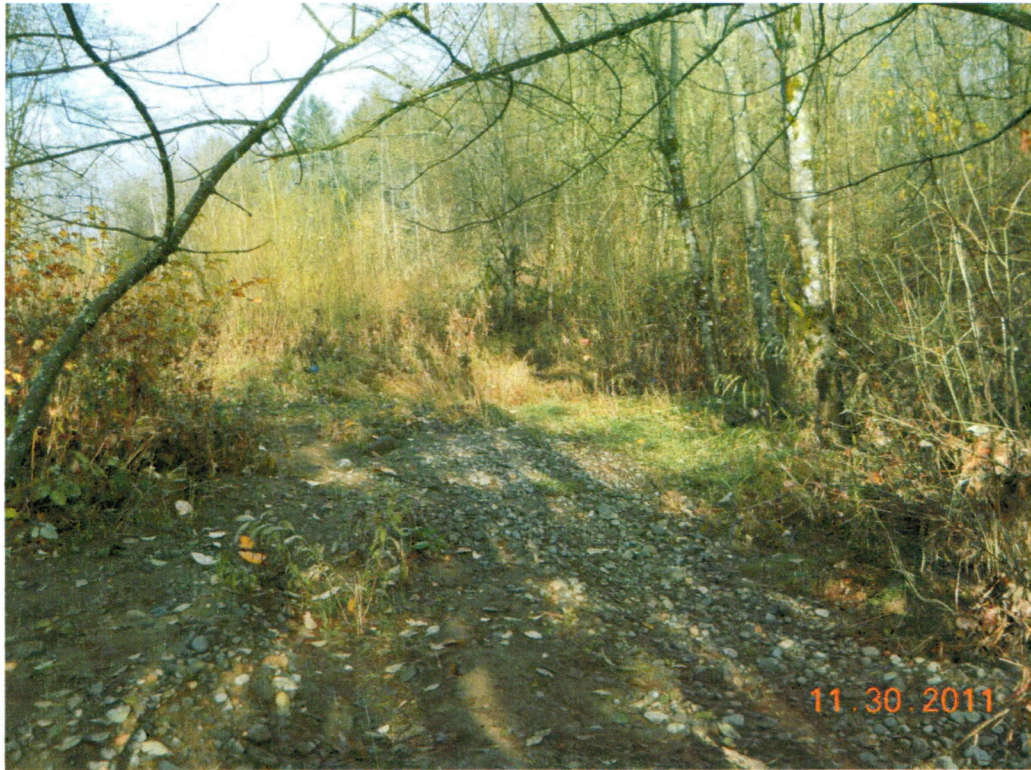
Photo 7. Looking north from Location #4 at overflow channel from E.F. Lewis River into County Pond #2.

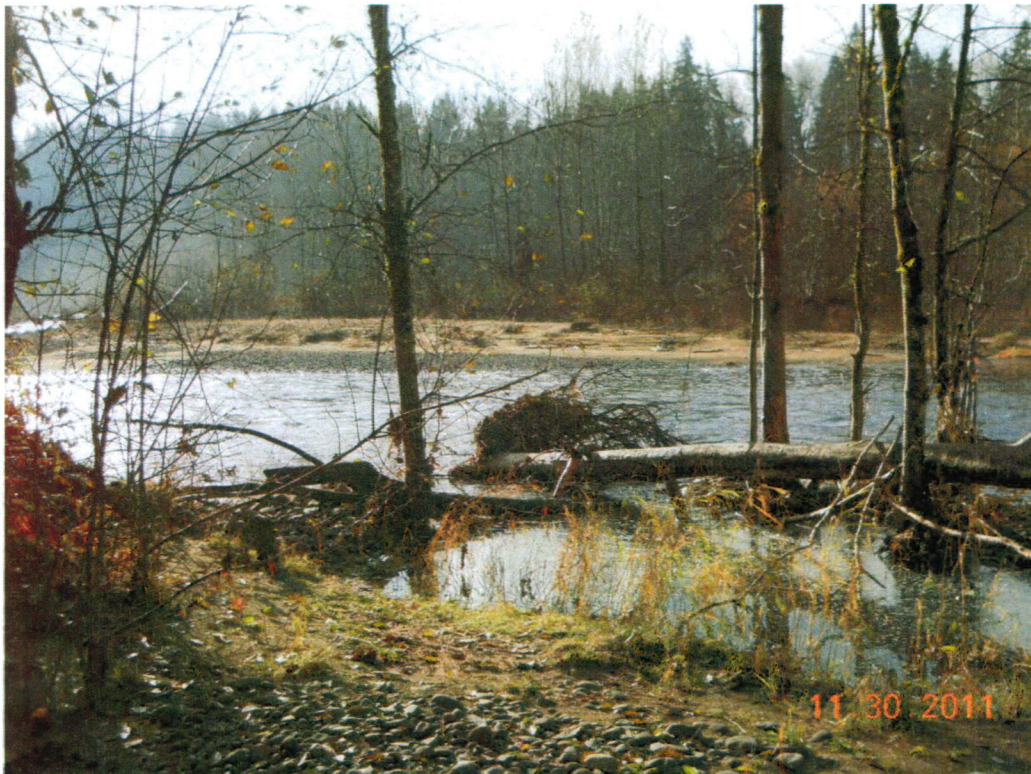
Photo 8. Looking south from Location #4 at upstream end of overflow channel from E.F. Lewis River into County Pond #2. Recently abandoned E.F. Lewis River channel in background.

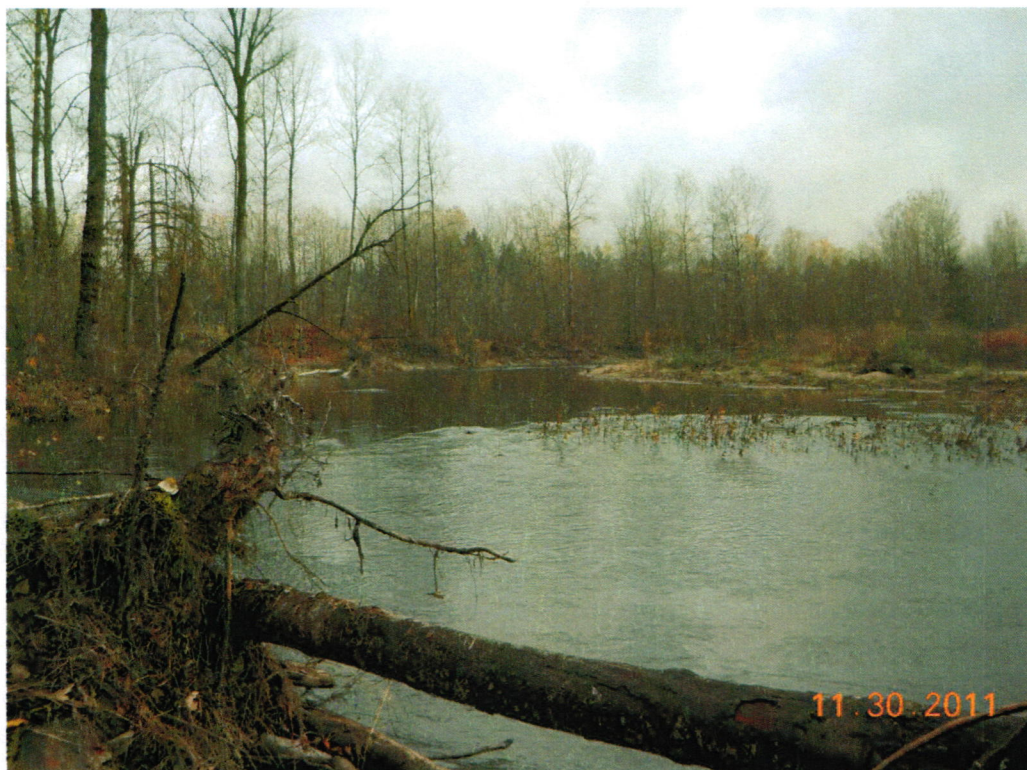
Photo 9A. Looking northeast northeast from Location #5A at right bank of recently abandoned section of E.F. Lewis River at location of overflow channel that leads to County Pond #2.

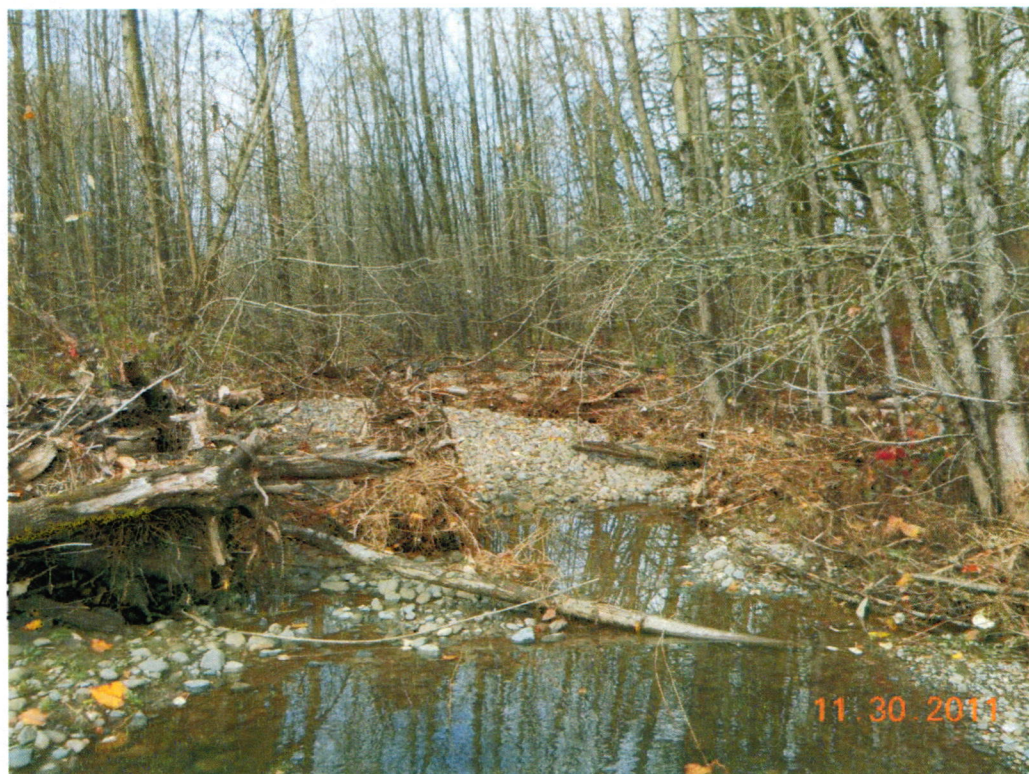
Photo 10A. Looking northwest from Location #5A at upstream end of secondary channel.

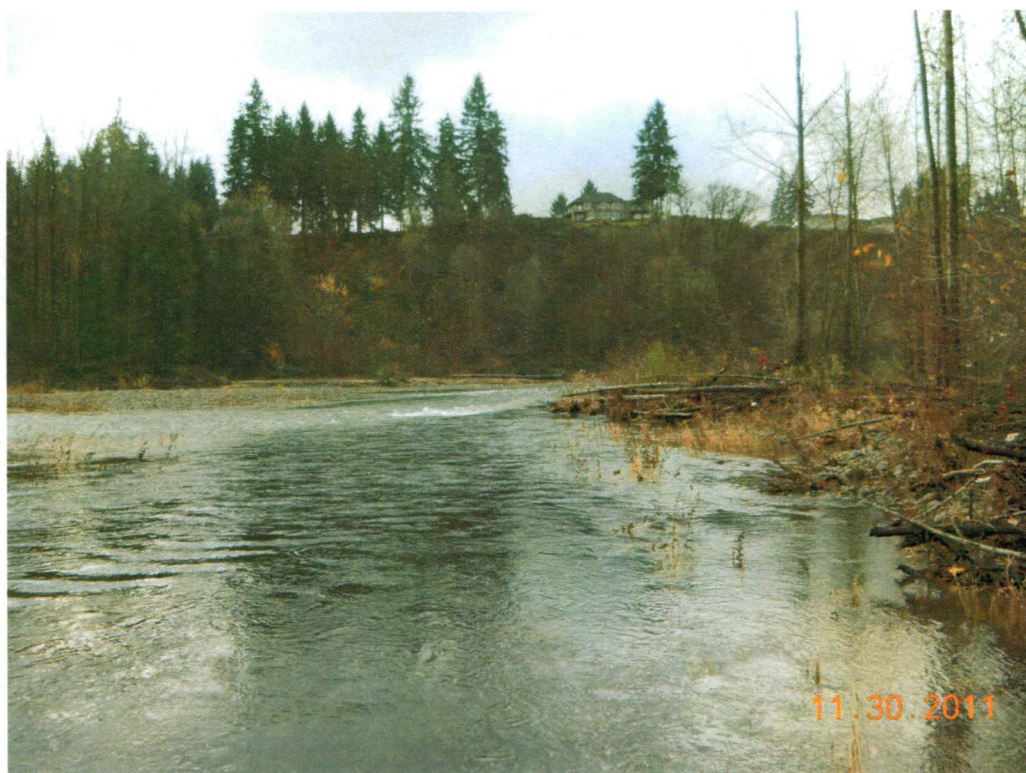
Photo 11A. Looking south from Location #5A at downstream end of recently abandoned section of E.F. Lewis River.

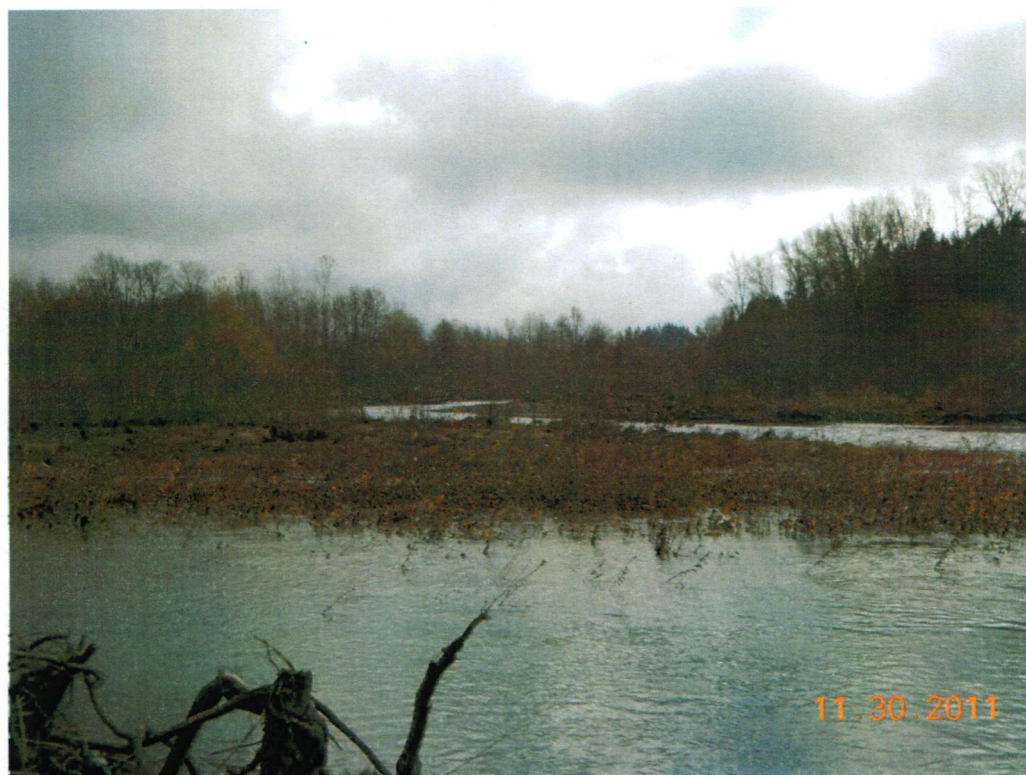
Photo 12A. Looking east southeast from Location #5A at downstream end of second E.F. Lewis meander cutoff channel.

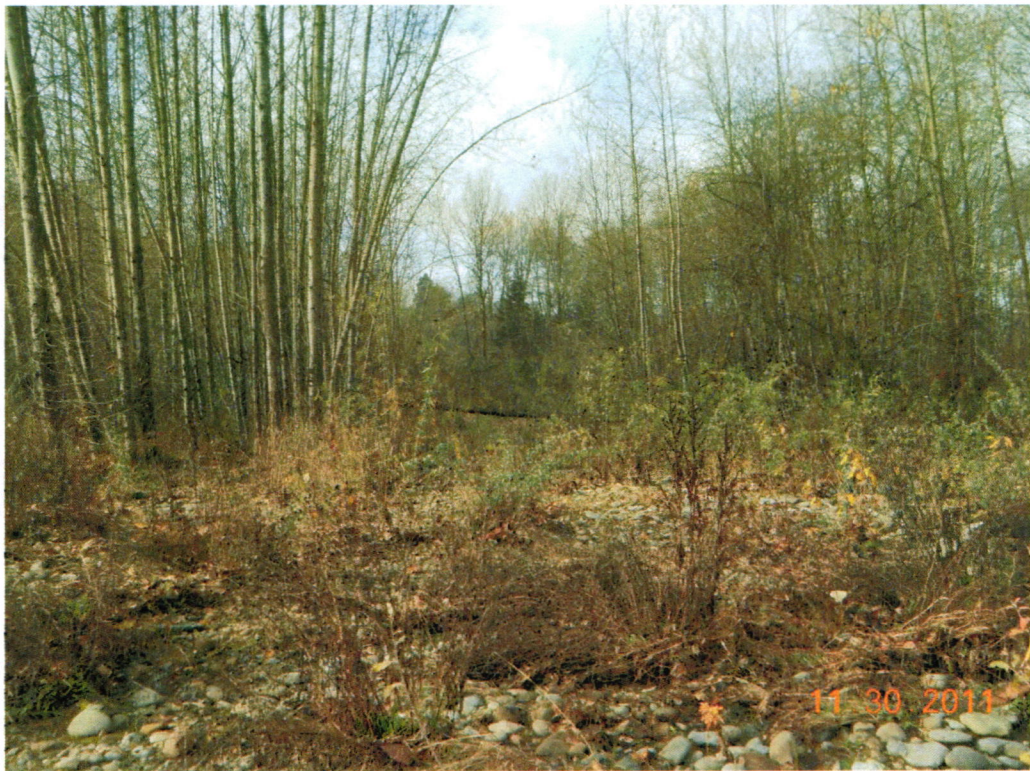
Photo 18. Looking west from Location #6 at upstream end of secondary floodplain channel.

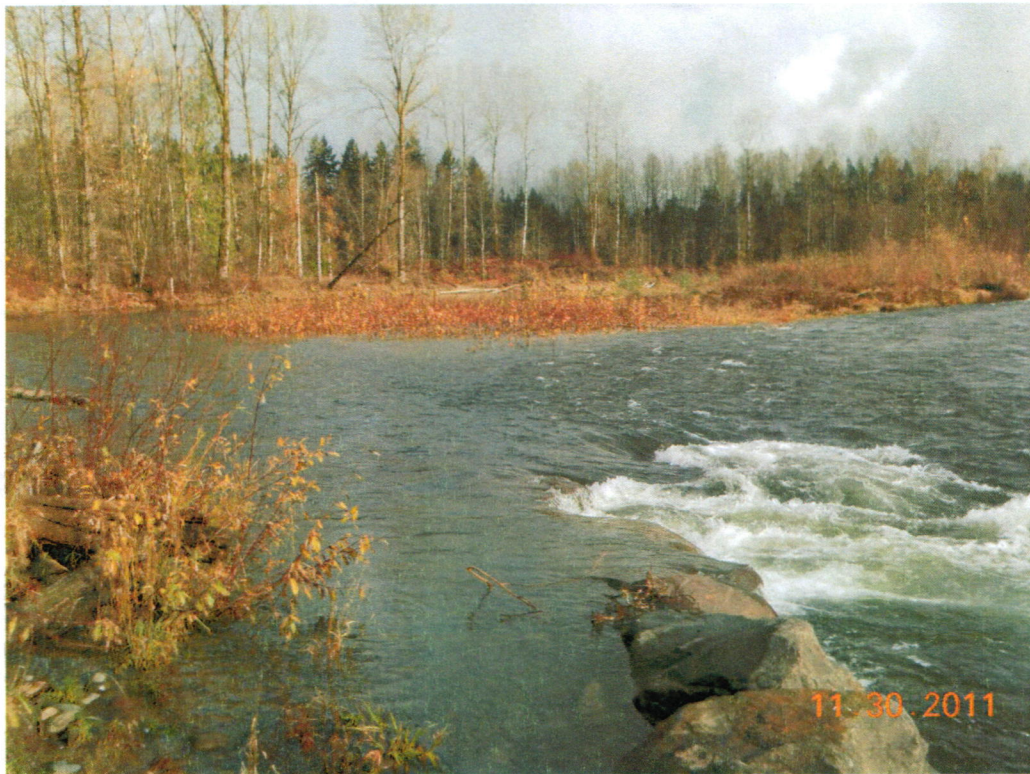
Photo 19. Looking north northeast from Location #6 at rock vane located along the right bank of recently abandoned section of E.F. Lewis River.

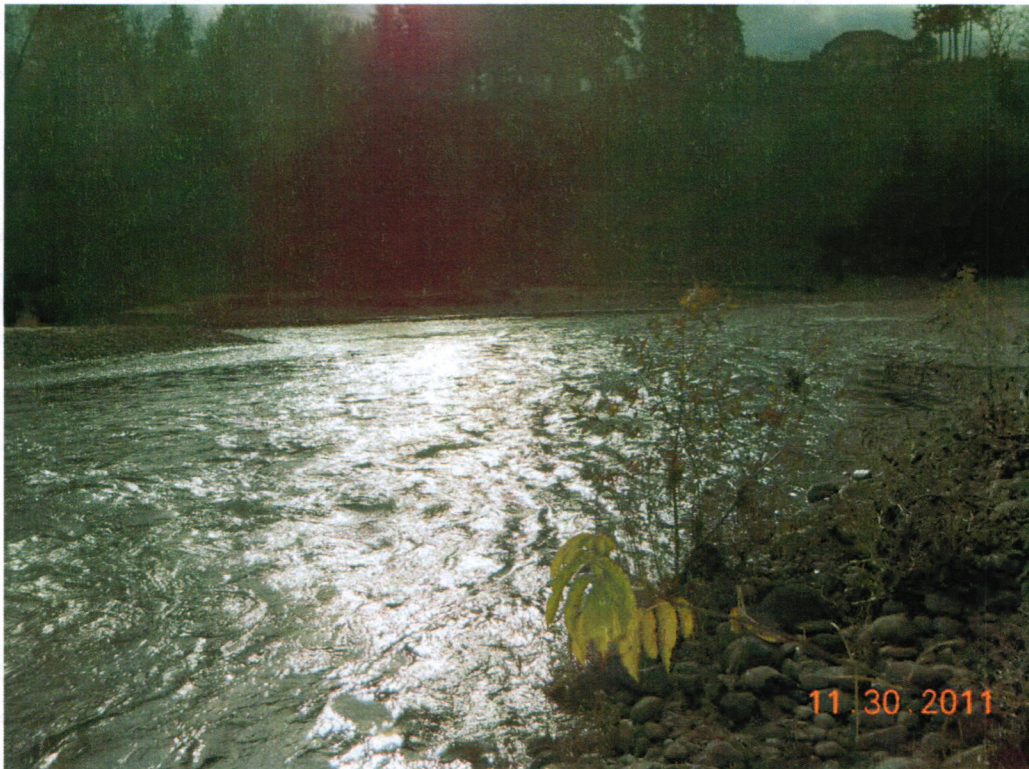
Photo 20. Looking southeast from Location #6 at downstream end of recently abandoned section of E.F. Lewis River. Note first cutoff channel at left side of photo.

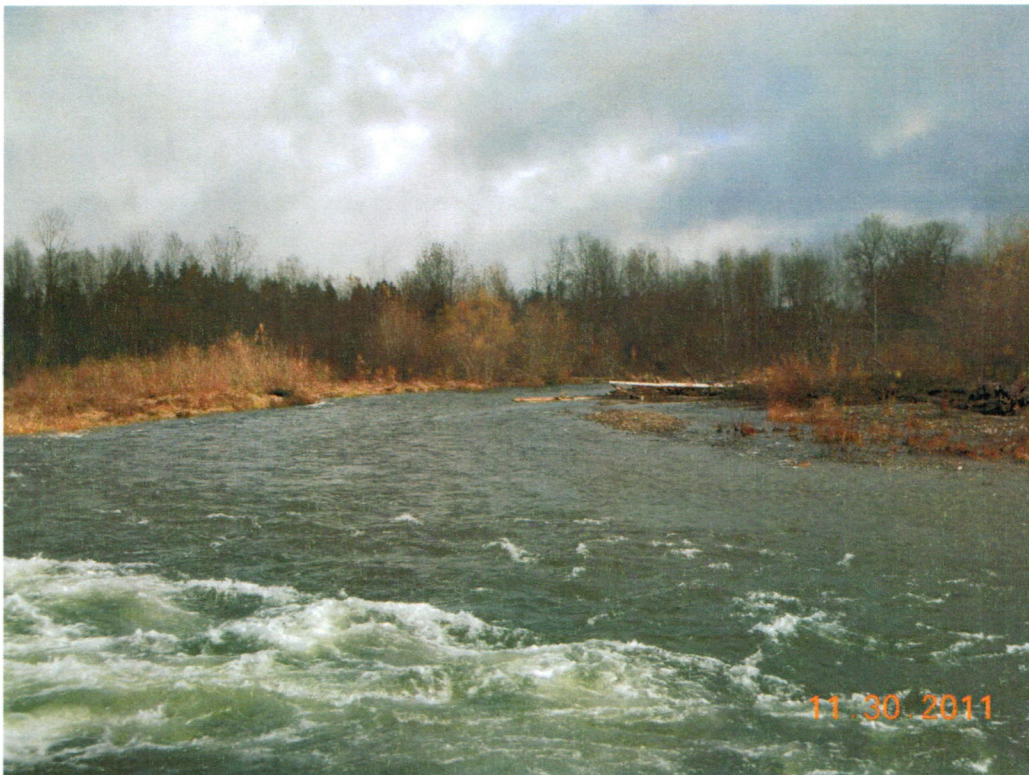
Photo 20A. Looking east northeast from Location #6 at downstream end of second E.F. Lewis River meander cutoff channel.

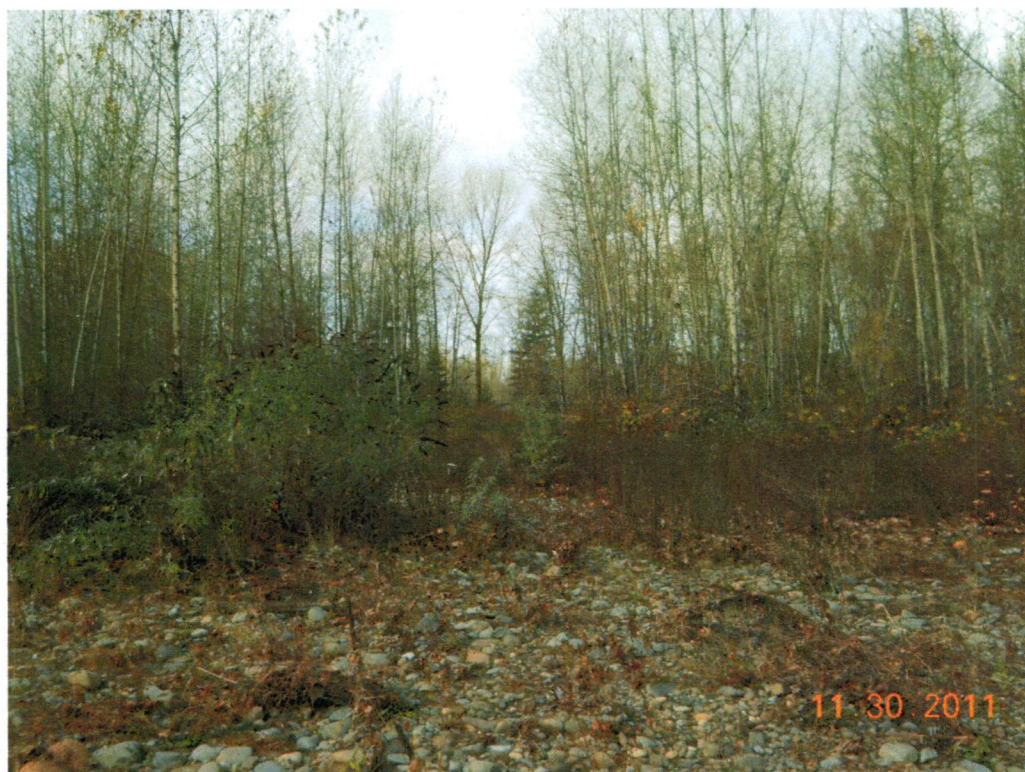
Photo 21. Looking northwest from Location #7 at upstream end of secondary floodplain channel.

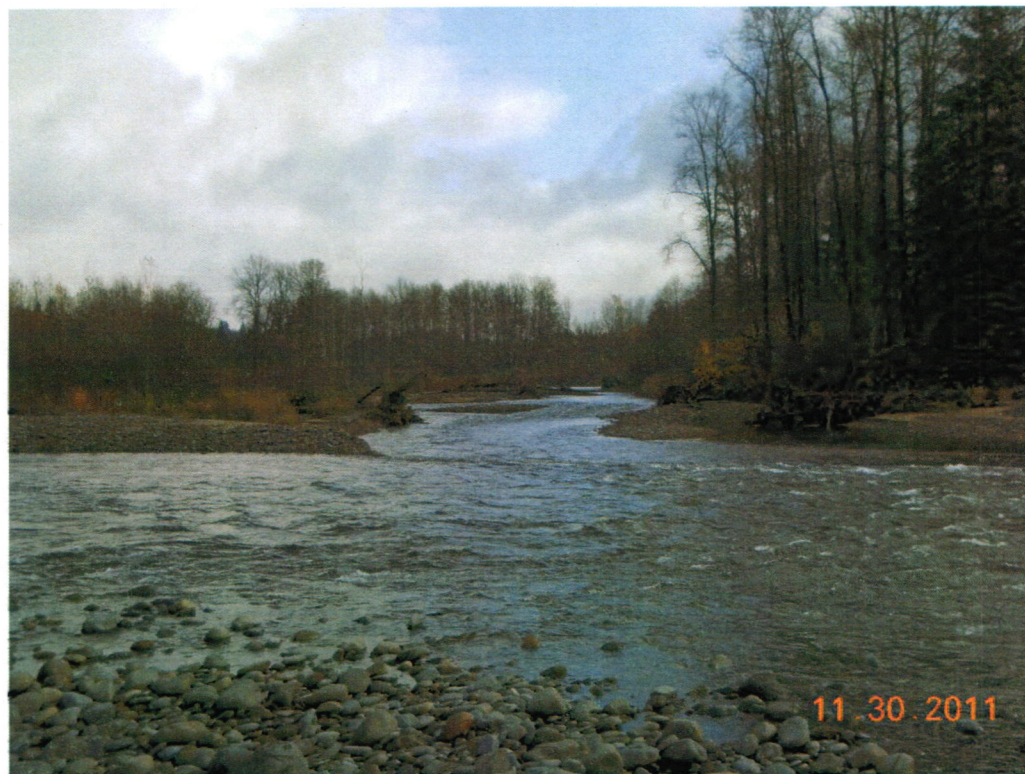
Photo 21A. Looking east southeast from Location #7 at downstream end of first E.F. Lewis River meander cutoff channel.

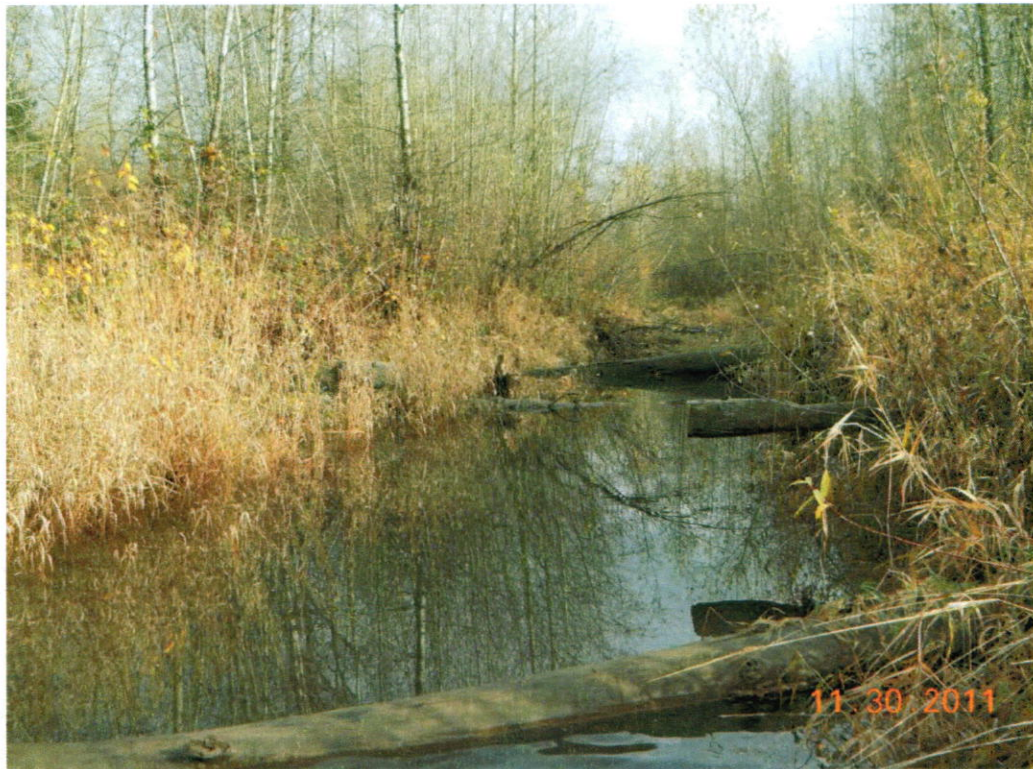
Photo 22. Looking east northeast from Location #8 at downstream end of secondary floodplain channel.

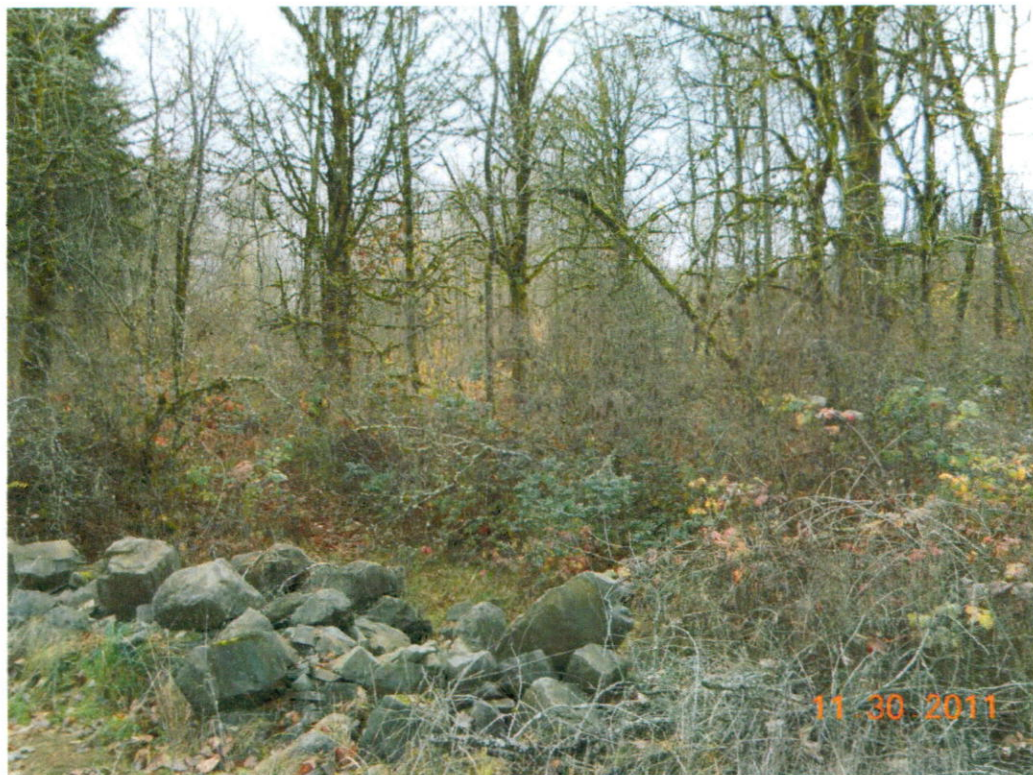
Photo 23. Looking southeast from Location #9 in direction of floodplain overflow channel shown in Photo 1.

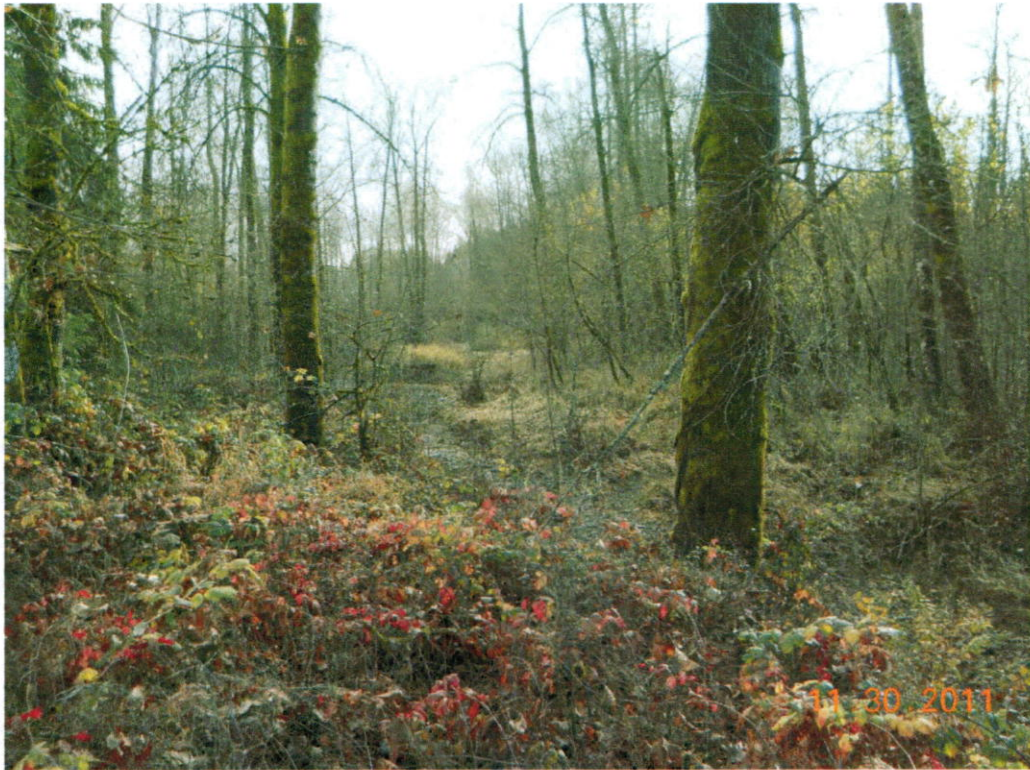
Photo 24. Looking southeast from Location #10 at floodplain adjacent to Storedahl Pit Road. Historic location of E.F. Lewis River channel.

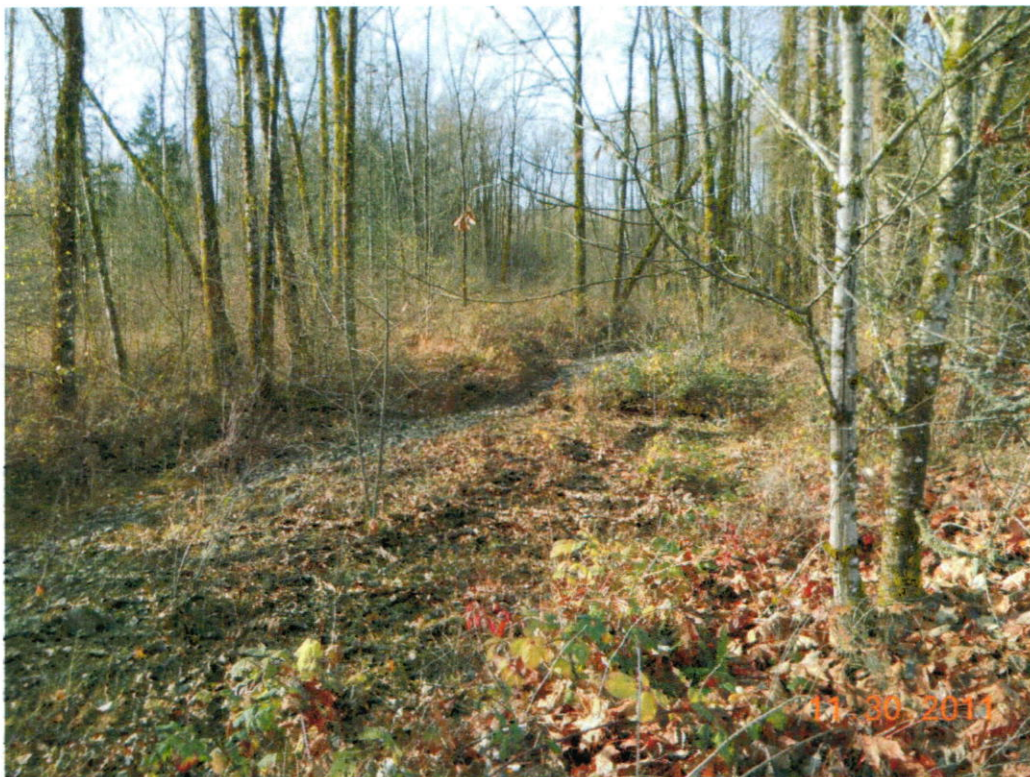
Photo 25. Looking west from Location #10 at floodplain adjacent to Storedahl Pit Road. Historic location of E.F. Lewis River channel.

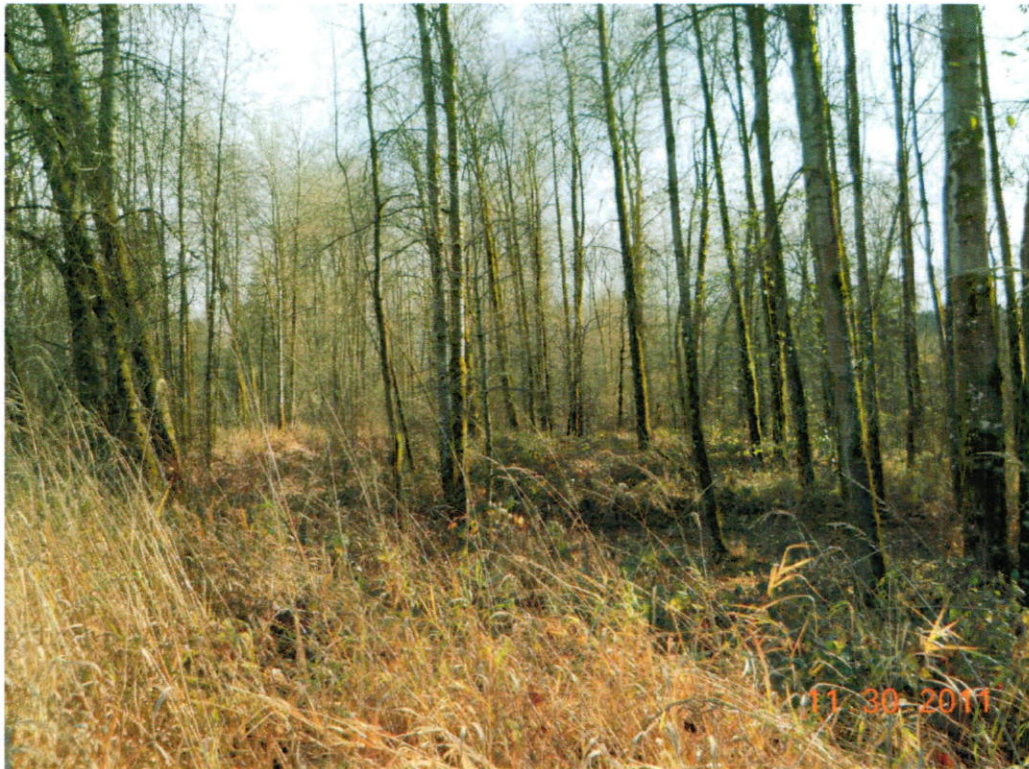
Photo 26. Looking southeast from Location #11 at floodplain adjacent to Storedahl Pit Road. Historic location of E.F. Lewis River channel.

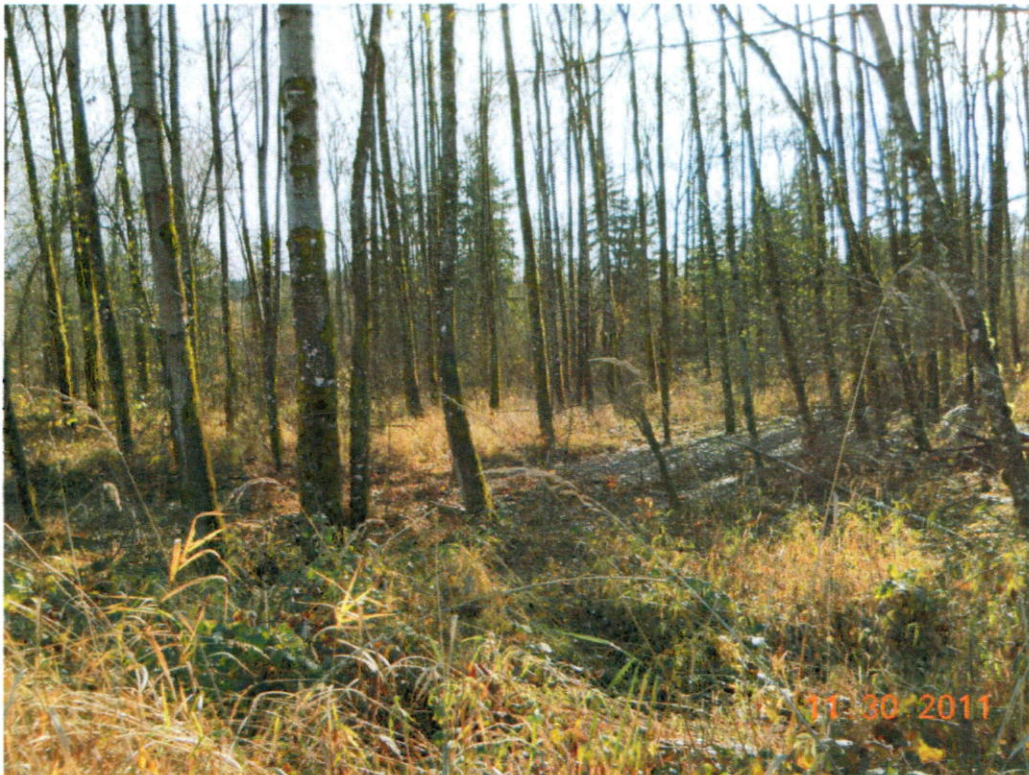
Photo 27. Looking south from Location #11 at floodplain adjacent to Storedahl Pit Road. Historic location of E.F. Lewis River channel.

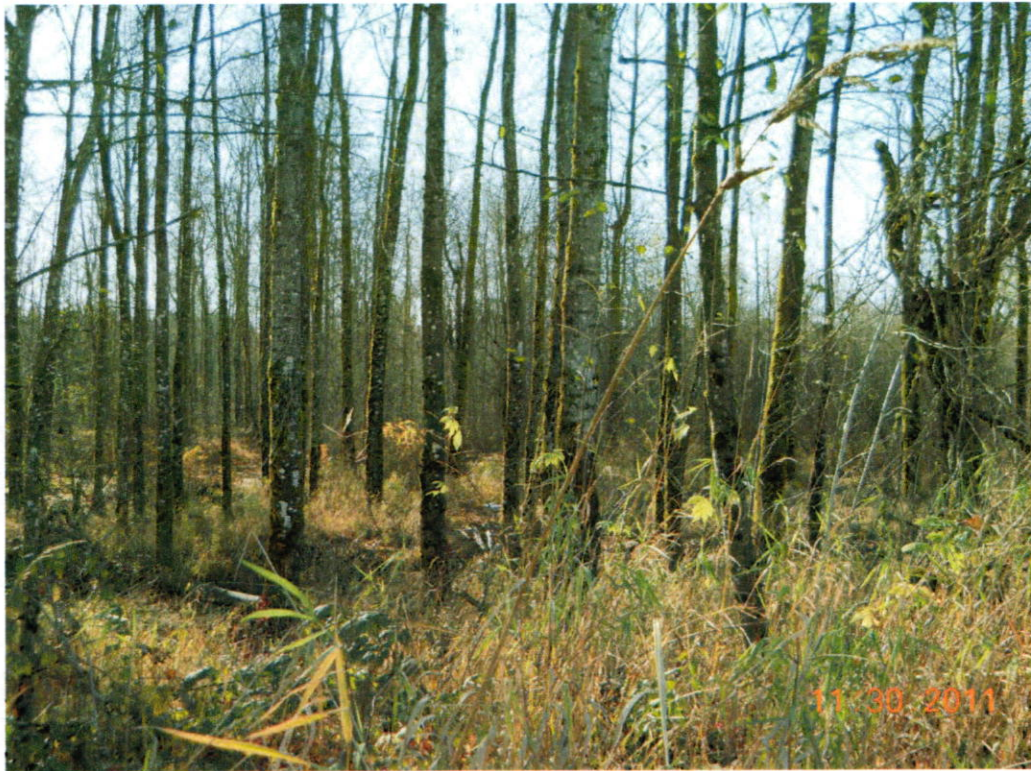
Photo 28. Looking west southwest from Location #11 at floodplain adjacent to Storedahl Pit Road. Historic location of E.F. Lewis River channel.

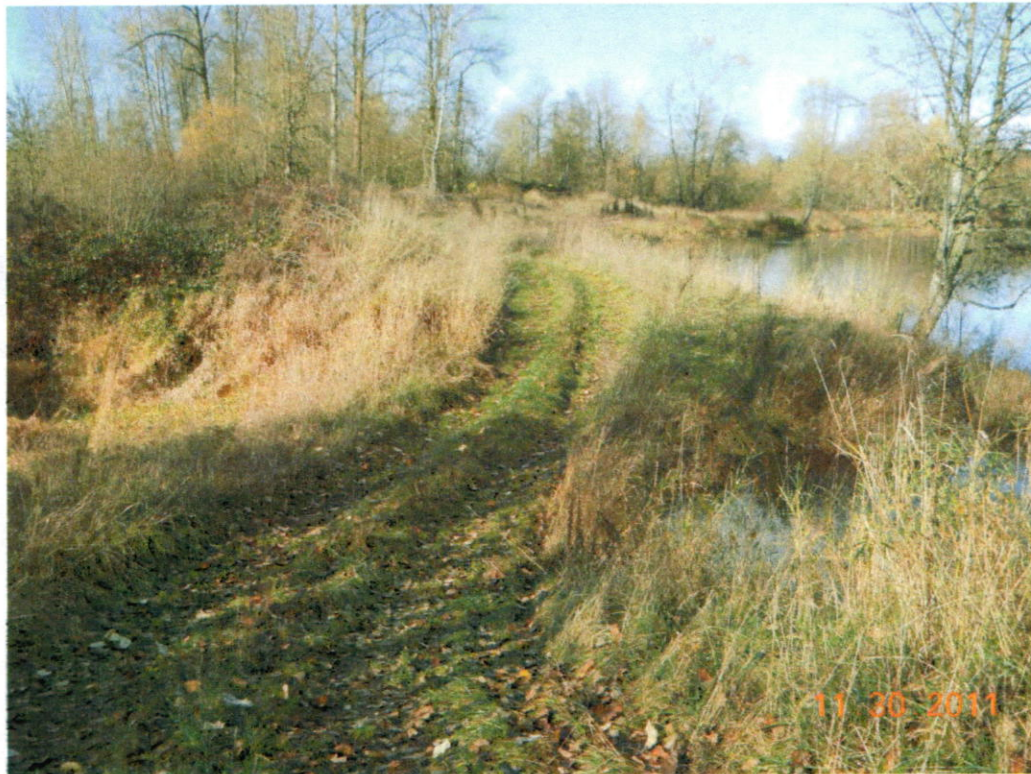
Photo 29. Looking northwest from Location #12 at Daybreak Pond #5 overflow into E.F. Lewis River floodplain.

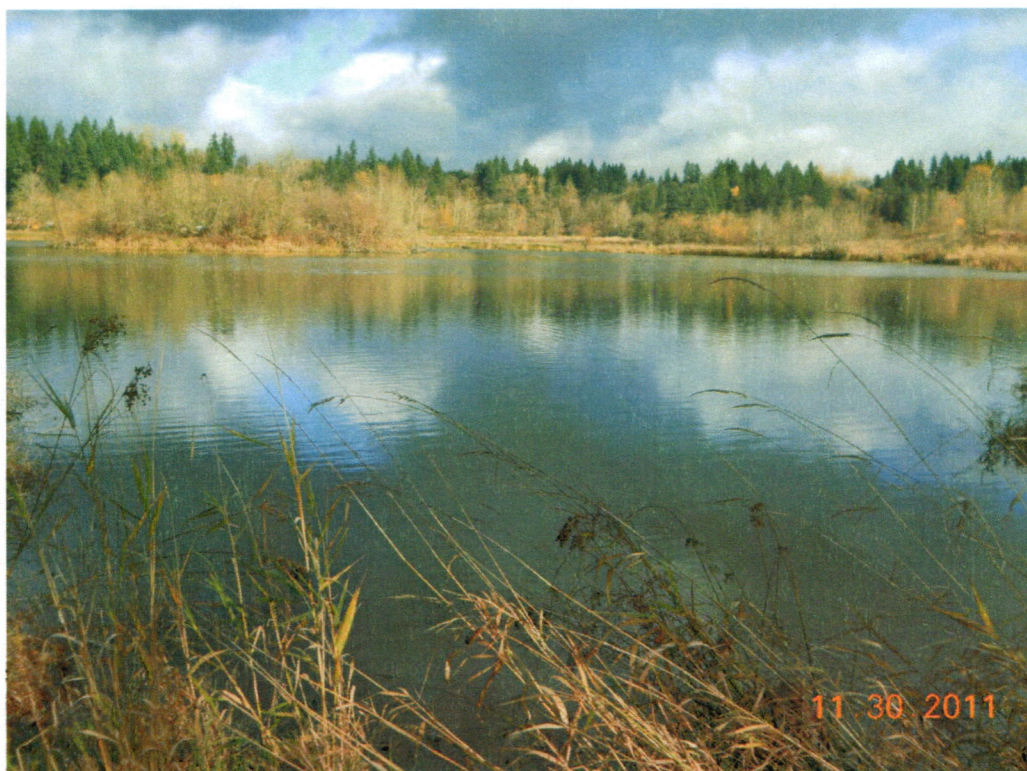
Photo 30. Looking northeast from Location # 12 at Daybreak Pond #5.

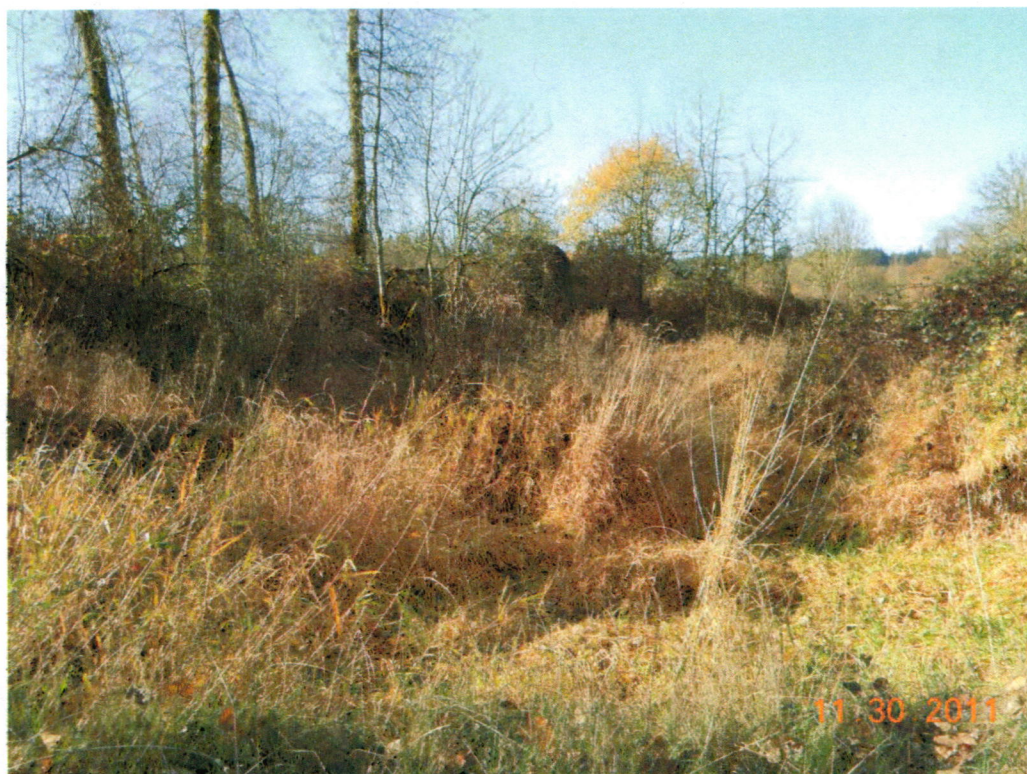
Photo 31. Looking west northwest from Location #12 at E.F. Lewis River floodplain.
