Photographic Log Base Map - November 30, 2011

# Technical Memo

**Date:** December 13, 2011

**Subject:** MEM-07 Monitoring Report – November 30, 2011 Field Reconnaissance

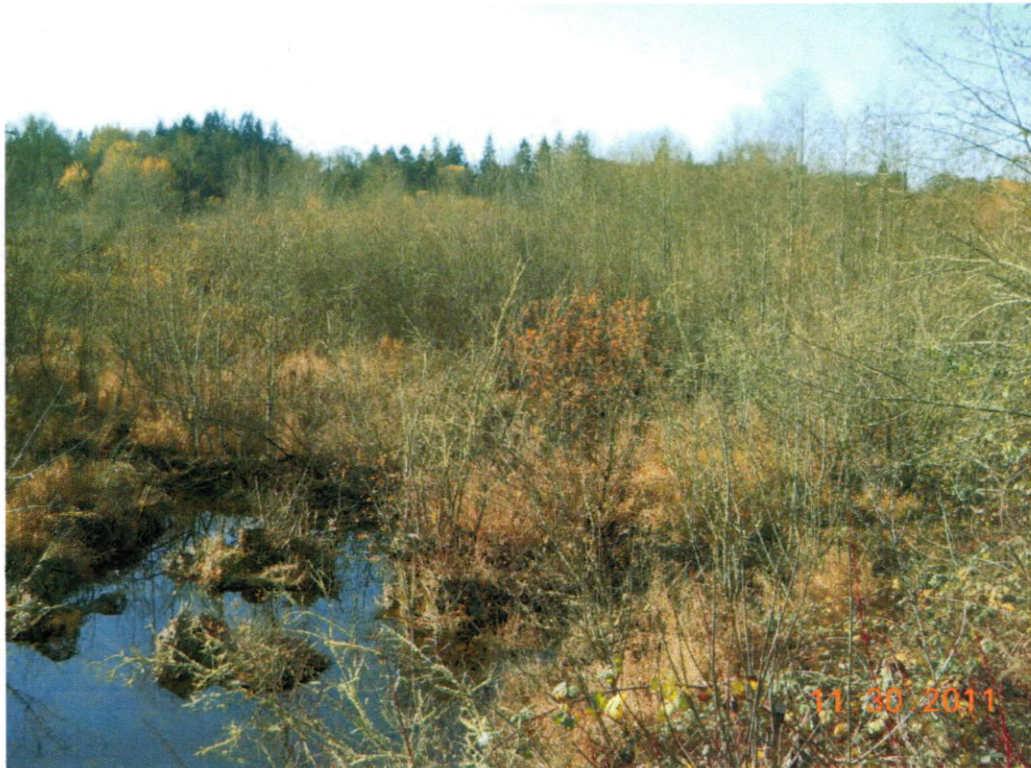
Photo 32. Looking west from Location #13 at E.F. Lewis River floodplain.

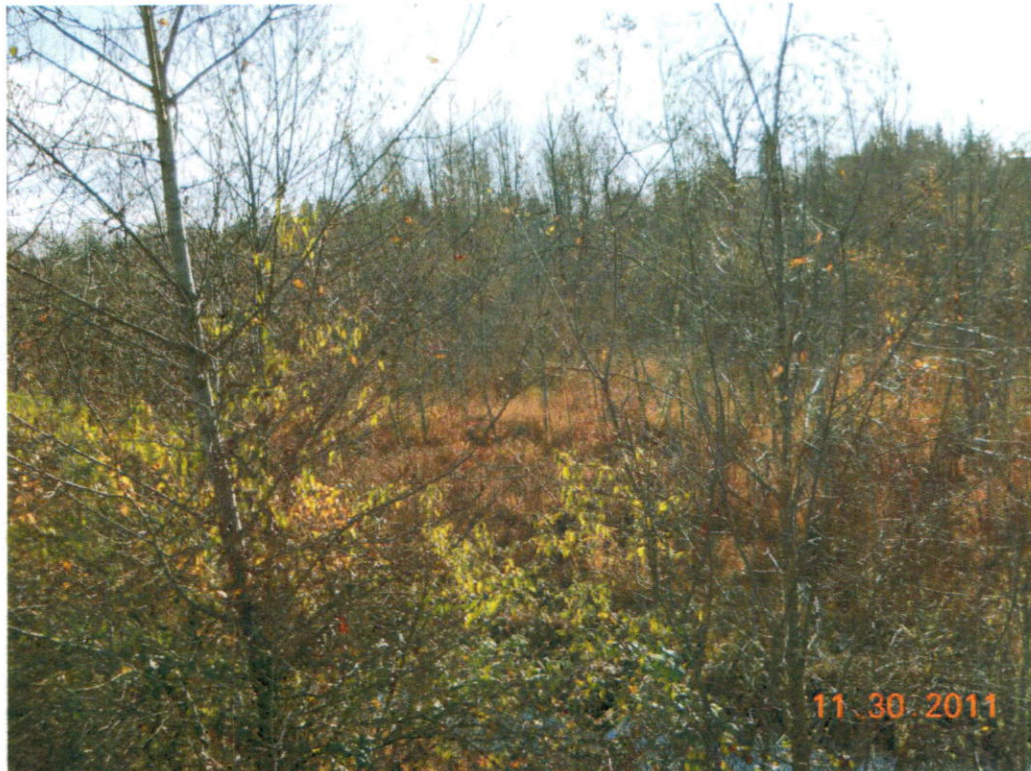
Photo 33. Looking southeast from Location #13 at E.F. Lewis River floodplain.

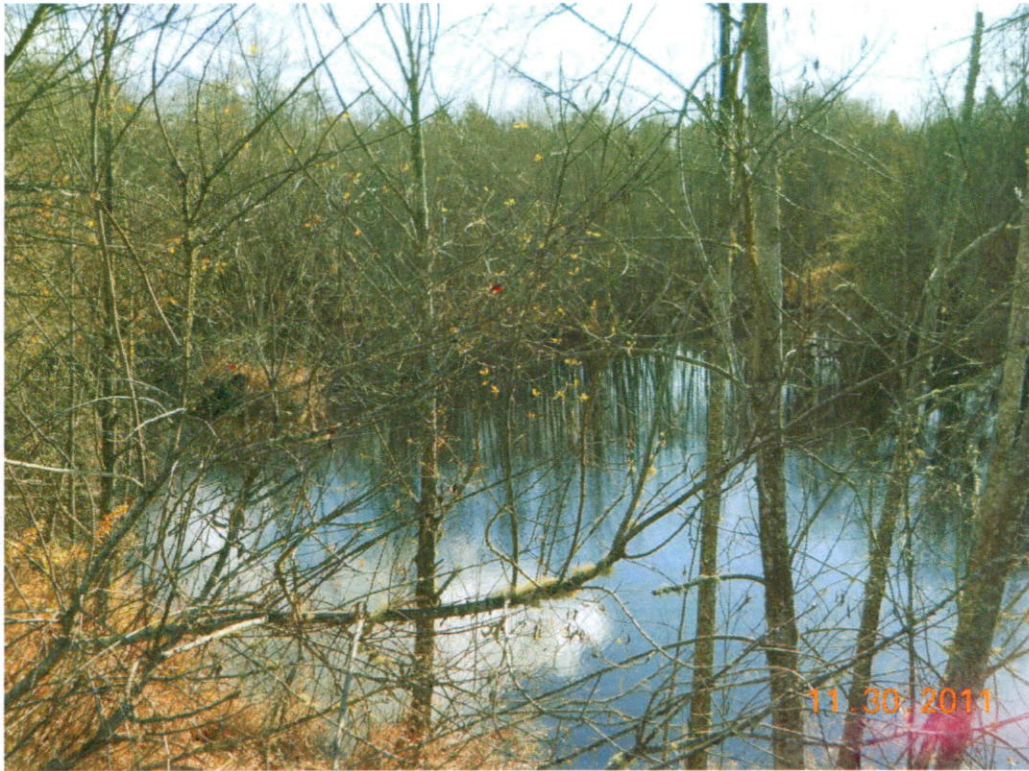
Photo 34. Looking south southeast from Location #14 at historic E.F. Lewis River channel.

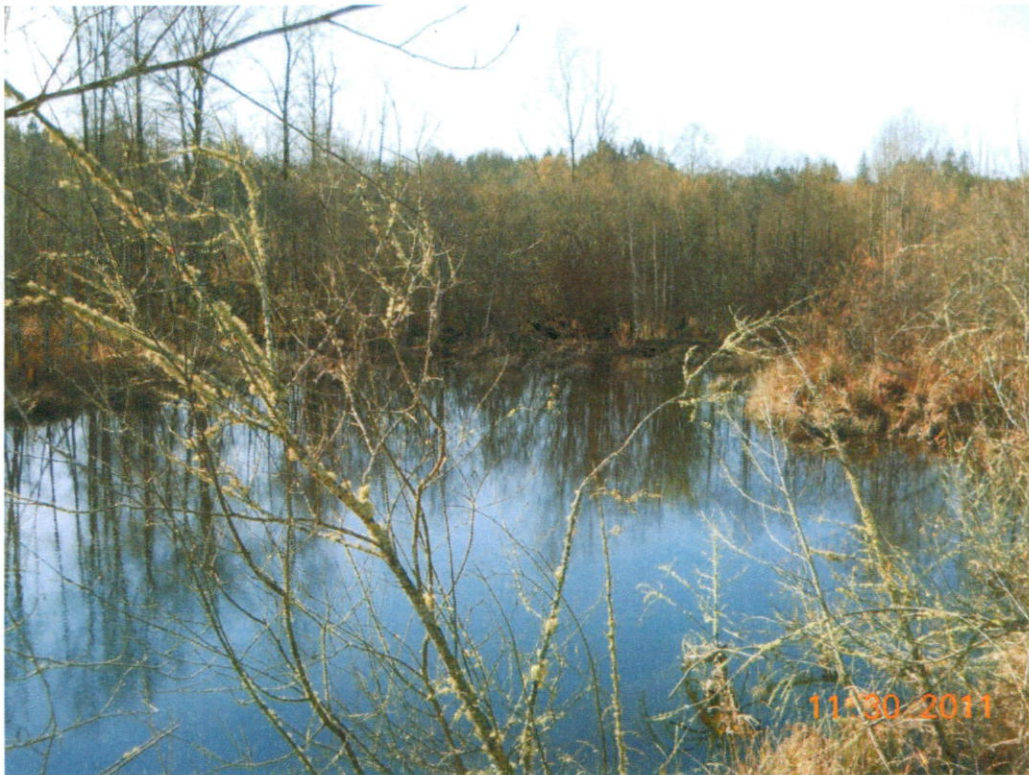
Photo 35. Looking west from Location #14 at historic E.F. Lewis River channel.

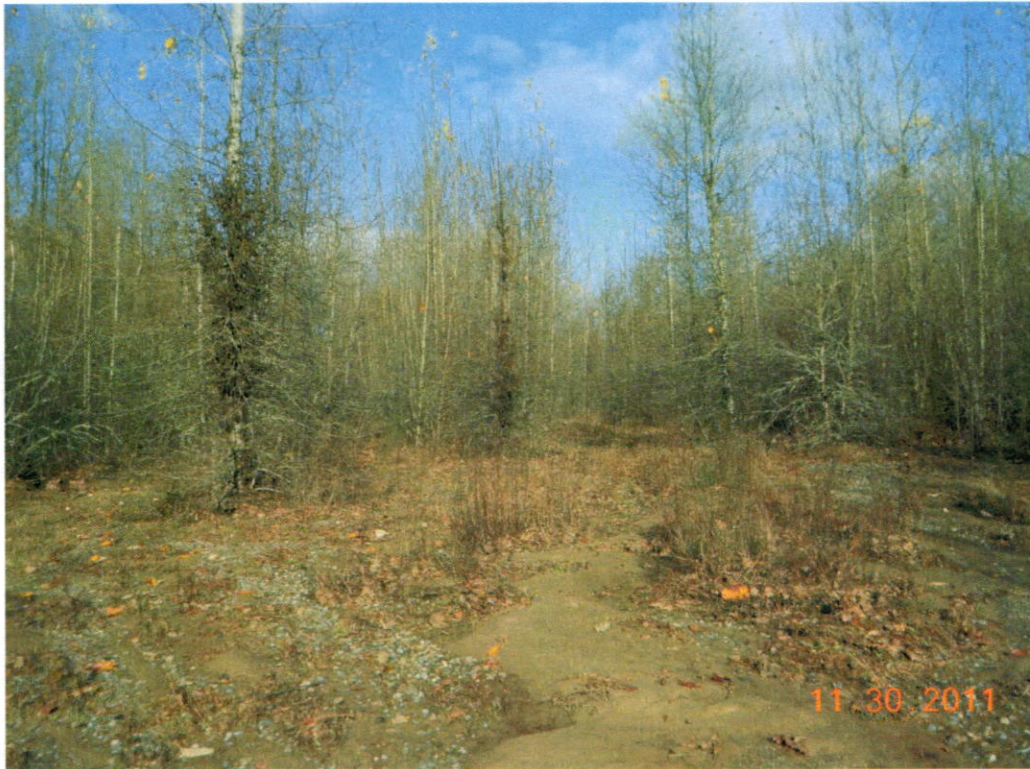
Photo 36. Looking north northeast from Location # 15 along alignment of historic E.F. Lewis River channel.

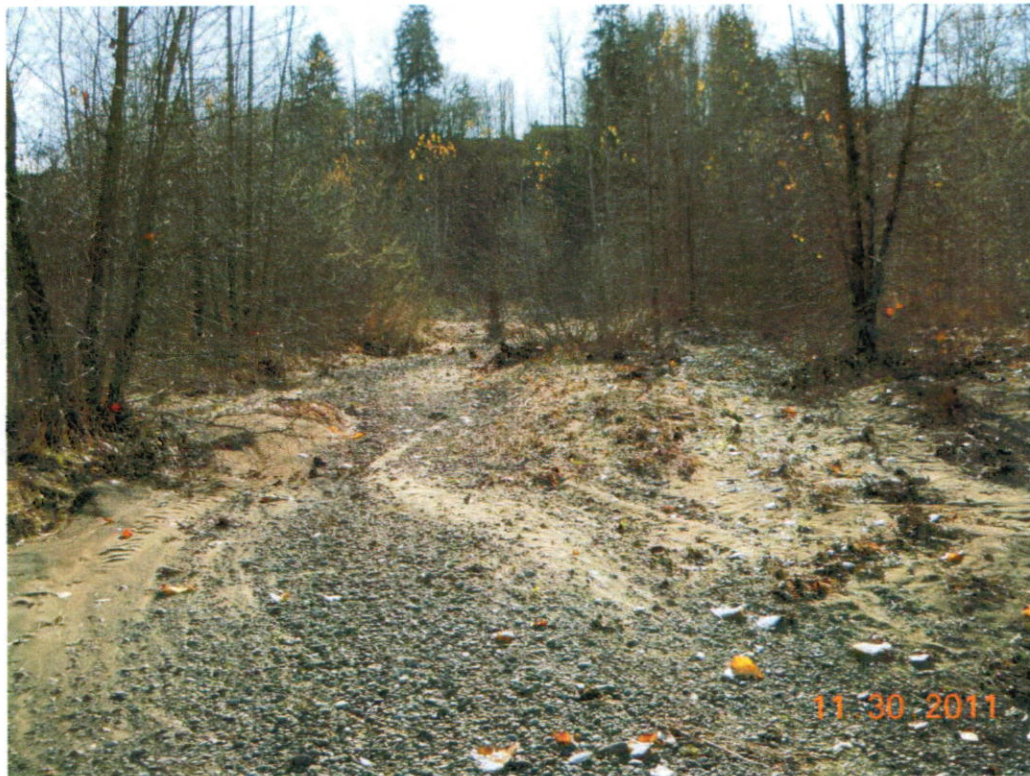
Photo 37. Looking south southwest from Location #15 along alignment of historic E.F. Lewis River channel.

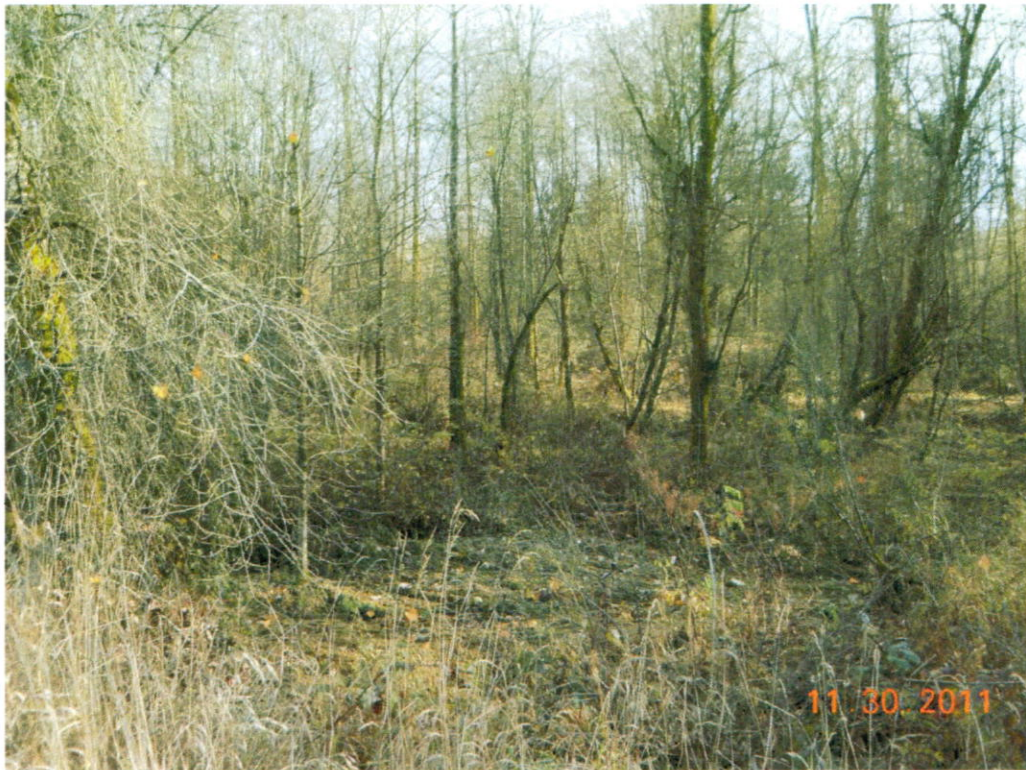
Photo 38. Looking east southeast from Location #16 at E. F. Lewis River floodplain. Historic location of E.F. Lewis River channel.

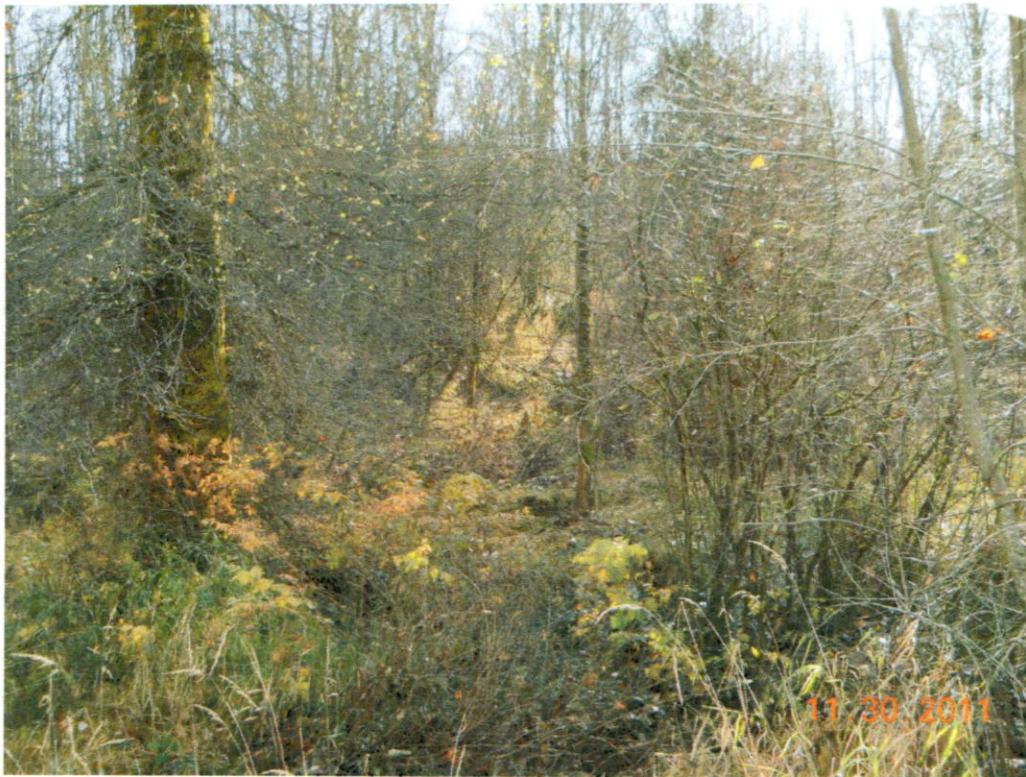
Photo 39. Looking west southwest from Location #16 at E.F. Lewis River floodplain. Historic location of E.F. Lewis River channel.
