## **Technical Memo**

MEM-07 Monitoring Report – March 28, 2013 Field Reconnaissance

WEST Consultants conducted the third annual field reconnaissance of the East Fork Lewis River in the vicinity of the Daybreak Mine as required under MEM-07 of the Habitat Conservation Plan. The reconnaissance was conducted by Hans R. Hadley P.E. and Thomas R. Grindeland P.E. on March 28, 2013. Observations of the river and floodplain were made to determine the likelihood of the river avulsing into the existing Daybreak ponds. This memo documents the results of that field reconnaissance. The highest discharge that occurred during winter 2012/2013 was 7,570 cfs which occurred on November 19, 2012. This is less than a 2-year recurrence interval peak discharge. Photographs of current conditions were taken at identical locations to those taken in November 2011 and utilize the same location number and photo number. The photograph locations are shown on an aerial photo base map (Appendix A) from August 2011. Arrows are depicted on the map to indicate the direction in which each photo was taken. A corresponding photographic log is provided in Appendix B.

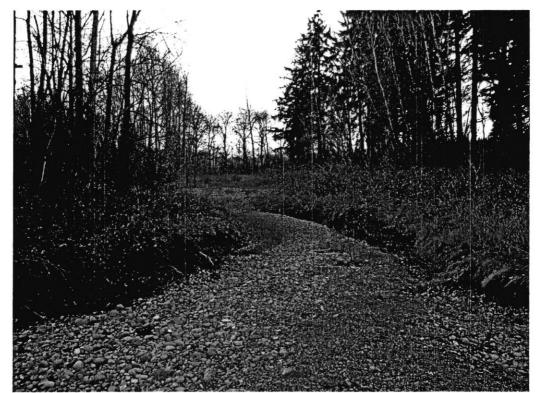
Photo 1. Looking northwest from Location #1 along secondary floodplain channel.

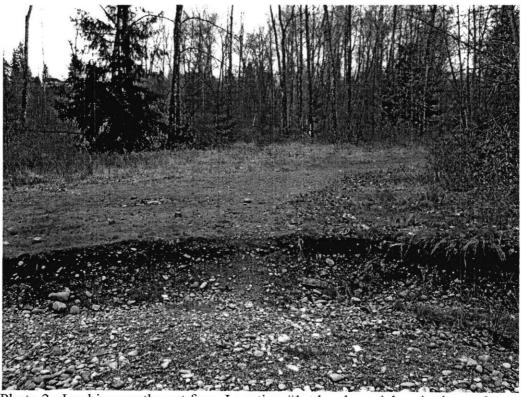
Photo 2. Looking southwest from Location #1at headcut nick point located at upstream end of secondary floodplain channel.

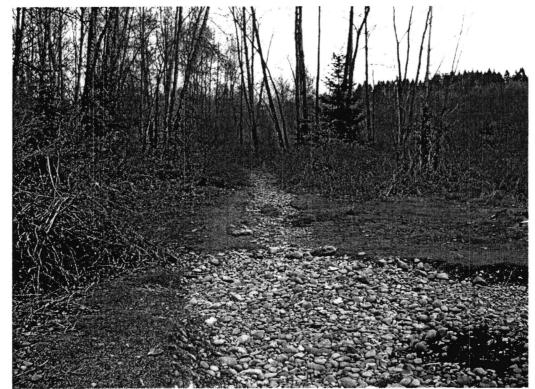
Photo 3. Looking south southeast from Location #1 toward County Pond #2.

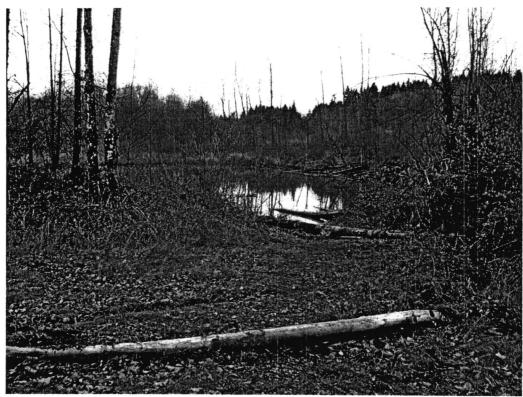
Photo 4. Looking southeast from Location #2 at overflow path from County Pond #2.

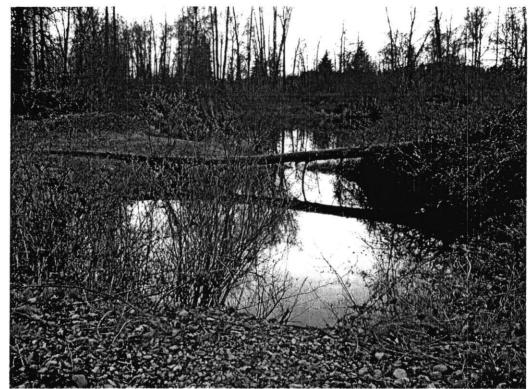
Photo 5. Looking northwest from Location #3 at overflow channel into County Pond #1.

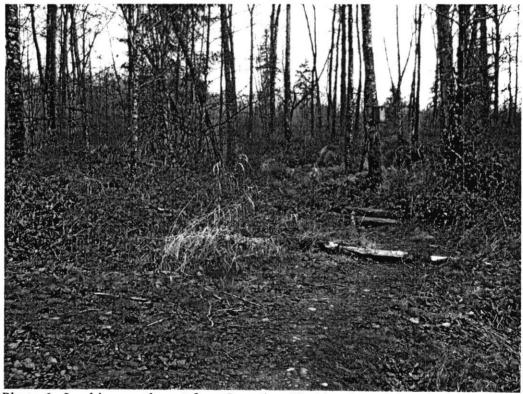
Photo 6. Looking southwest from Location #3 at headcut nick point located at upstream end of overflow channel into County Pond #1.

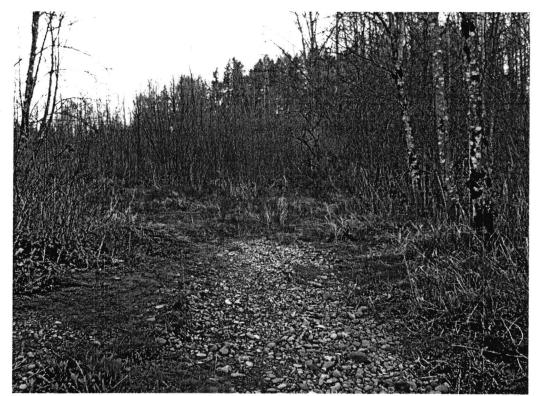
Photo 7. Looking north from Location #4 at overflow channel from E.F. Lewis River into County Pond #2.

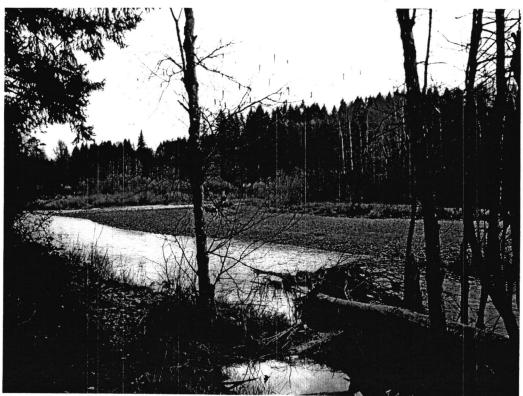
Photo 8. Looking south from Location #4 at upstream end of overflow channel from E.F. Lewis River into County Pond #2. Recently abandoned E.F. Lewis River channel in background.

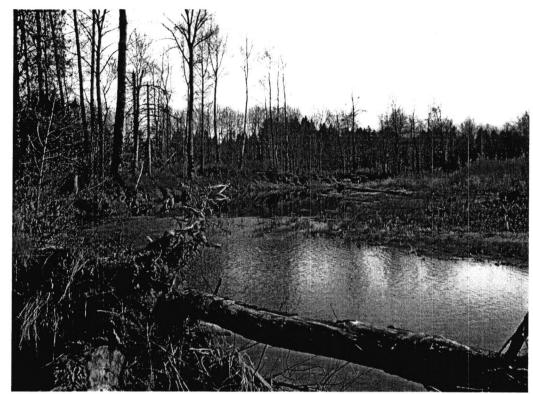
Photo 9A. Looking northeast northeast from Location #5A at right bank of recently abandoned section of E.F. Lewis River at location of overflow channel that leads to County Pond #2.

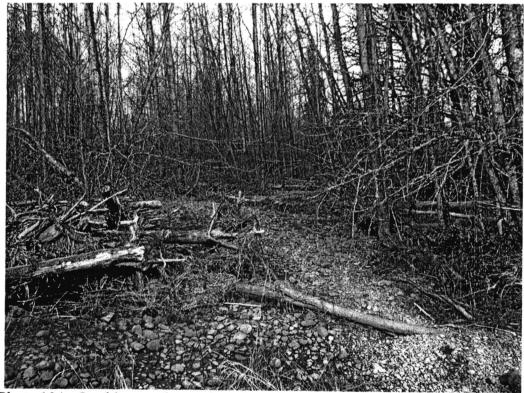
Photo 10A. Looking northwest from Location #5A at upstream end of secondary channel.

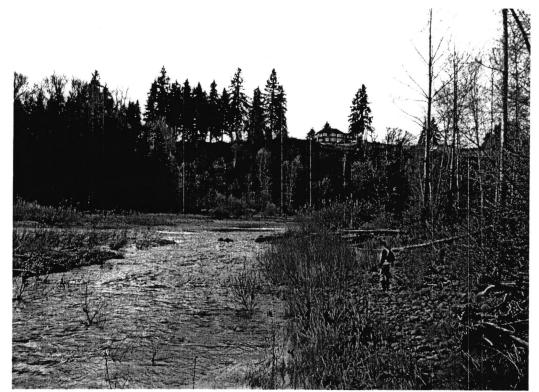
Photo 11A. Looking south from Location #5A at downstream end of recently abandoned section of E.F. Lewis River.

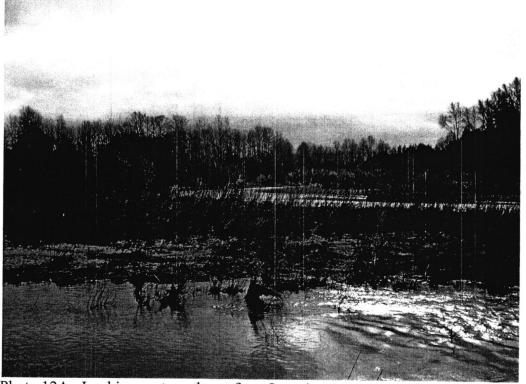
Photo 12A. Looking east southeast from Location #5A at downstream end of second E.F. Lewis meander cutoff channel.

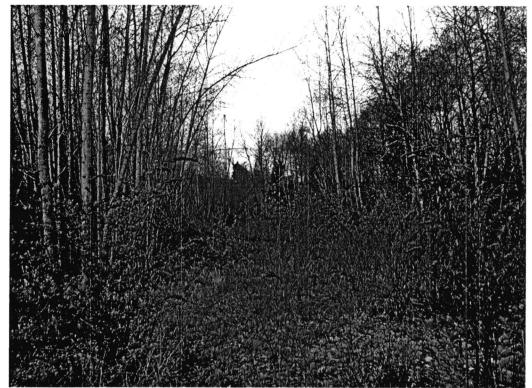
Photo 18. Looking west from Location #6 at upstream end of secondary floodplain channel.

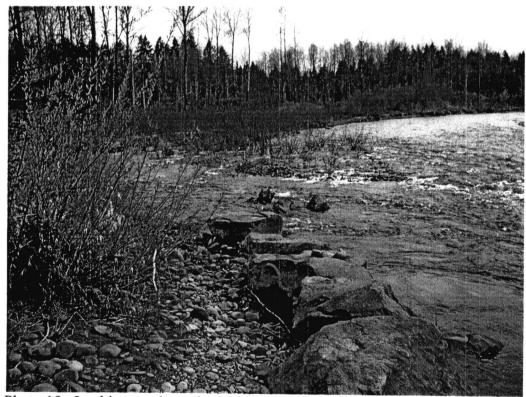
Photo 19. Looking north northeast from Location #6 at rock vane located along the right bank of recently abandoned section of E.F. Lewis River.

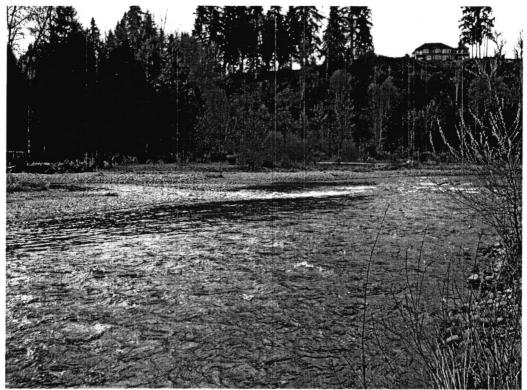
Photo 20. Looking southeast from Location #6 at downstream end of recently abandoned section of E.F. Lewis River. Note first cutoff channel at left side of photo.

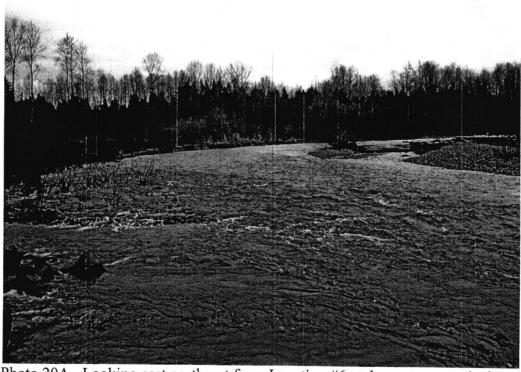
Photo 20A. Looking east northeast from Location #6 at downstream end of second E.F. Lewis River meander cutoff channel.

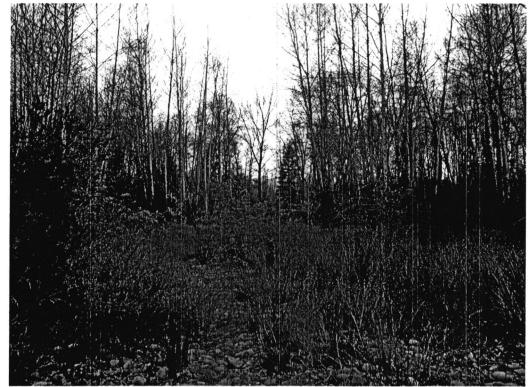
Photo 21. Looking northwest from Location #7 at upstream end of secondary floodplain channel.

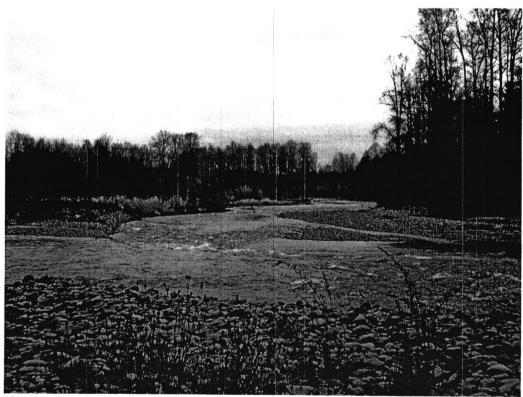
Photo 21A. Looking east southeast from Location #7 at downstream end of first E.F. Lewis River meander cutoff channel.

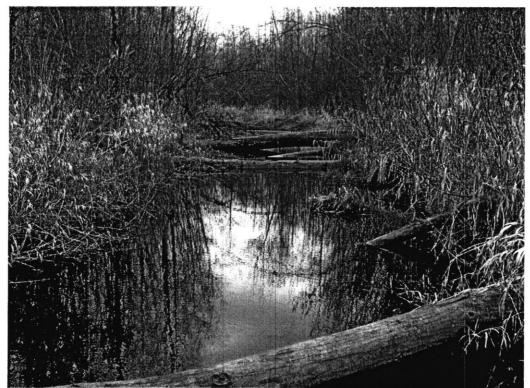
Photo 22. Looking east northeast from Location #8 at downstream end of secondary floodplain channel.

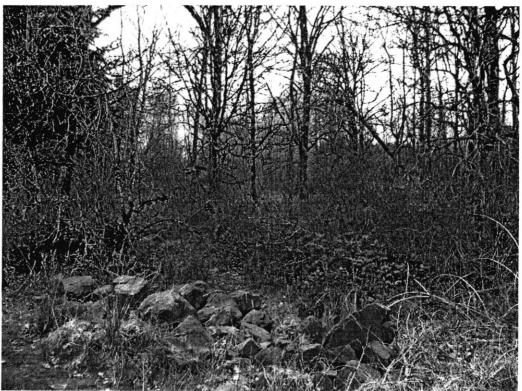
Photo 23. Looking southeast from Location #9 in direction of floodplain overflow channel shown in Photo 1.

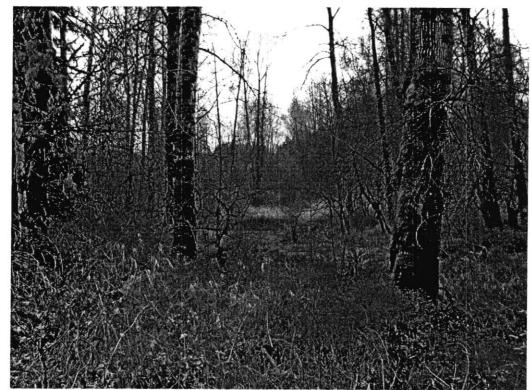
Photo 24. Looking southeast from Location #10 at floodplain adjacent to Storedahl Pit Road. Historic location of E.F. Lewis River channel.

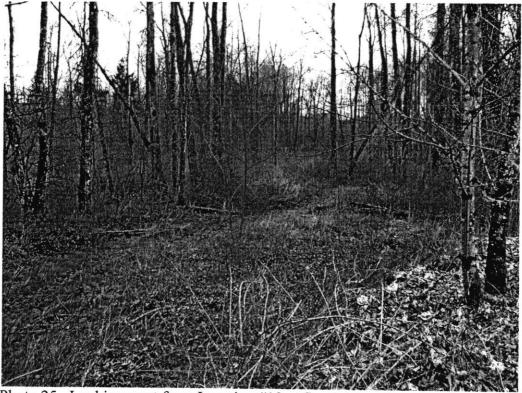
Photo 25. Looking west from Location #10 at floodplain adjacent to Storedahl Pit Road. Historic location of E.F. Lewis River channel.

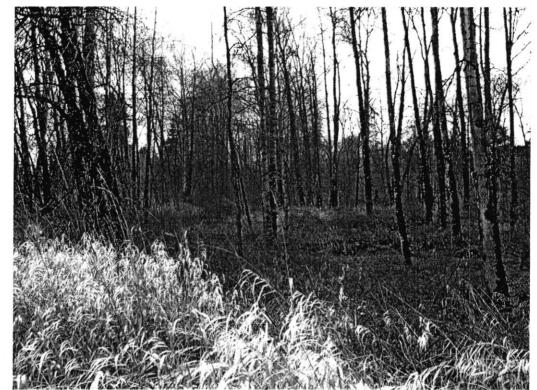
Photo 26. Looking southeast from Location #11 at floodplain adjacent to Storedahl Pit Road. Historic location of E.F. Lewis River channel.

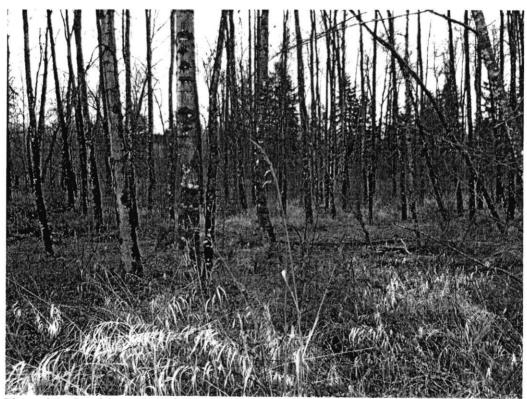
Photo 27. Looking south from Location #11 at floodplain adjacent to Storedahl Pit Road. Historic location of E.F. Lewis River channel.

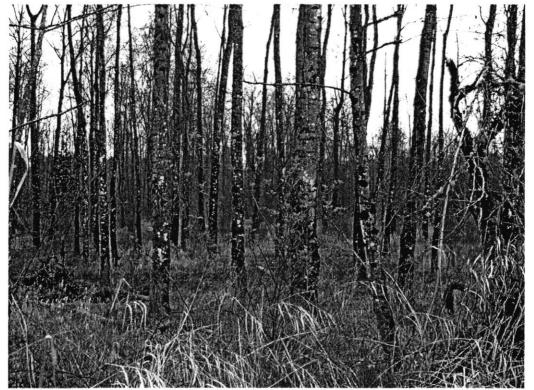
Photo 28. Looking west southwest from Location #11 at floodplain adjacent to Storedahl Pit Road. Historic location of E.F. Lewis River channel.

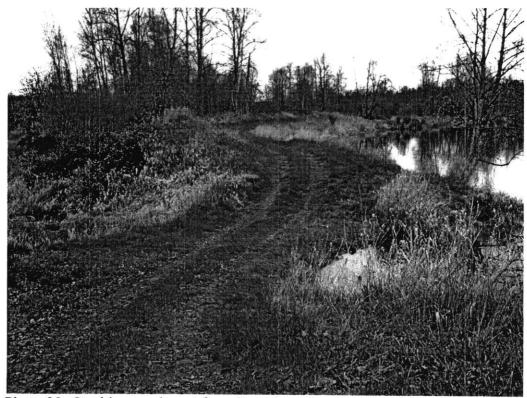
Photo 29. Looking northwest from Location #12 at Daybreak Pond #5 overflow into E.F. Lewis River floodplain.

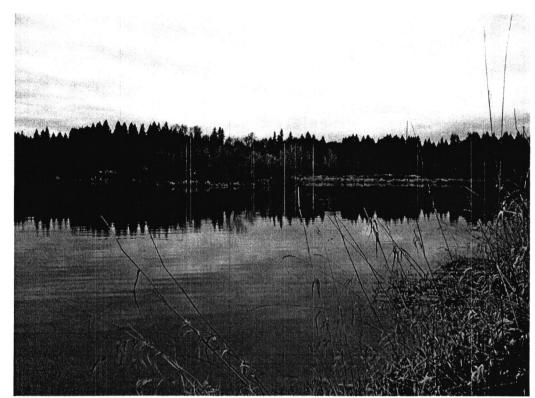
Photo 30. Looking northeast from Location # 12 at Daybreak Pond #5.

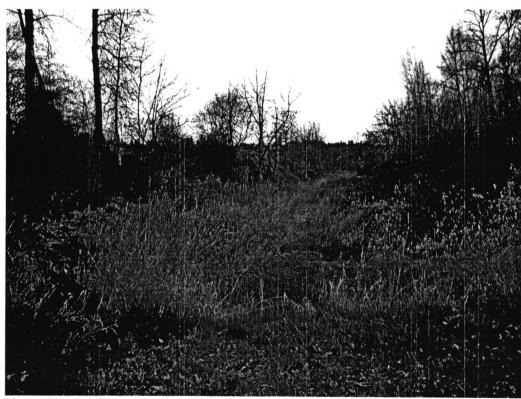
Photo 31. Looking west northwest from Location #12 at E.F. Lewis River floodplain.

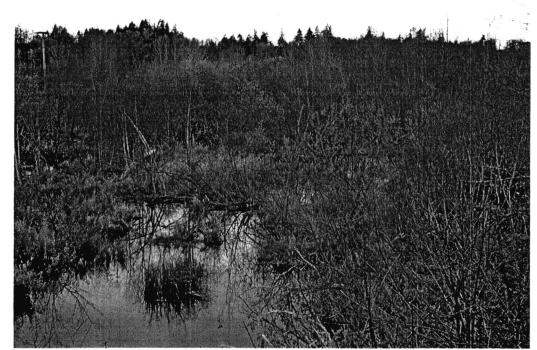
Photo 32. Looking west from Location #13 at E.F. Lewis River floodplain.

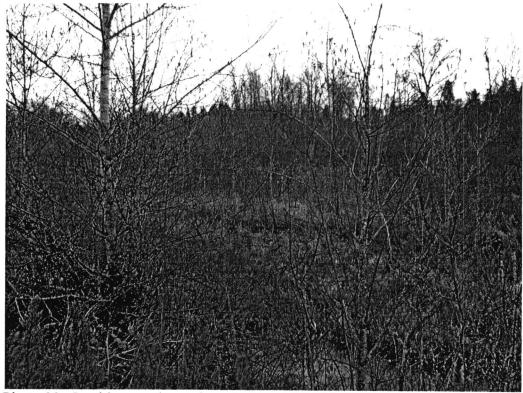
Photo 33. Looking southeast from Location #13 at E.F. Lewis River floodplain.

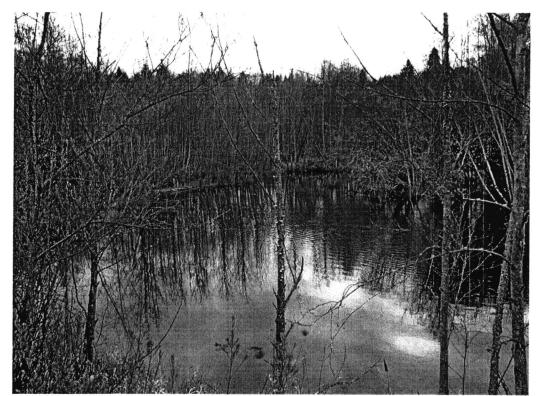
Photo 34. Looking south southeast from Location #14 at historic E.F. Lewis River channel.

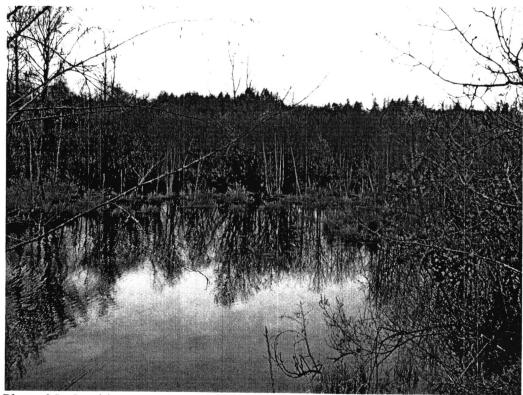
Photo 35. Looking west from Location #14 at historic E.F. Lewis River channel.

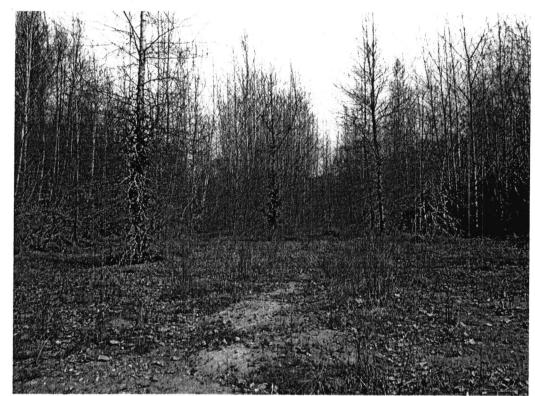
Photo 36. Looking north northeast from Location # 15 along alignment of historic E.F. Lewis River channel.

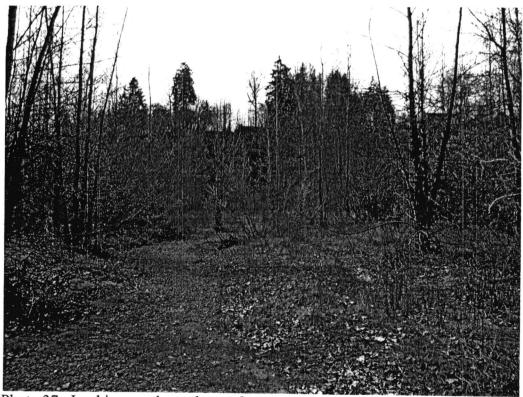
Photo 37. Looking south southwest from Location #15 along alignment of historic E.F. Lewis River channel.

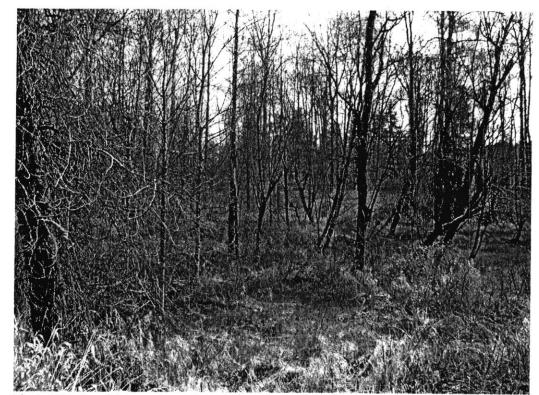
Photo 38. Looking east southeast from Location #16 at E. F. Lewis River floodplain. Historic location of E.F. Lewis River channel.

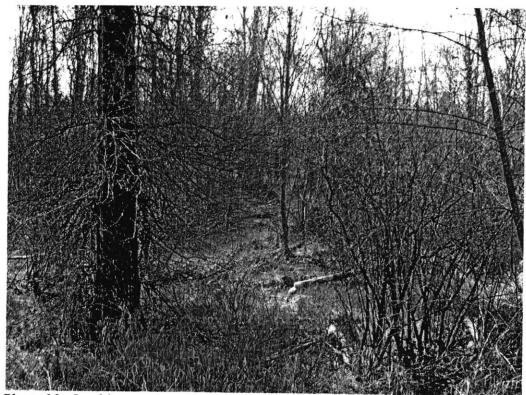
Photo 39. Looking west southwest from Location #16 at E.F. Lewis River floodplain. Historic location of E.F. Lewis River channel.
