## **Technical Memo**

MEM-07 Monitoring Report - February 5, 2014 Field Reconnaissance

WEST Consultants conducted the fourth annual field reconnaissance of the East Fork Lewis River in the vicinity of the Daybreak Mine as required under MEM-07 of the Habitat Conservation Plan. The reconnaissance was conducted by Hans R. Hadley P.E. and Thomas R. Grindeland P.E. on February 5, 2014. Observations of the river and floodplain were made to determine the likelihood of the river avulsing into the existing Daybreak ponds. This memo documents the results of that field reconnaissance. The highest discharge that occurred prior to the site visit for winter 2013/2014 was 6,660 cfs which occurred on December 2, 2013. This is less than a 2-year recurrence interval peak discharge. Photographs of current conditions were taken at identical locations to those taken in November 2011 and March 2013 and utilize the same location number and photo number. The photograph locations are shown on an aerial photo base map (Appendix A) from July 2013. Arrows are depicted on the map to indicate the direction in which each photo was taken. A corresponding photographic log is provided in Appendix B.

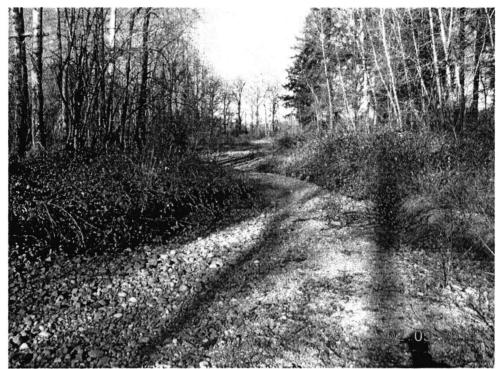
Photo 1. Looking northwest from Location #1 along secondary floodplain channel.

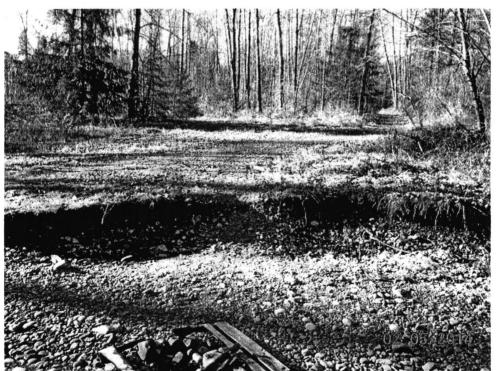
Photo 2. Looking southwest from Location #1at headcut nick point located at upstream end of secondary floodplain channel.

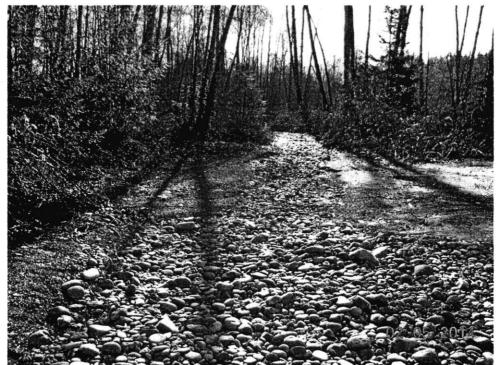
Photo 3. Looking south southeast from Location #1 toward County Pond #2.

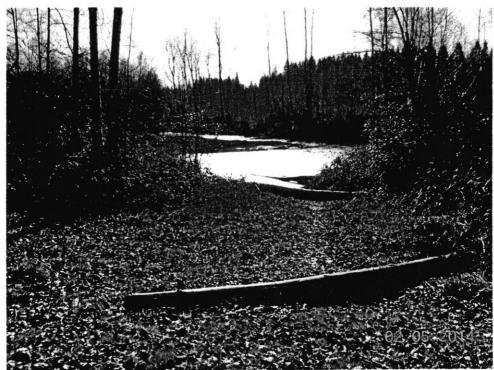
Photo 4. Looking southeast from Location #2 at overflow path from County Pond #2.

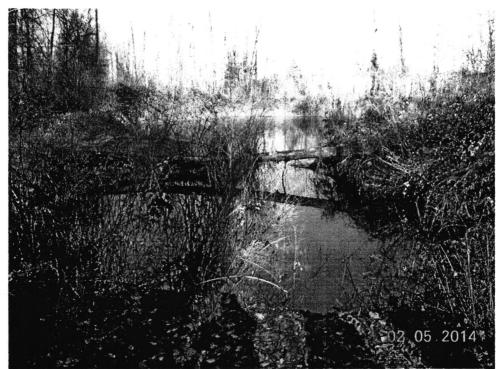
Photo 5. Looking northwest from Location #3 at overflow channel into County Pond #1.

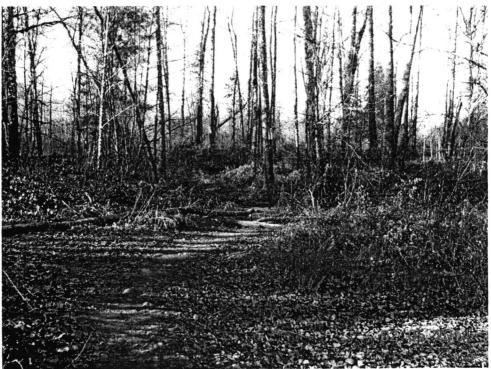
Photo 6. Looking southwest from Location #3 at headcut nick point located at upstream end of overflow channel into County Pond #1.

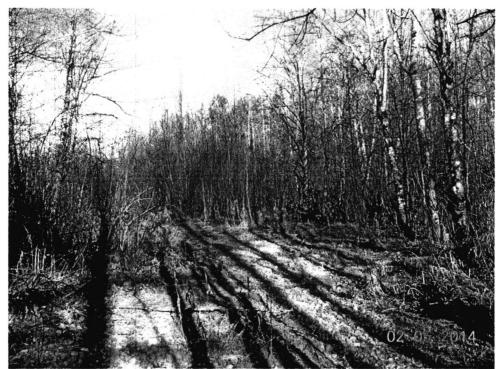
Photo 7. Looking north from Location #4 at overflow channel from E.F. Lewis River into County Pond #2.

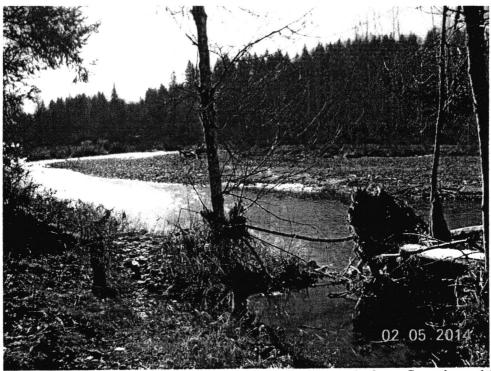
Photo 8. Looking south from Location #4 at upstream end of overflow channel from E.F. Lewis River into County Pond #2. Recently abandoned E.F. Lewis River channel in background.

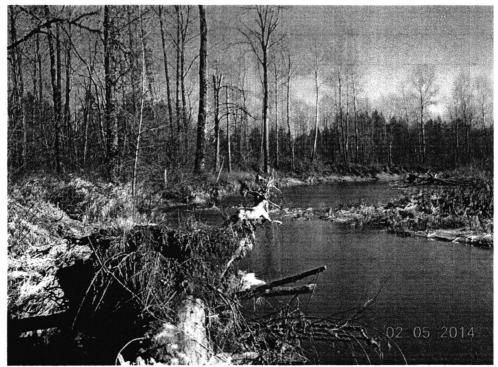
Photo 9A. Looking northeast northeast from Location #5A at right bank of recently abandoned section of E.F. Lewis River at location of overflow channel that leads to County Pond #2.

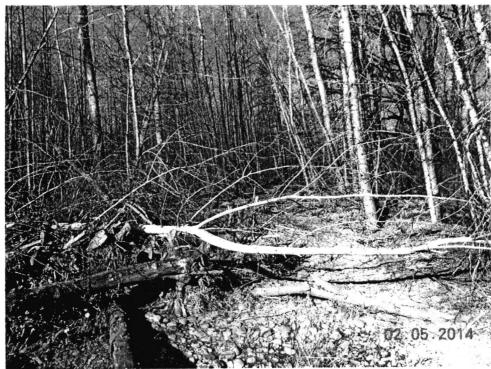
Photo 10A. Looking northwest from Location #5A at upstream end of secondary channel.

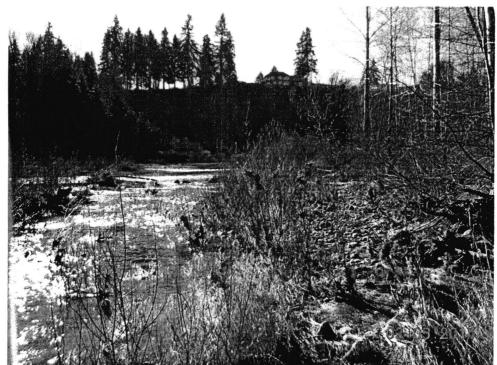
Photo 11A. Looking south from Location #5A at downstream end of recently abandoned section of E.F. Lewis River.

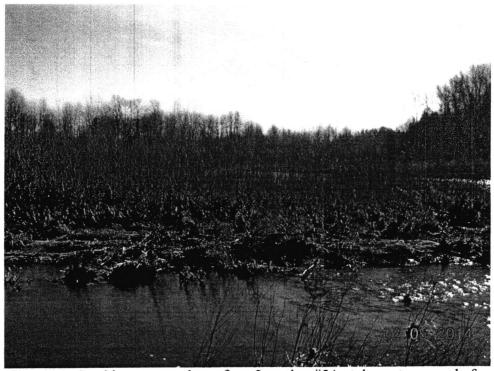
Photo 12A. Looking east southeast from Location #5A at downstream end of second E.F. Lewis meander cutoff channel.

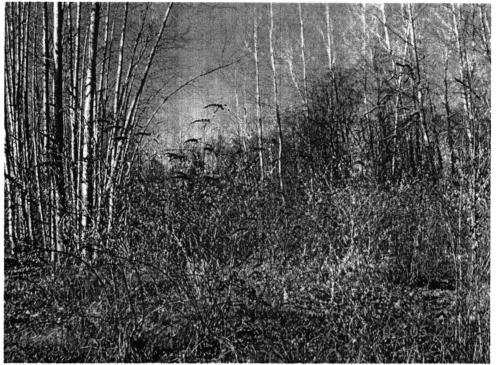
Photo 18. Looking west from Location #6 at upstream end of secondary floodplain channel.

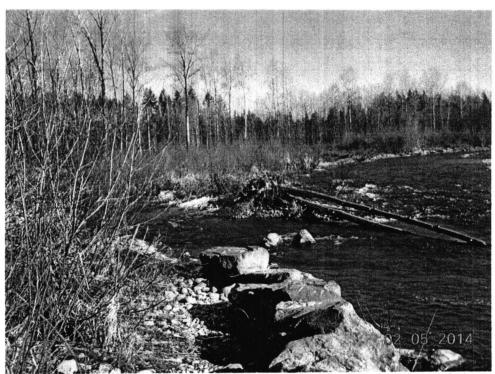
Photo 19. Looking north northeast from Location #6 at rock vane located along the right bank of recently abandoned section of E.F. Lewis River.

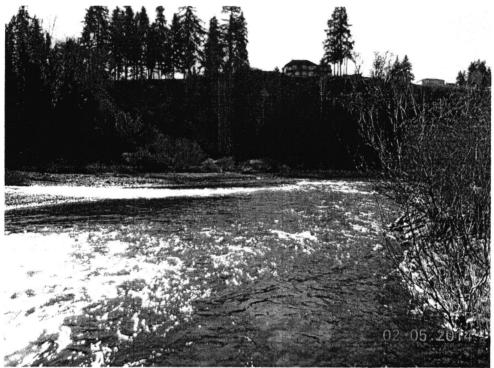
Photo 20. Looking southeast from Location #6 at downstream end of recently abandoned section of E.F. Lewis River. Note first cutoff channel at left side of photo.

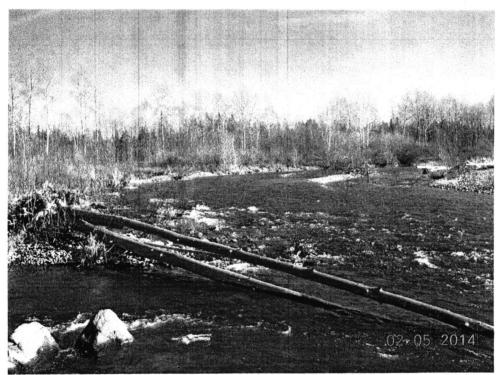
Photo 20A. Looking east northeast from Location #6 at downstream end of second E.F. Lewis River meander cutoff channel.

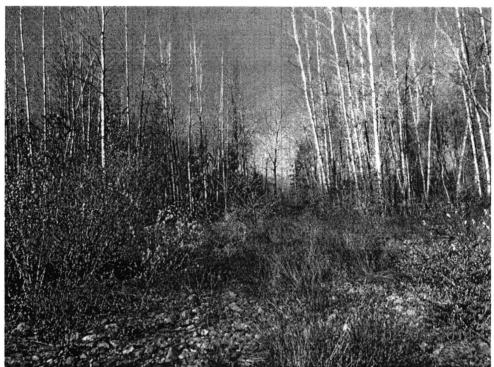
Photo 21. Looking northwest from Location #7 at upstream end of secondary floodplain channel.

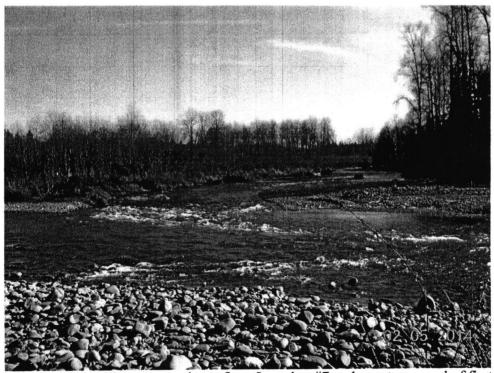
Photo 21A. Looking east southeast from Location #7 at downstream end of first E.F. Lewis River meander cutoff channel.

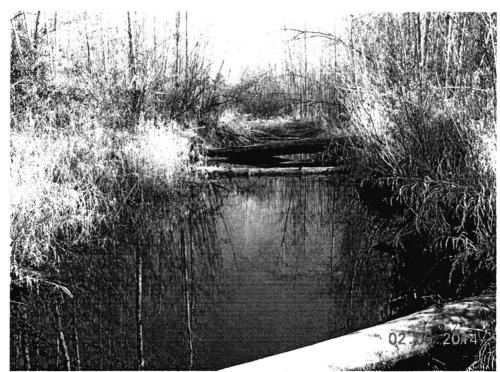
Photo 22. Looking east northeast from Location #8 at downstream end of secondary floodplain channel.

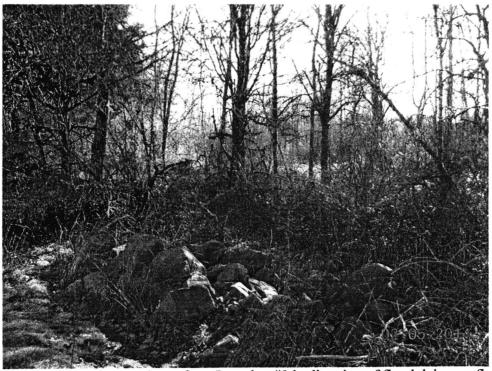
Photo 23. Looking southeast from Location #9 in direction of floodplain overflow channel shown in Photo 1.

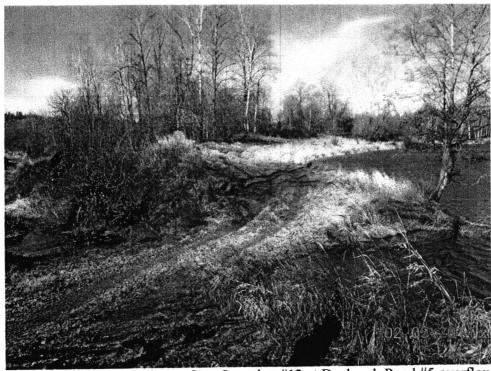
Photo 29. Looking northwest from Location #12 at Daybreak Pond #5 overflow into E.F. Lewis River floodplain.
