# Technical Memo

**Name:** Kimball Storedahl  
**Company:** J.L. Storedahl & Sons, Inc.  
**Date:** March 18, 2015  
**From:** Hans R. Hadley, P.E.  
Senior Hydraulic Engineer

**Subject:** MEM-07 Monitoring Report – March 3, 2015 Field Reconnaissance

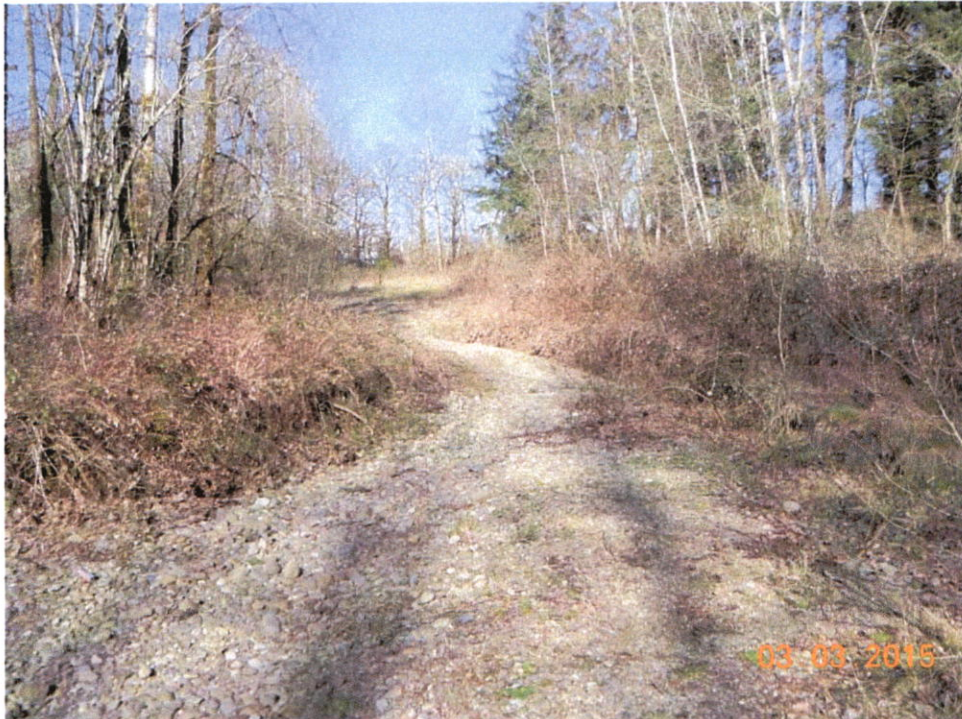
Photo 1. Looking northwest from Location #1 along secondary floodplain channel.

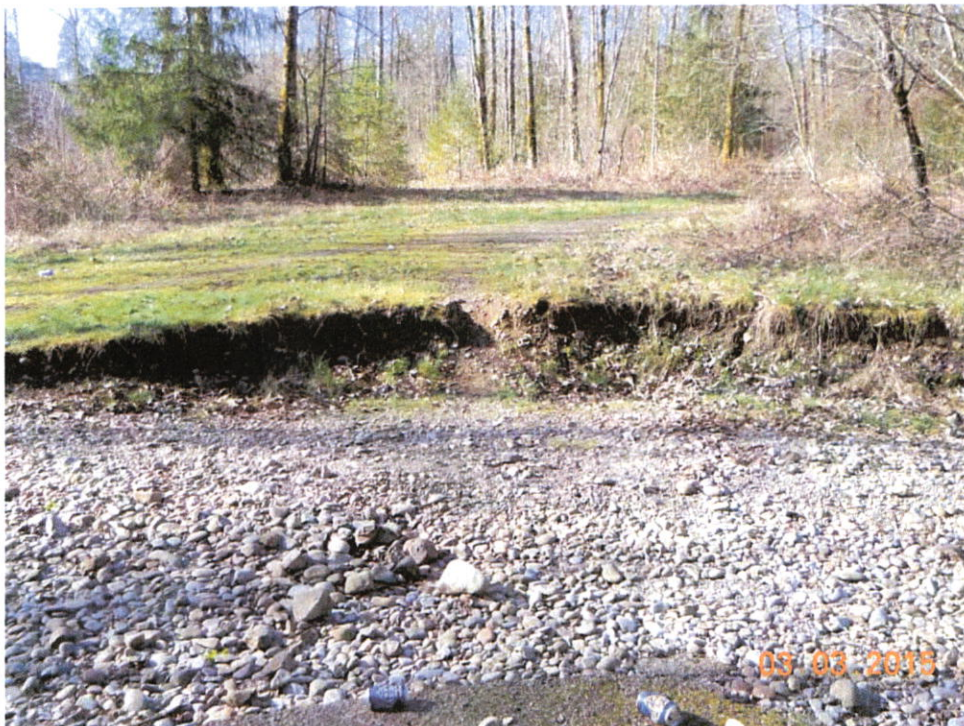
Photo 2. Looking southwest from Location #1 at headcut nick point located at upstream end of secondary floodplain channel.

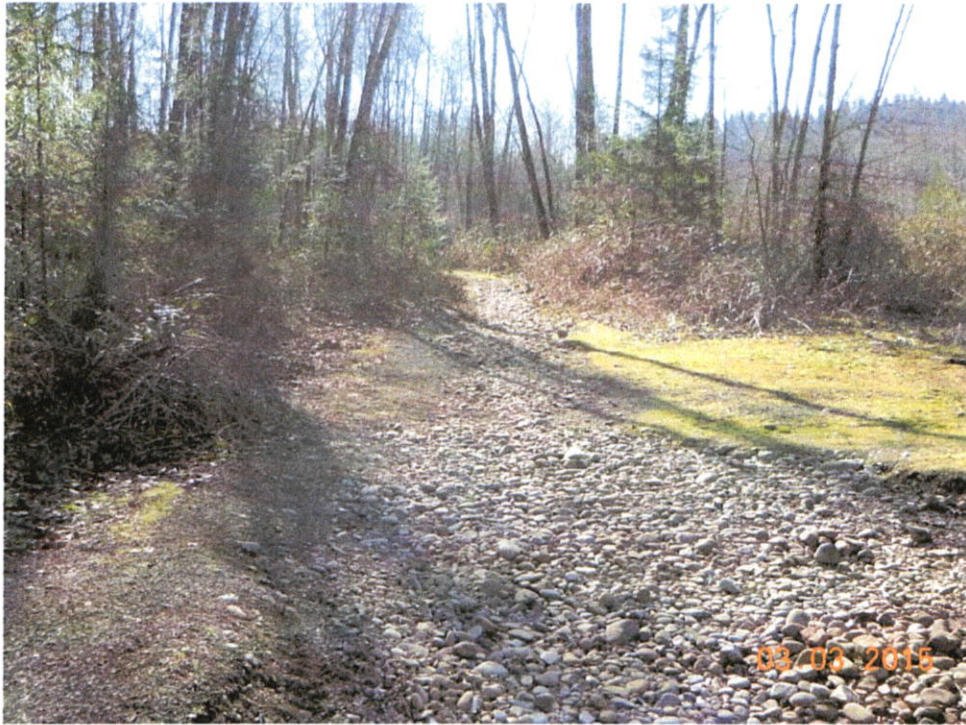
Photo 3. Looking south southeast from Location #1 toward County Pond #2.

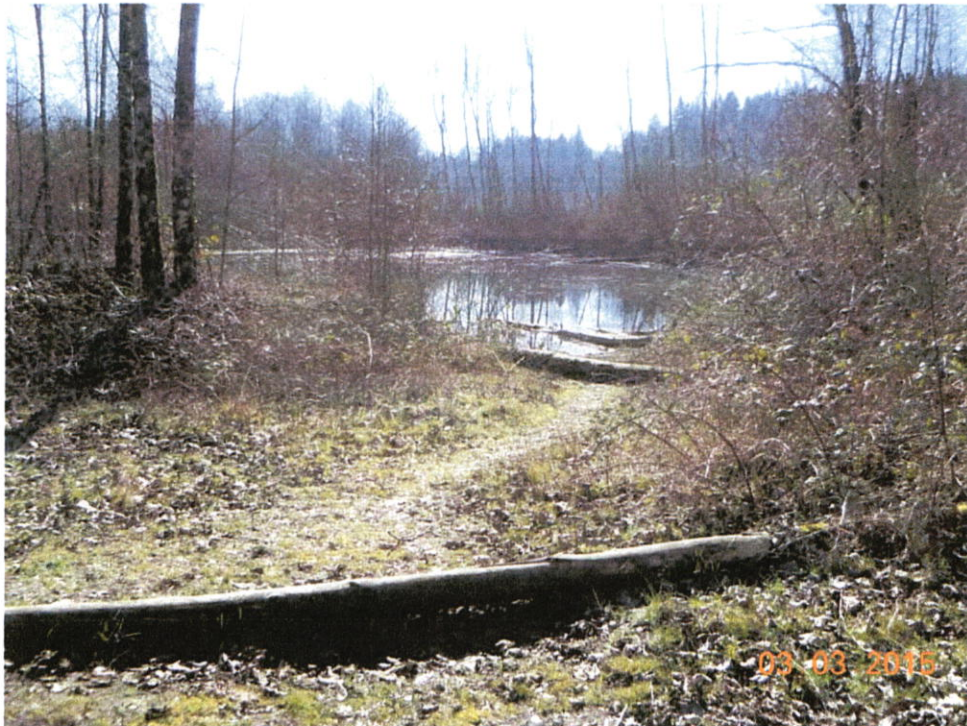
Photo 4. Looking southeast from Location #2 at overflow path from County Pond #2.

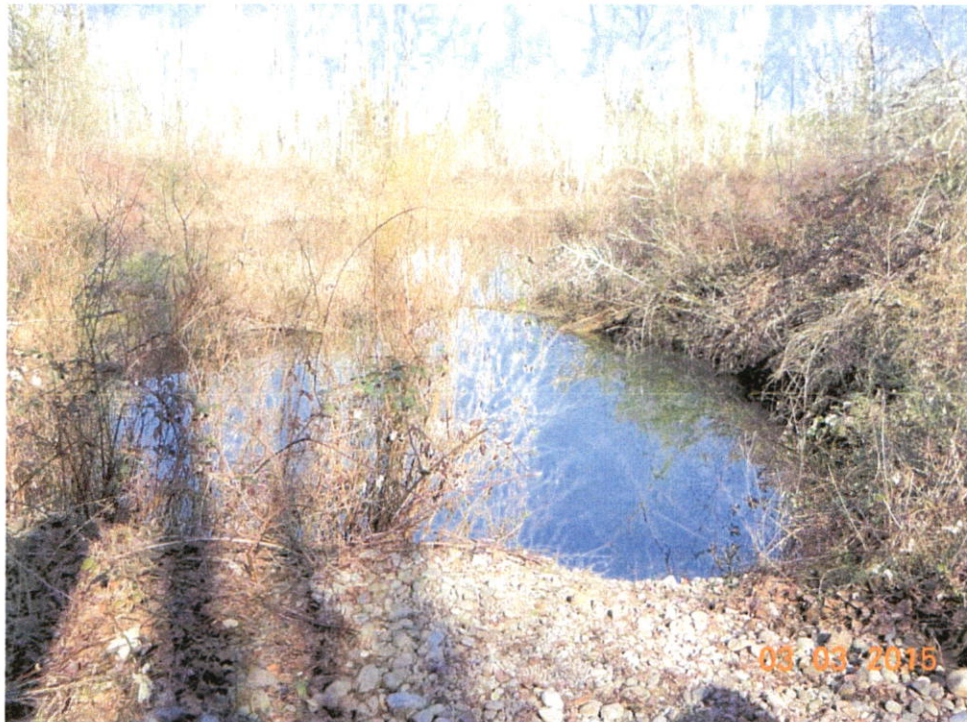
Photo 5. Looking northwest from Location #3 at overflow channel into County Pond #1.

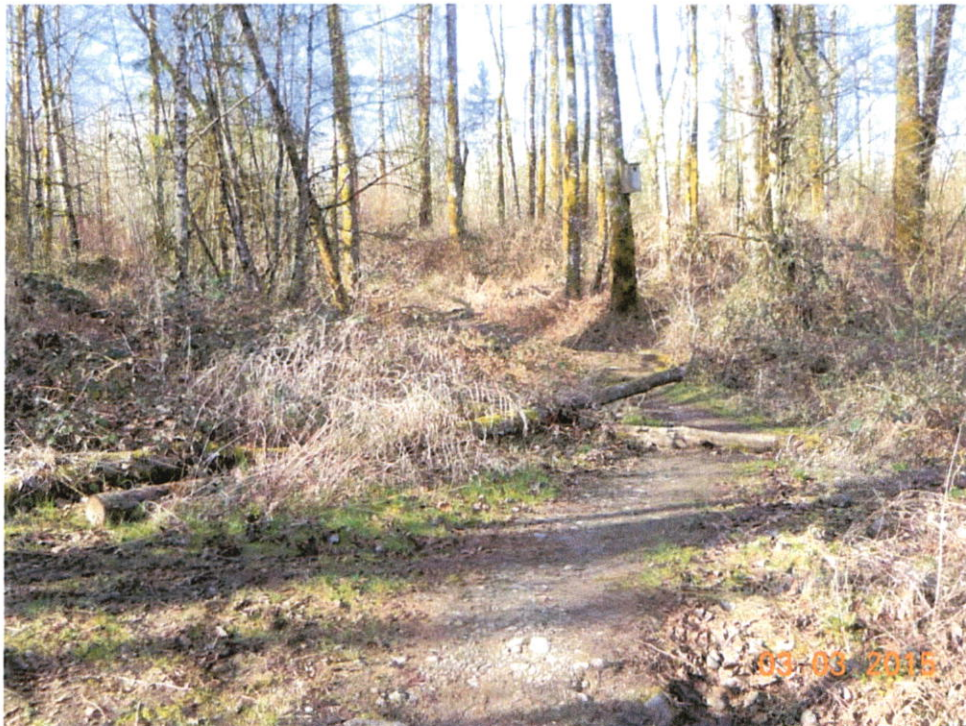
Photo 6. Looking southwest from Location #3 at headcut nick point located at upstream end of overflow channel into County Pond #1.

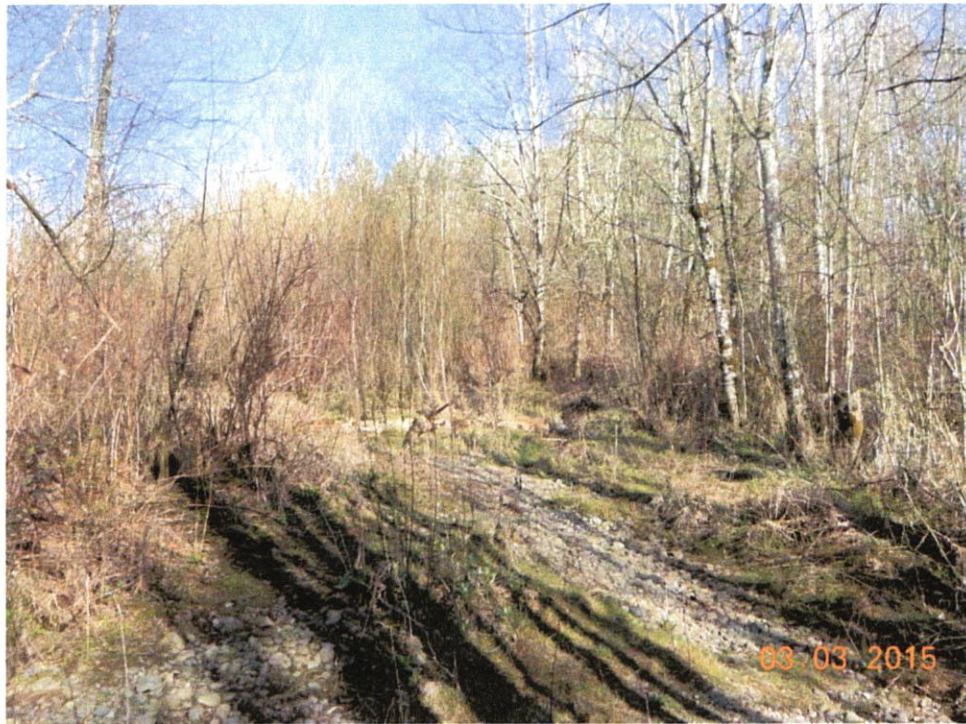
Photo 7. Looking north from Location #4 at overflow channel from E.F. Lewis River into County Pond #2.

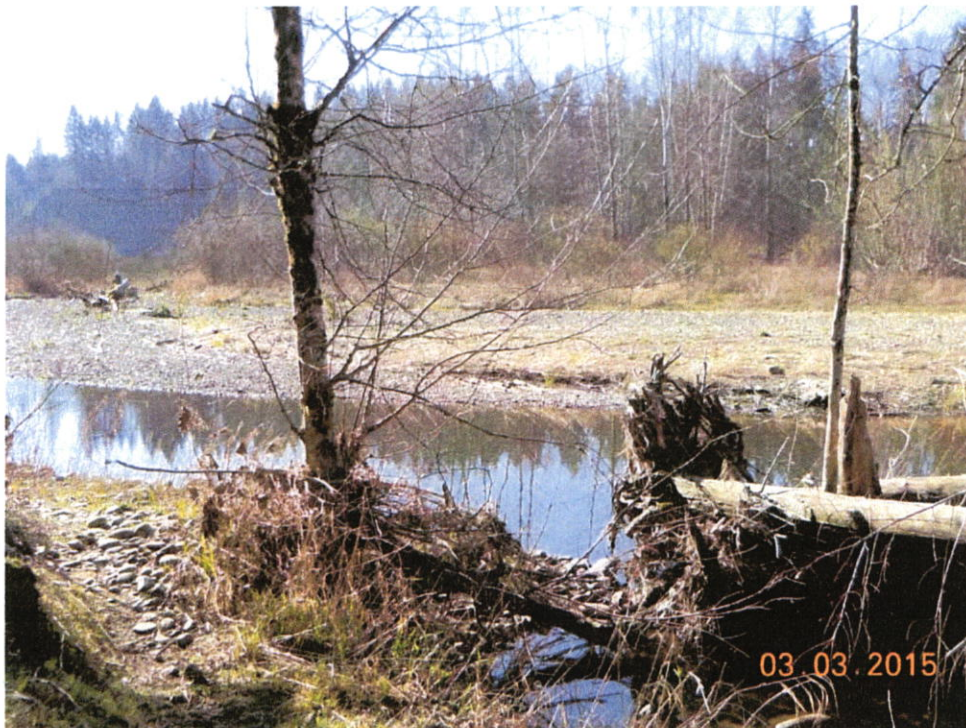
Photo 8. Looking south from Location #4 at upstream end of overflow channel from E.F. Lewis River into County Pond #2. Recently abandoned E.F. Lewis River channel in background.

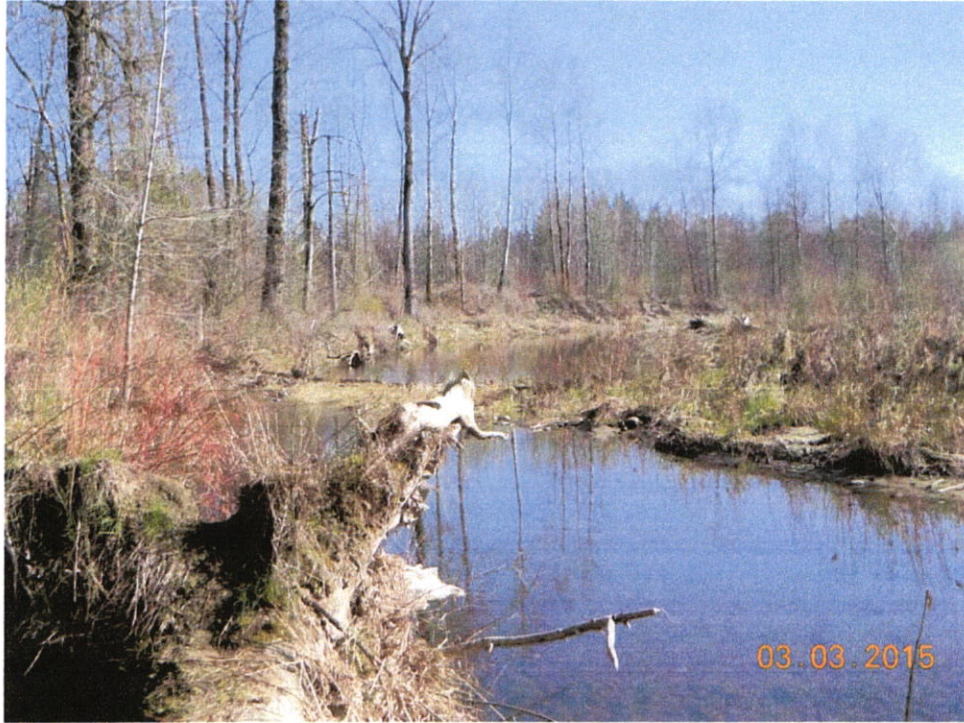
Photo 9A. Looking northeast from Location #5A at right bank of recently abandoned section of E.F. Lewis River at location of overflow channel that leads to County Pond #2.

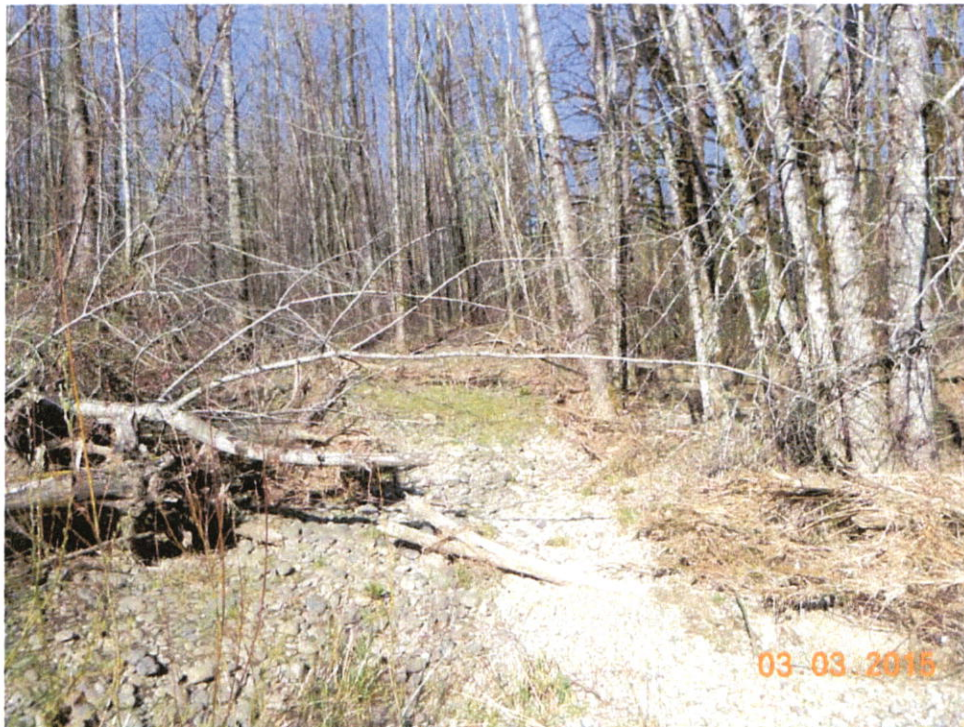
Photo 10A. Looking northwest from Location #5A at upstream end of secondary channel.

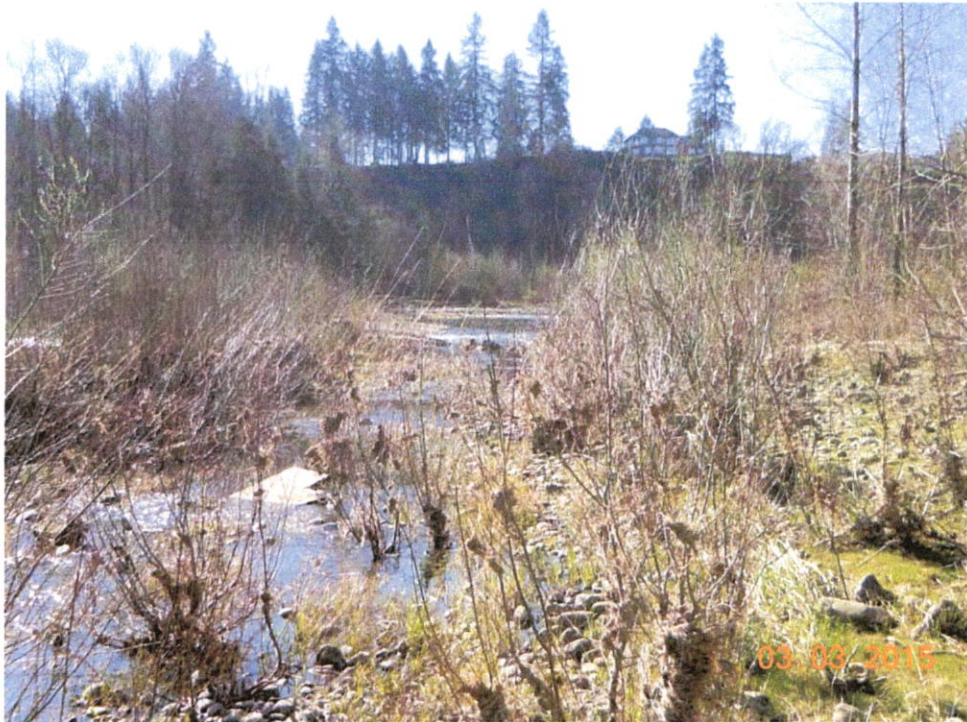
Photo 11A. Looking south from Location #5A at downstream end of recently abandoned section of E.F. Lewis River.

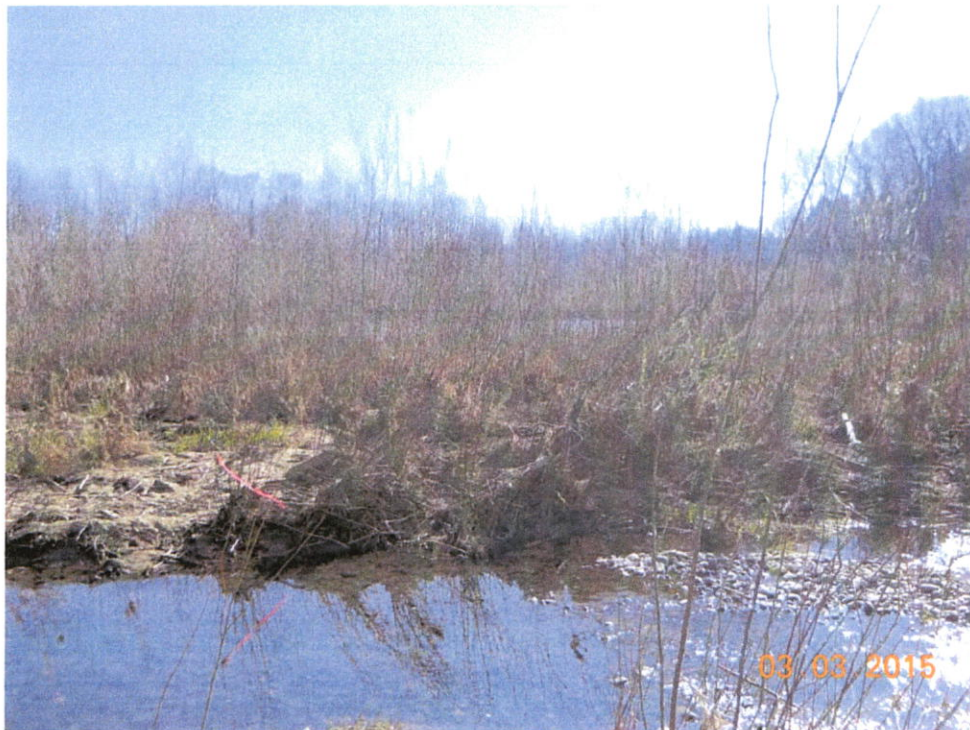
Photo 12A. Looking east southeast from Location #5A at downstream end of second E.F. Lewis meander cutoff channel.

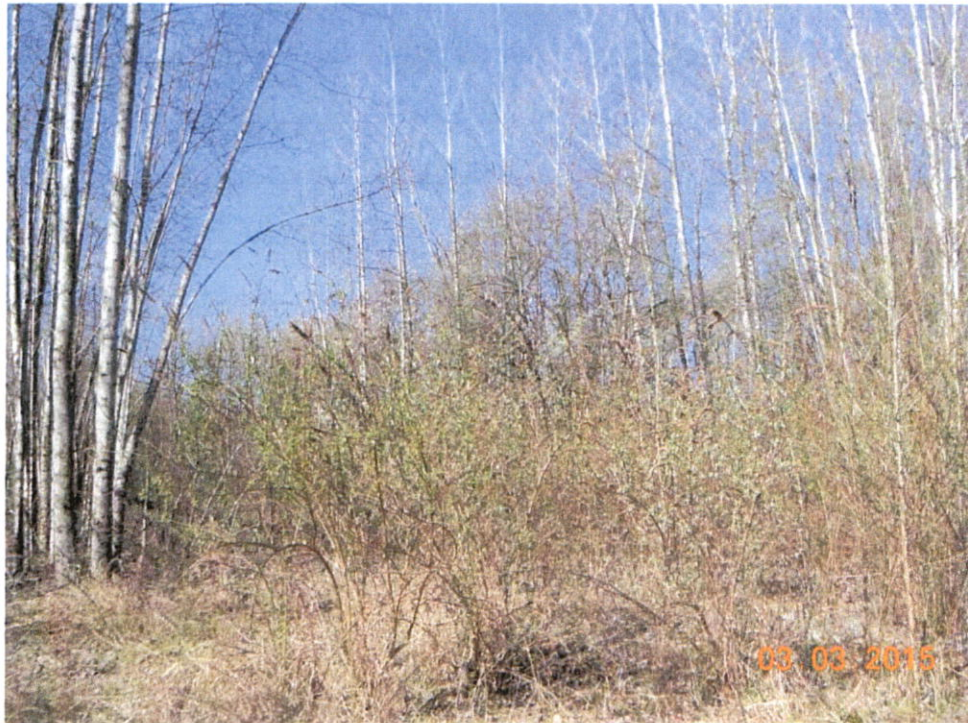
Photo 18. Looking west from Location #6 at upstream end of secondary floodplain channel.

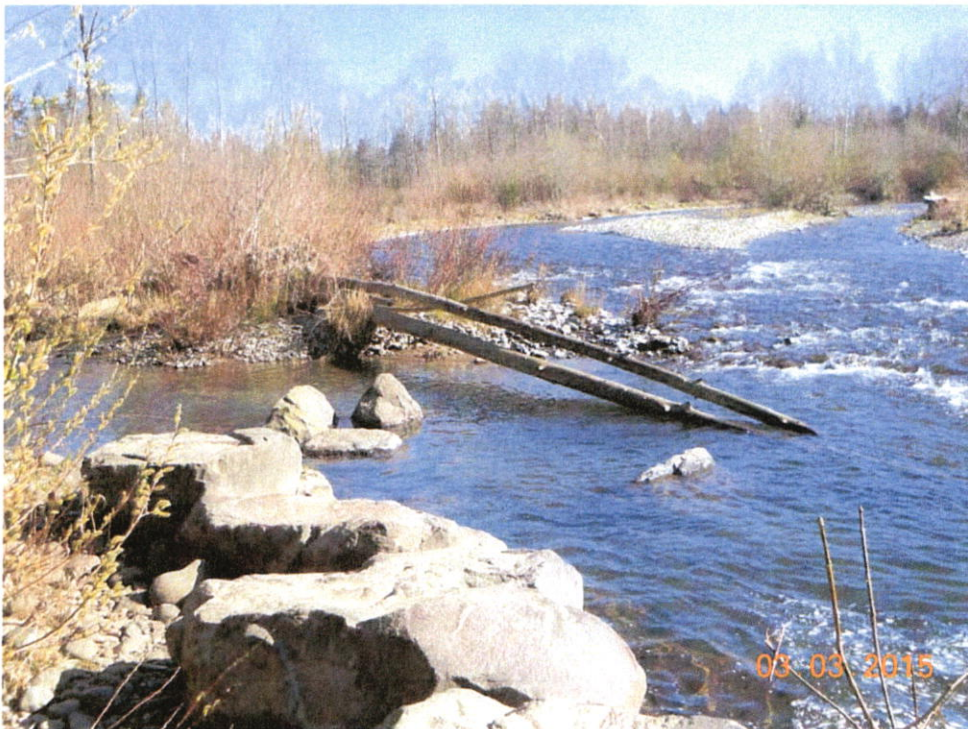
Photo 19. Looking north northeast from Location #6 at rock vane located along the right bank of recently abandoned section of E.F. Lewis River.

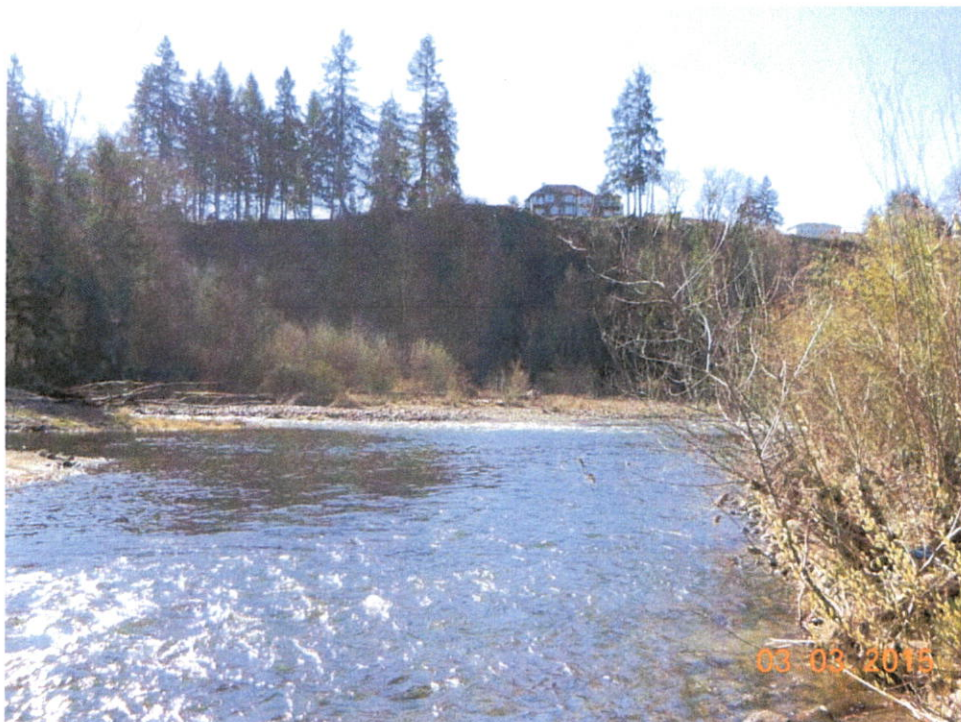
Photo 20. Looking southeast from Location #6 at downstream end of recently abandoned section of E.F. Lewis River. Note first cutoff channel at left side of photo.

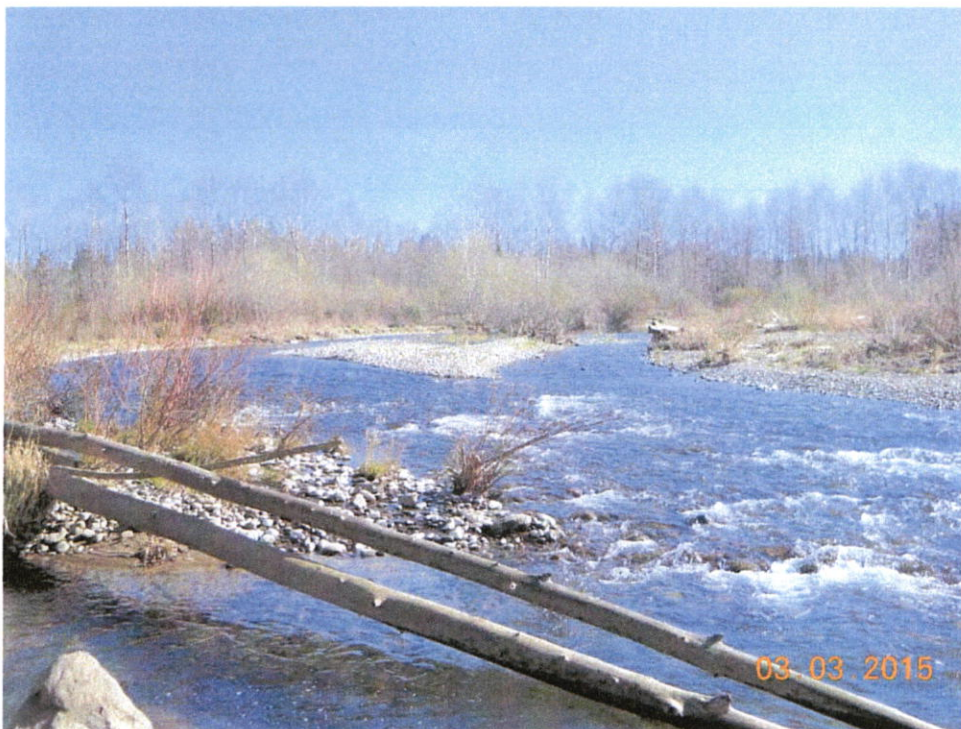
Photo 20A. Looking east northeast from Location #6 at downstream end of second E.F. Lewis River meander cutoff channel.

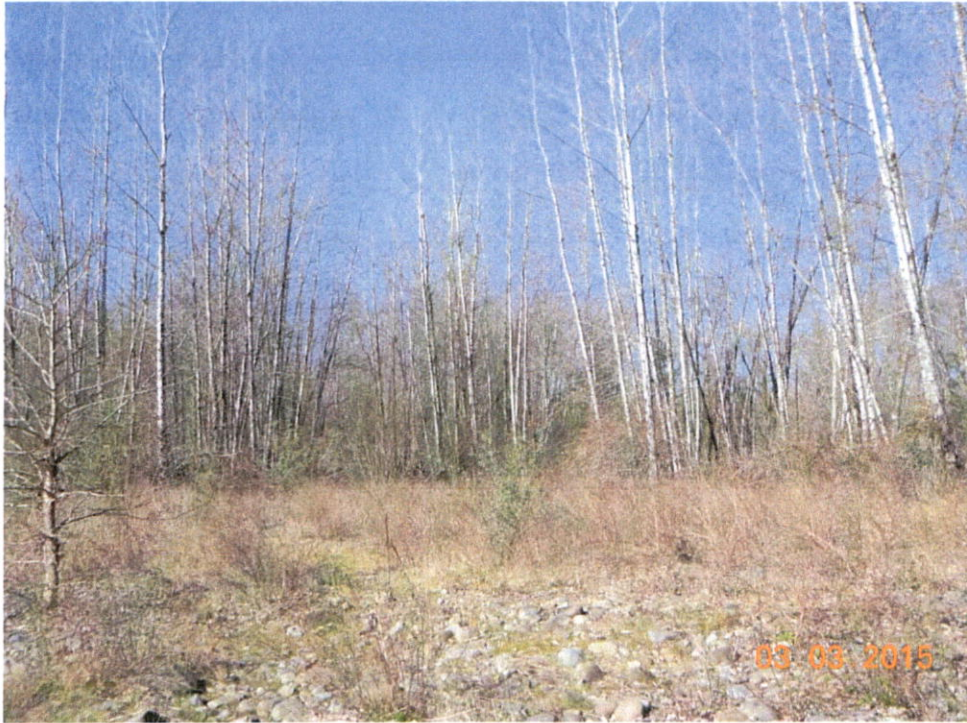
Photo 21. Looking northwest from Location #7 at upstream end of secondary floodplain channel.

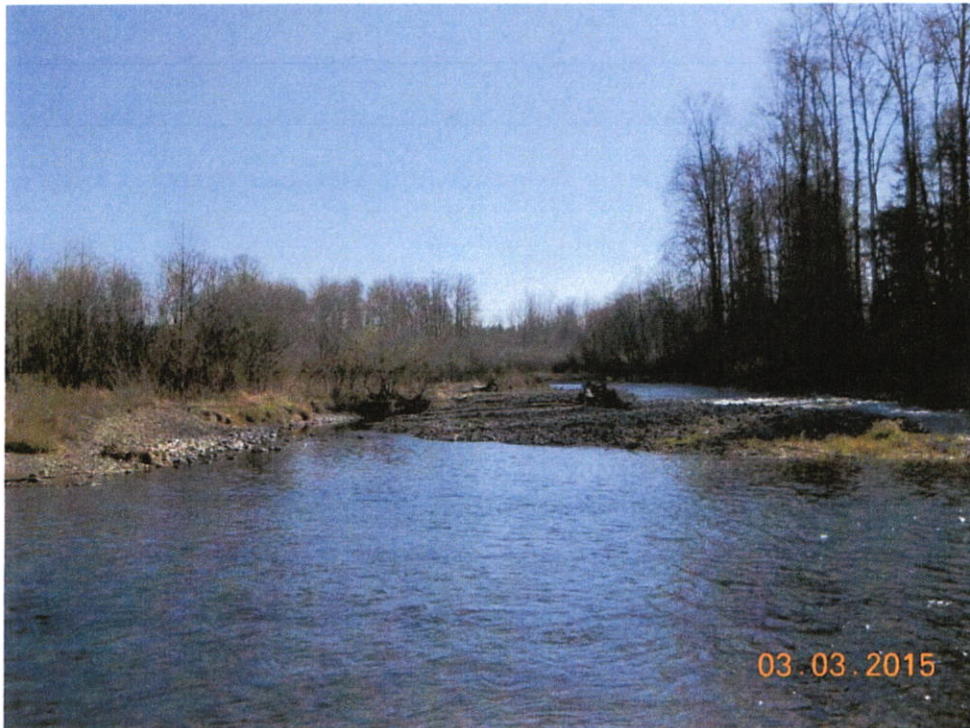
Photo 21A. Looking east southeast from Location #7 at downstream end of first E.F. Lewis River meander cutoff channel.

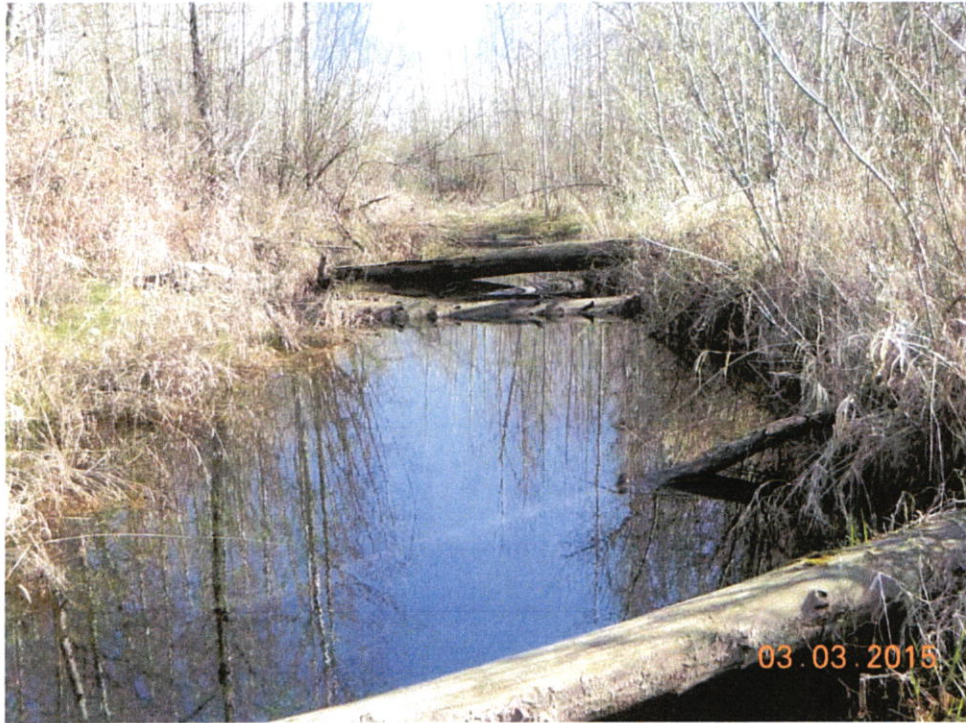
Photo 22. Looking east northeast from Location #8 at downstream end of secondary floodplain channel.

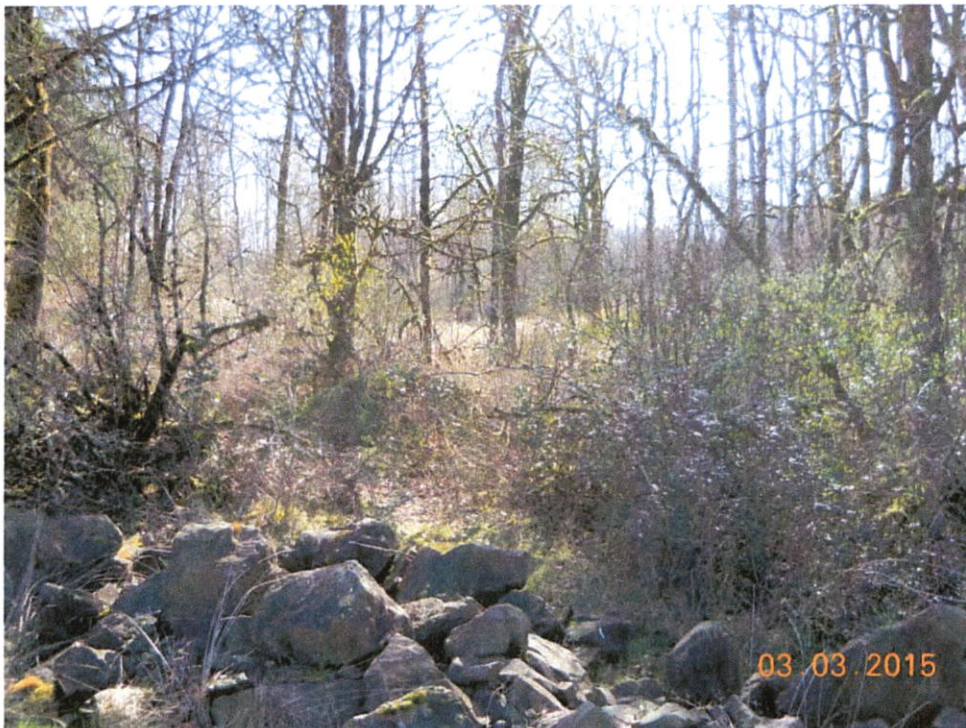
Photo 23. Looking southeast from Location #9 in direction of floodplain overflow channel shown in Photo 1.

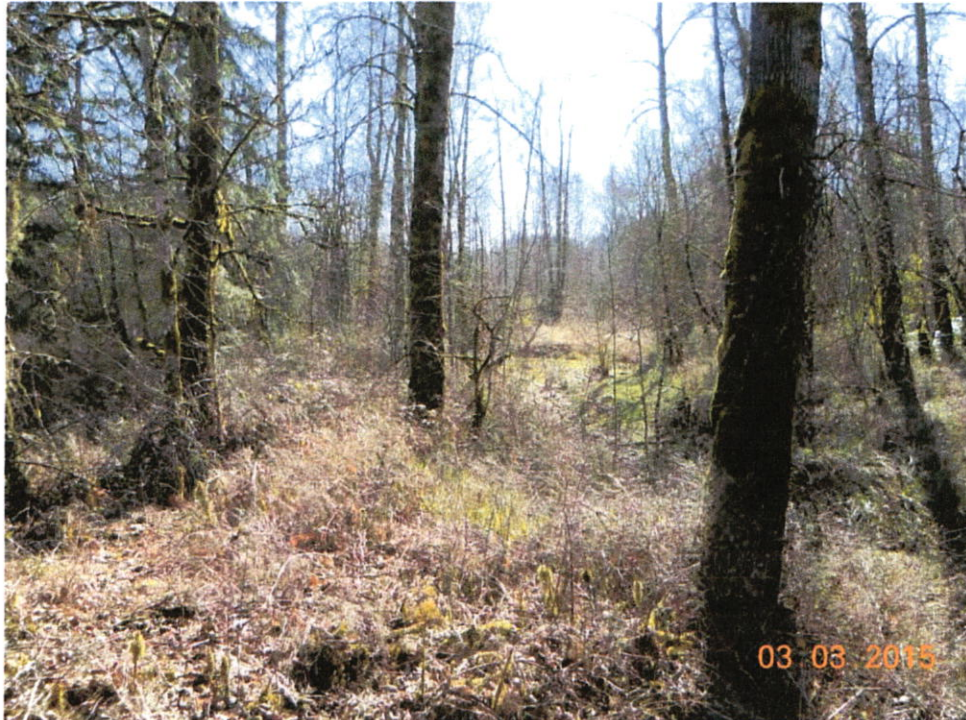
Photo 24. Looking southeast from Location #10 at floodplain adjacent to Storedahl Pit Road. Historic location of E.F. Lewis River channel.

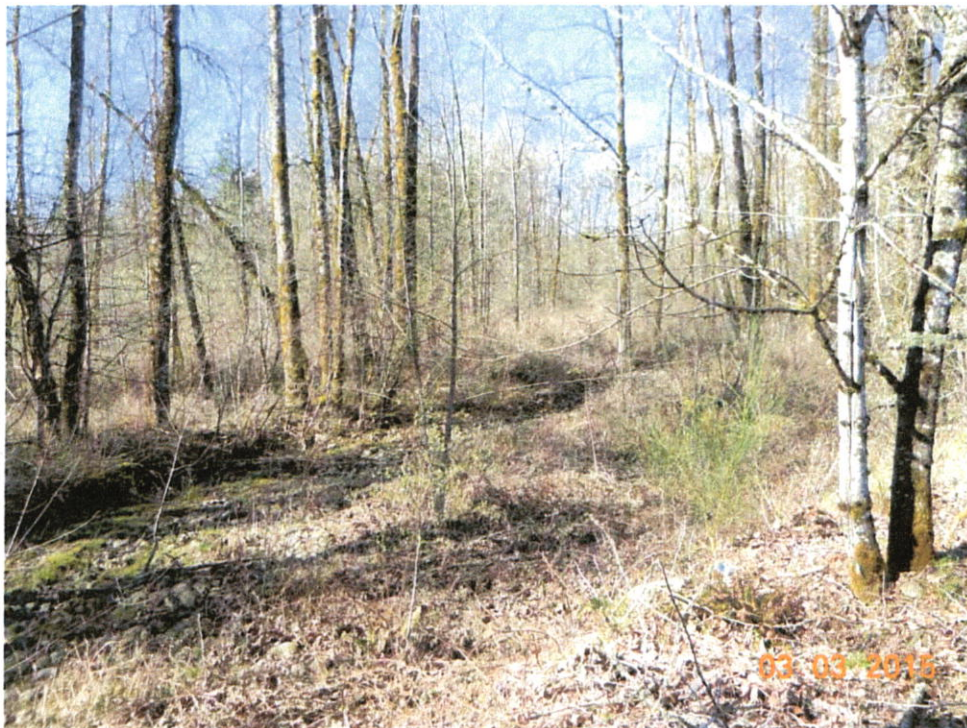
Photo 25. Looking west from Location #10 at floodplain adjacent to Storedahl Pit Road. Historic location of E.F. Lewis River channel.

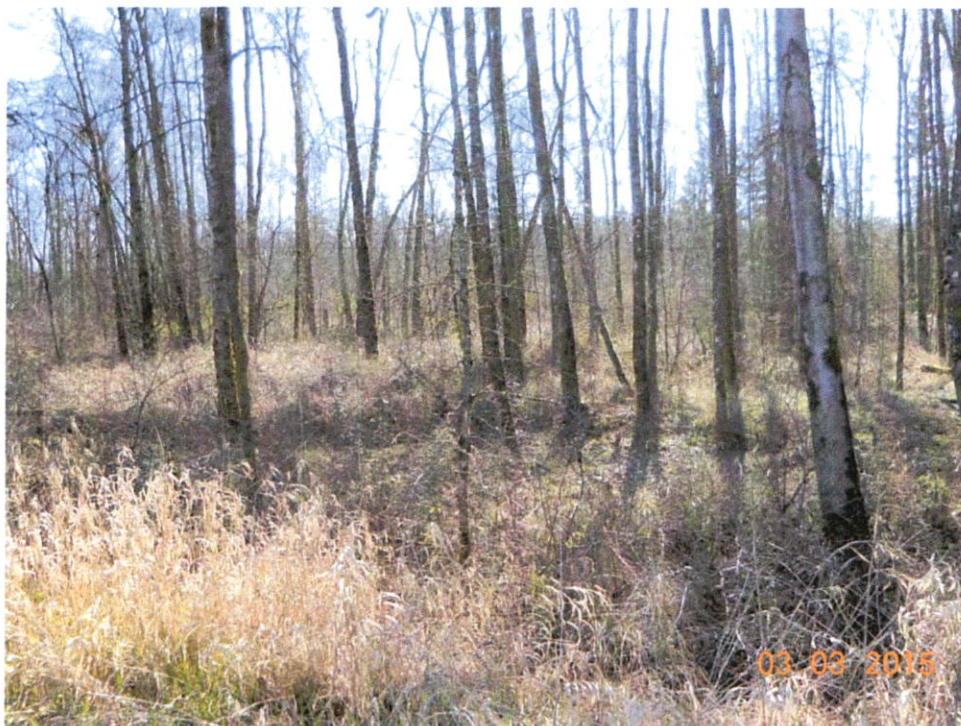
Photo 26. Looking southeast from Location #11 at floodplain adjacent to Storedahl Pit Road. Historic location of E.F. Lewis River channel.

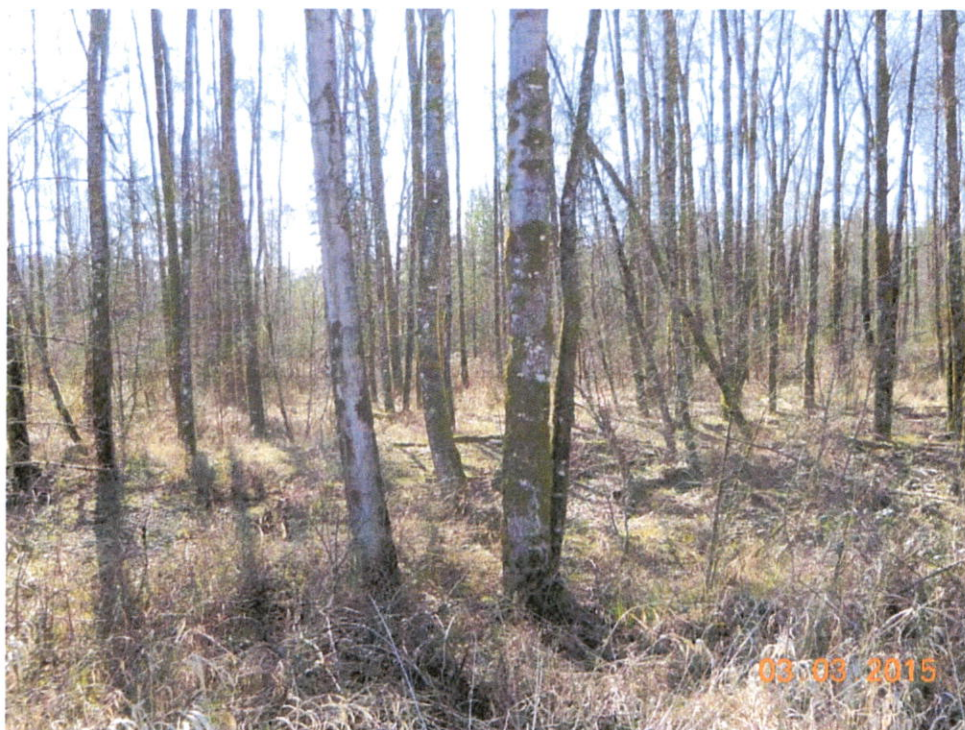
Photo 27. Looking south from Location #11 at floodplain adjacent to Storedahl Pit Road. Historic location of E.F. Lewis River channel.

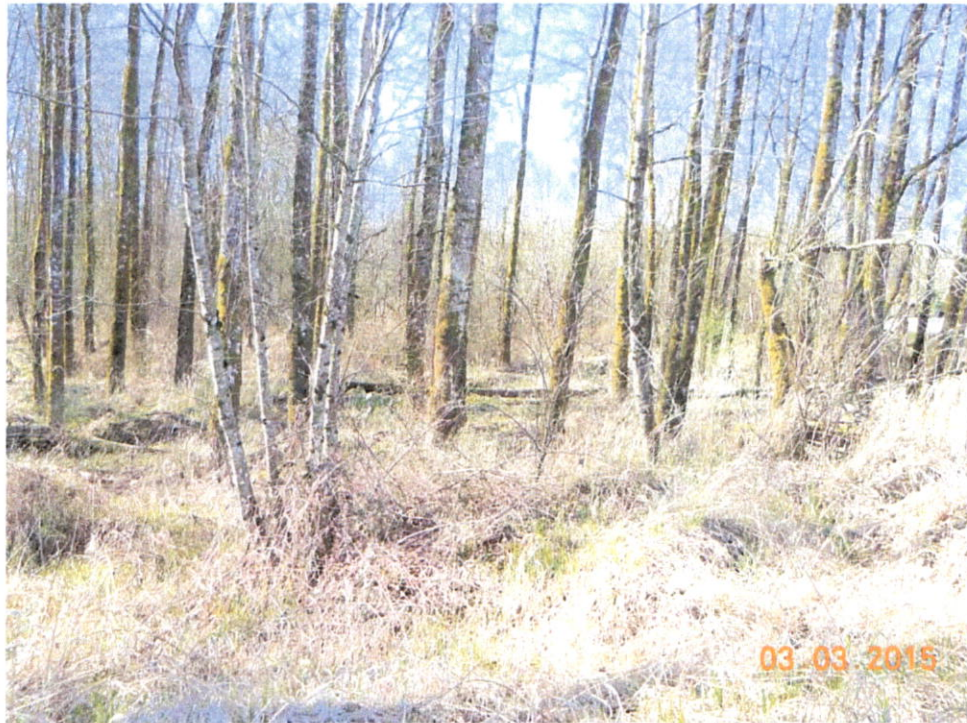
Photo 28. Looking west southwest from Location #11 at floodplain adjacent to Storedahl Pit Road. Historic location of E.F. Lewis River channel.

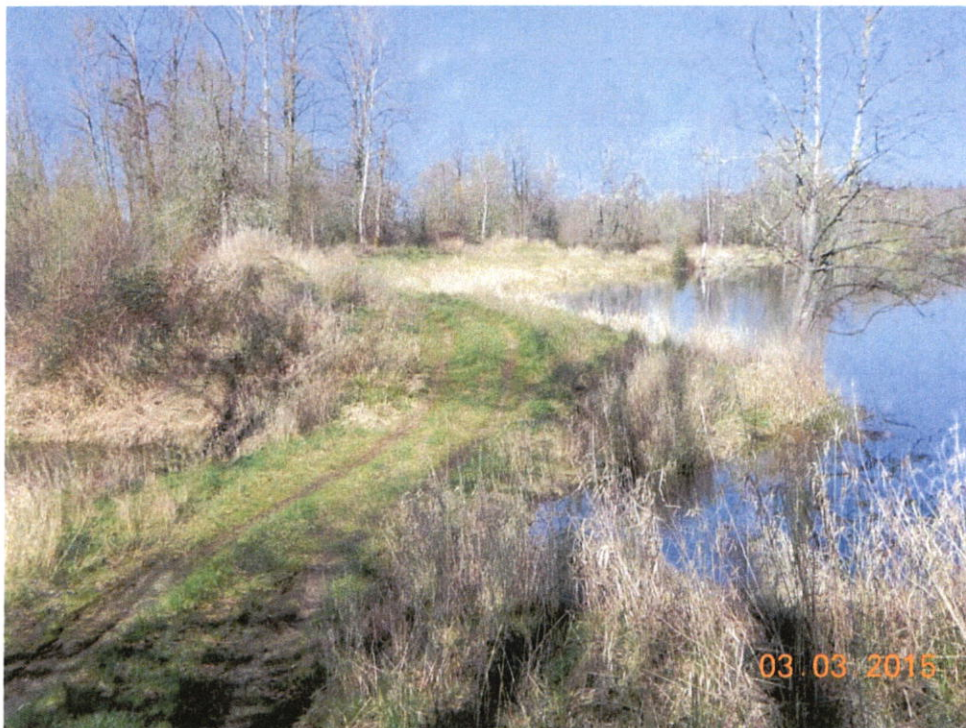
Photo 29. Looking northwest from Location #12 at Daybreak Pond #5 overflow into E.F. Lewis River floodplain.

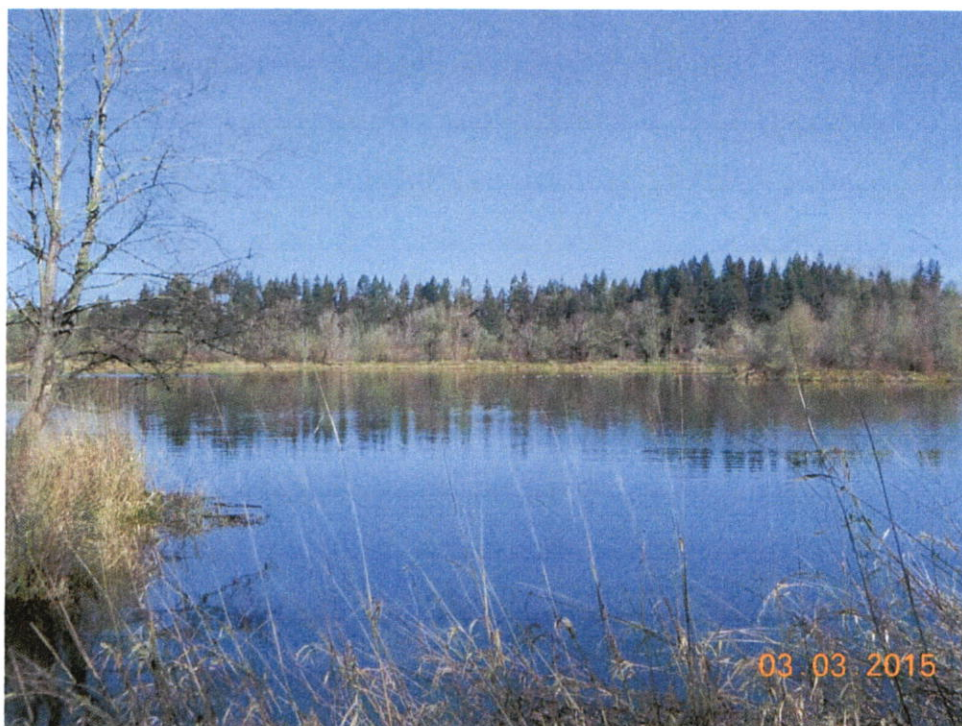
Photo 30. Looking northeast from Location # 12 at Daybreak Pond #5.

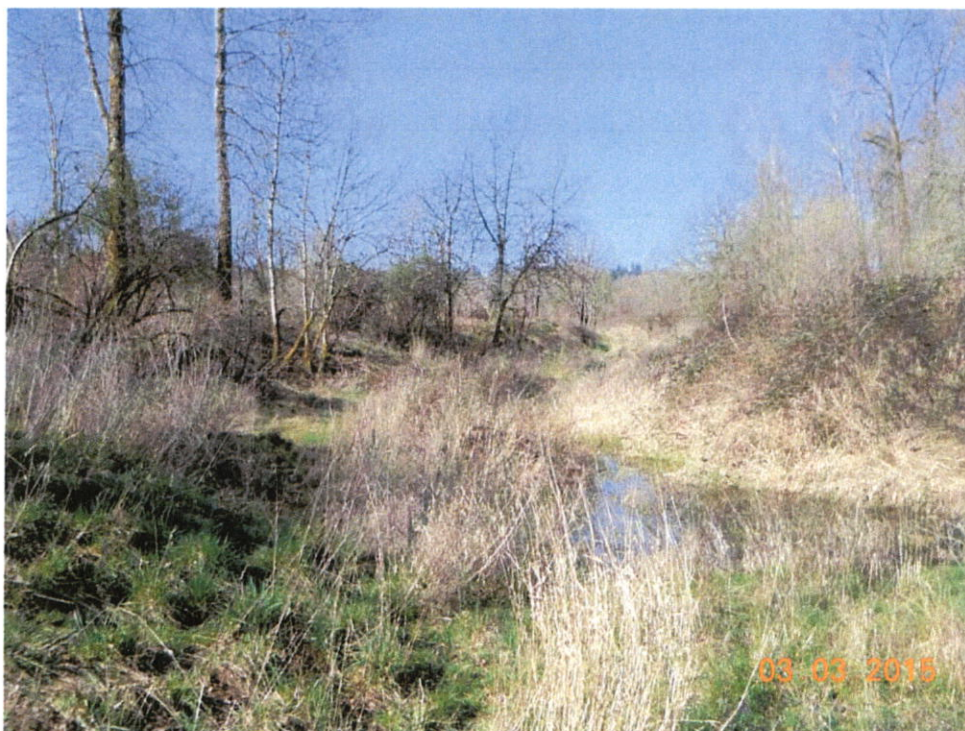
Photo 31. Looking west northwest from Location #12 at E.F. Lewis River floodplain.

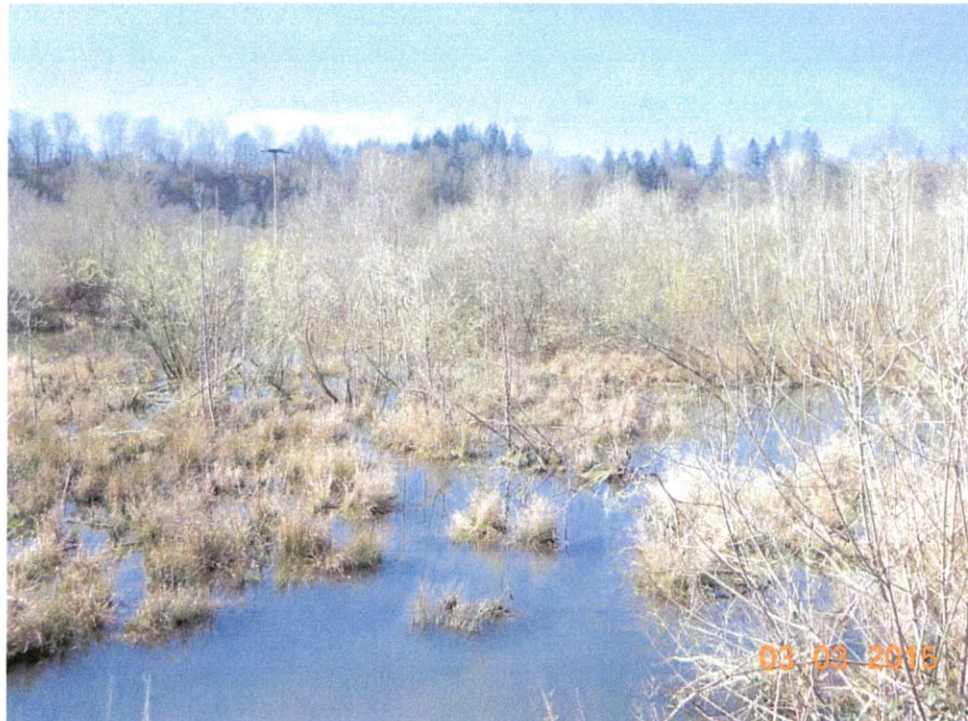
Photo 32. Looking west from Location #13 at E.F. Lewis River floodplain.

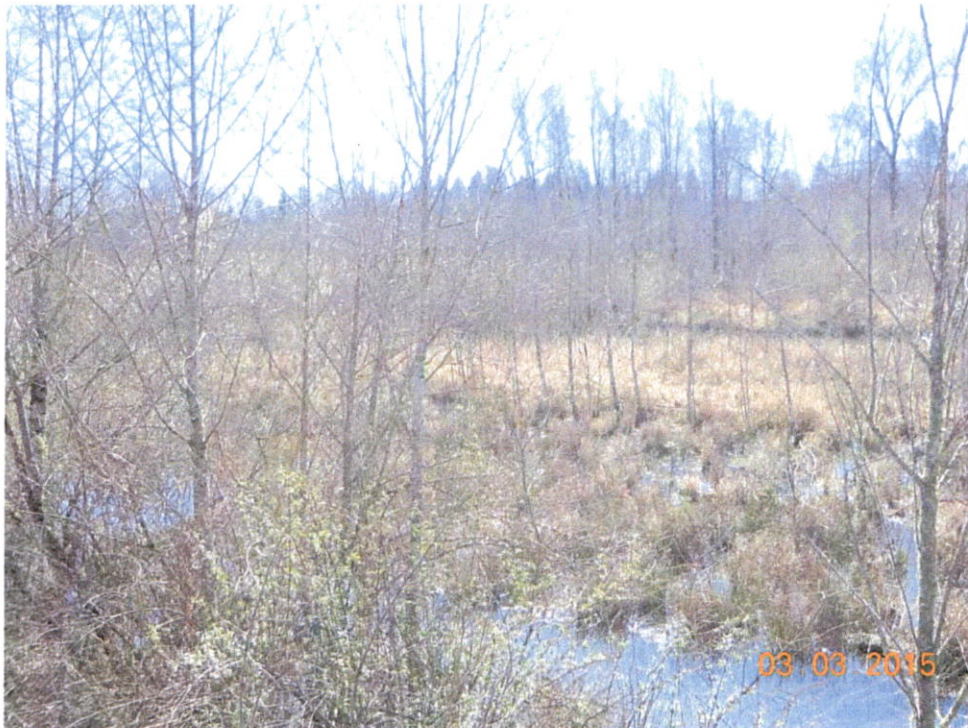
Photo 33. Looking southeast from Location #13 at E.F. Lewis River floodplain.

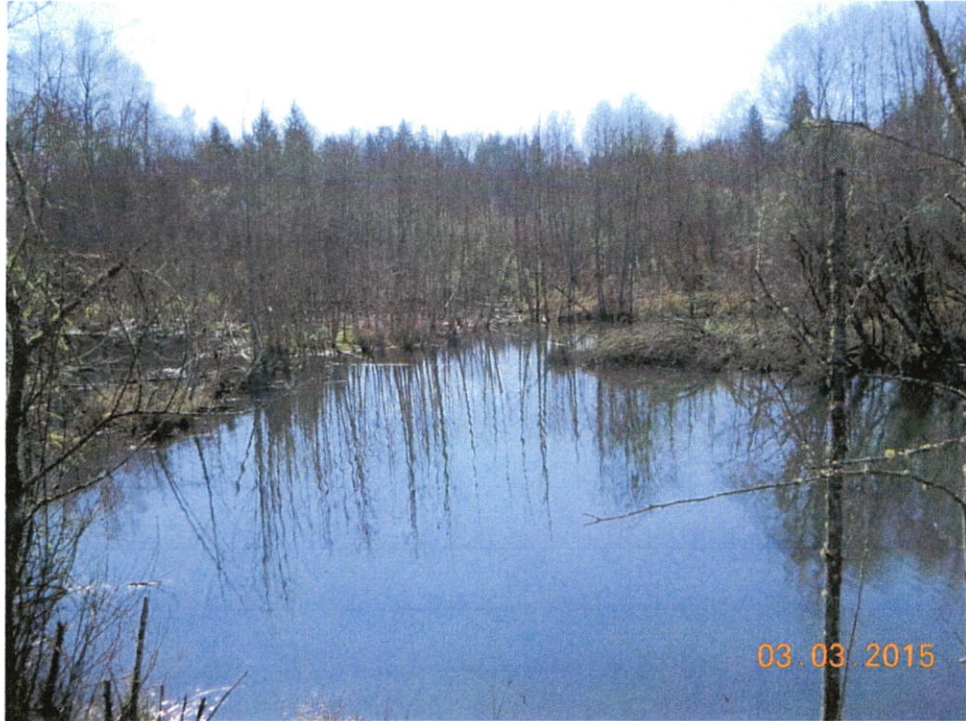
Photo 34. Looking south southeast from Location #14 at historic E.F. Lewis River channel.
