# Technical Memo

**Name:** Kimball Storedahl  
**Company:** J.L. Storedahl & Sons, Inc.  
**Date:** March 18, 2015  
**From:** Hans R. Hadley, P.E.  
Senior Hydraulic Engineer

**Subject:** MEM-07 Monitoring Report – March 3, 2015 Field Reconnaissance

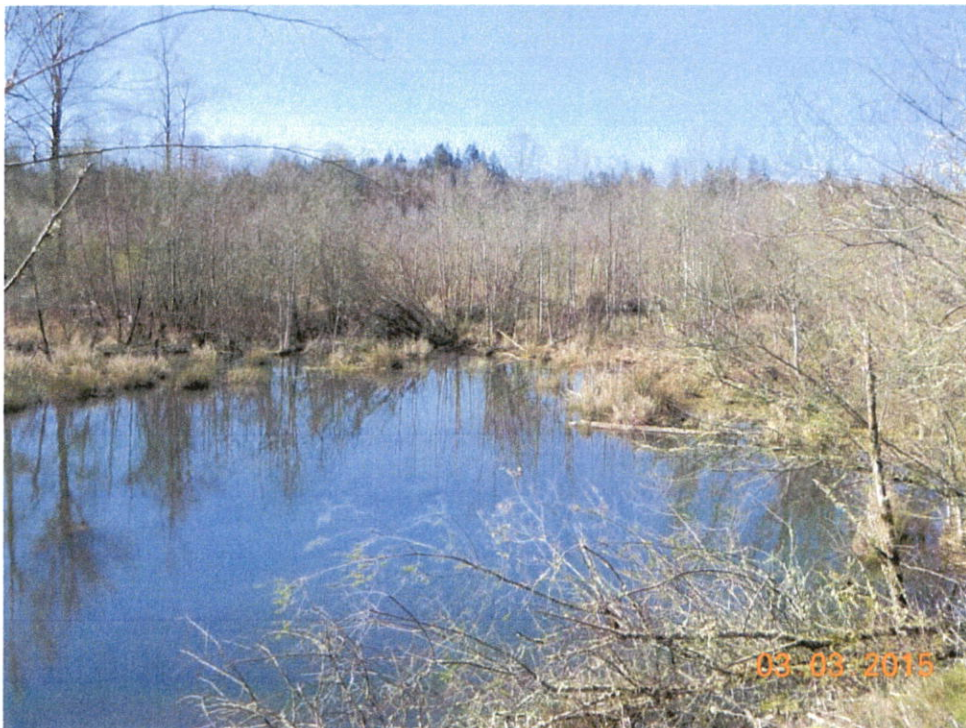
Photo 35. Looking west from Location #14 at historic E.F. Lewis River channel.

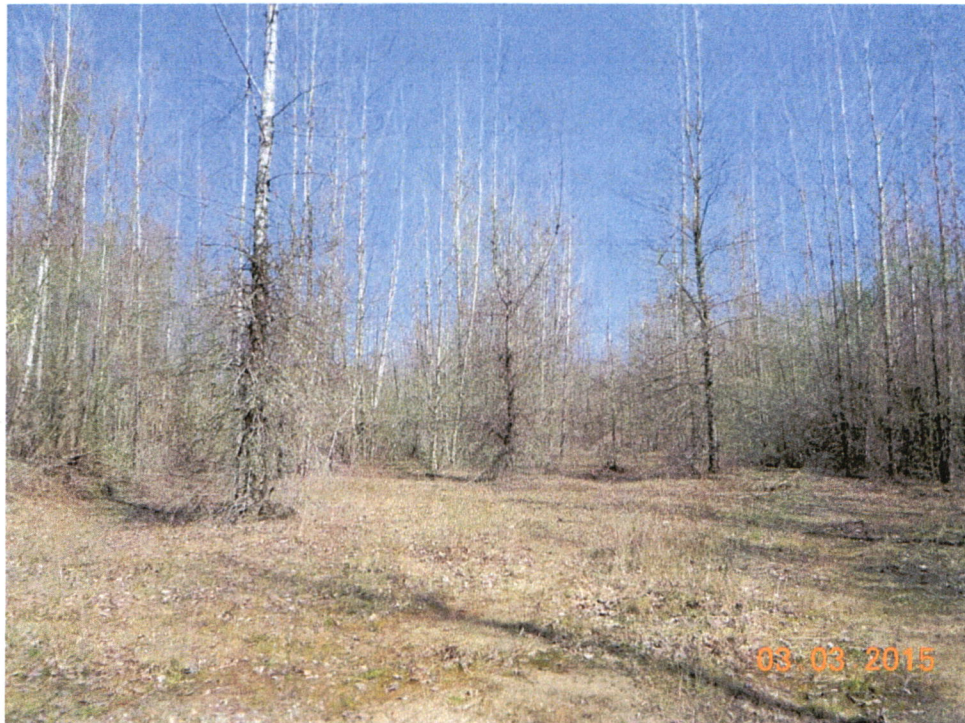
Photo 36. Looking north northeast from Location # 15 along alignment of historic E.F. Lewis River channel.

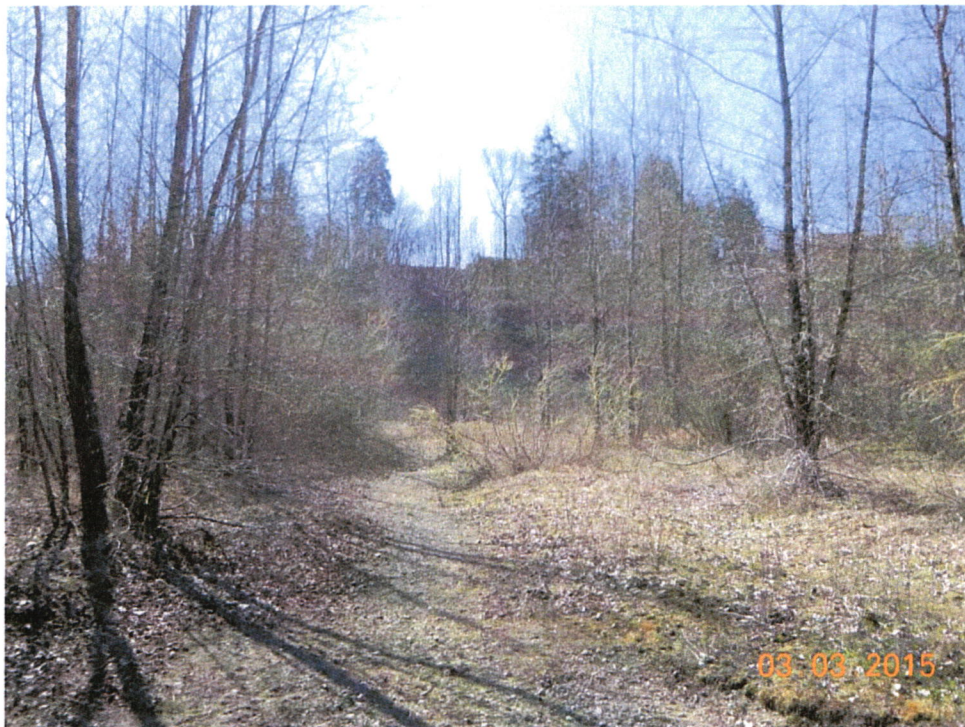
Photo 37. Looking south southwest from Location #15 along alignment of historic E.F. Lewis River channel.

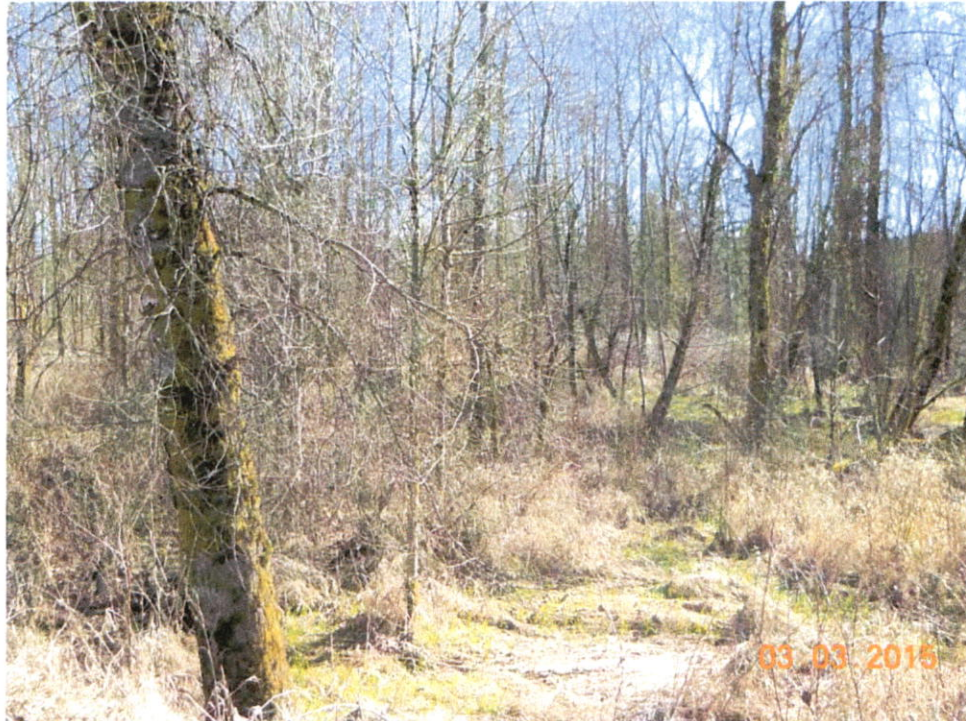
Photo 38. Looking east southeast from Location #16 at E. F. Lewis River floodplain. Historic location of E.F. Lewis River channel.

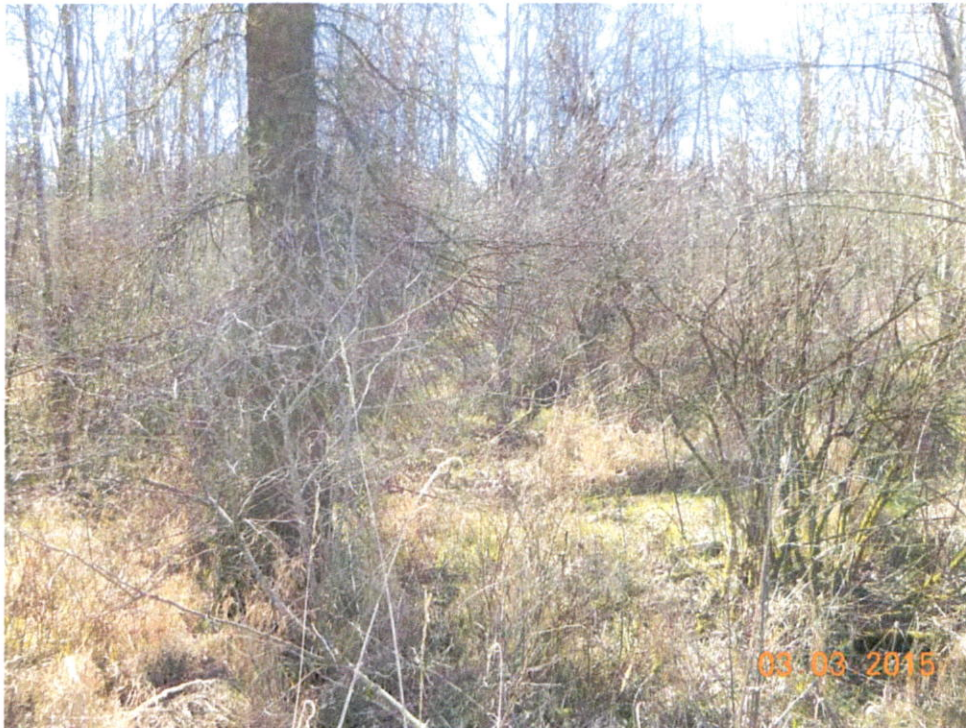
Photo 39. Looking west southwest from Location #16 at E.F. Lewis River floodplain. Historic location of E.F. Lewis River channel.
