Technical Memo

MEM-07 Monitoring Report – February 26, 2016 Field Reconnaissance

WEST Consultants conducted the sixth annual field reconnaissance of the East Fork Lewis River in the vicinity of the Daybreak Mine as required under MEM-07 of the Habitat Conservation Plan. The reconnaissance was conducted by Hans R. Hadley P.E. and Thomas R. Grindeland P.E. on February 26, 2016. Observations of the river and floodplain were made to determine the likelihood of the river avulsing into the existing Daybreak ponds. This memo documents the results of that field reconnaissance. The highest discharge that occurred prior to the site visit for winter 2015/2016 was 22,400 cfs which occurred on December 9, 2015. This is the second highest recorded flow in the East Fork Lewis River at the Heisson Gage, second only to the February 1996 flood, and has nearly a 25-year recurrence interval. Photographs of current conditions were taken at identical locations to those taken in November 2011, March 2013, February 2014, and March 2015, utilizing the same location number and photo number. The photograph locations are shown on an aerial photo base map (Appendix A) from June 2015. Arrows are depicted on t

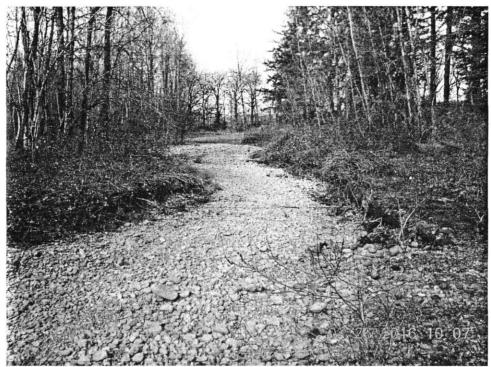
Photo 1. Looking northwest from Location #1 along secondary floodplain channel.

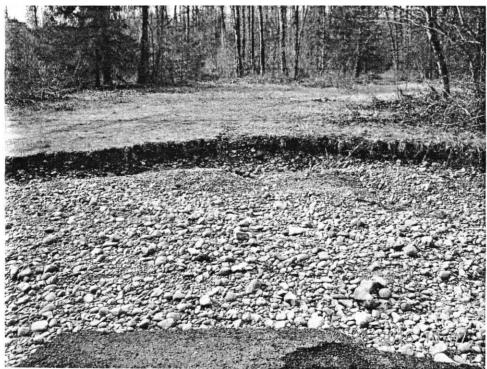
Photo 2. Looking southwest from Location #1 at headcut nick point located at upstream end of secondary floodplain channel.

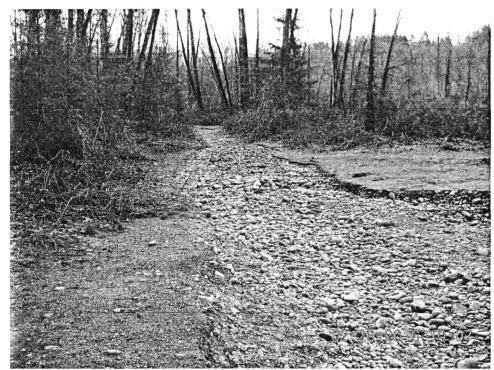
At Location #1, the existing headcut appears to have migrated a short distance further upstream from its observed location in November 2011 (see Photo 3). Indications of bank erosion and

sediment deposition were also observed downstream of the head cut. The secondary channel appears to terminate at County Pond #1 but could pose an avulsion threat in the future and will continue to be monitored for changes in size and extent during subsequent field reconnaissance efforts.

Photo 3. Looking south southeast from Location #1 toward County Pond #2.

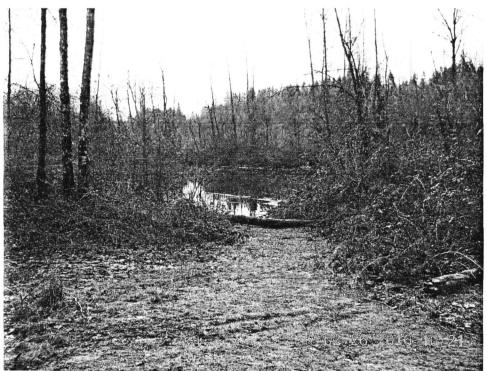
Photo 4. Looking southeast from Location #2 at overflow path from County Pond #2.

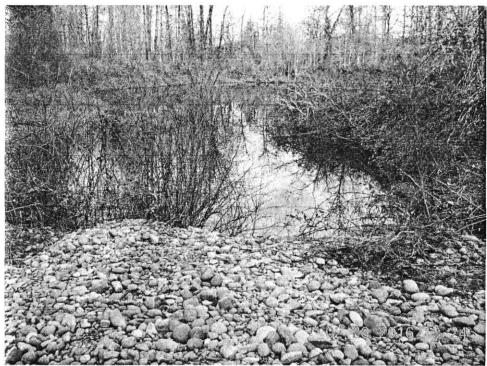
Photo 5. Looking northwest from Location #3 at overflow channel into County Pond #1.

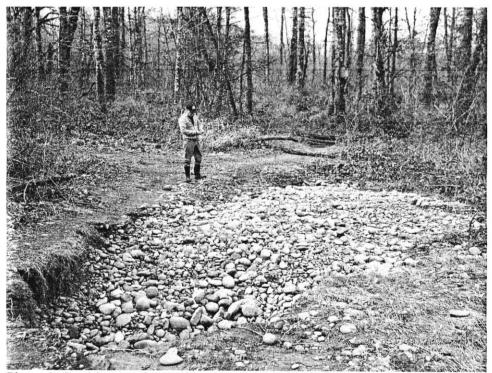
Photo 6. Looking southwest from Location #3 at headcut nick point located at upstream end of overflow channel into County Pond #1.

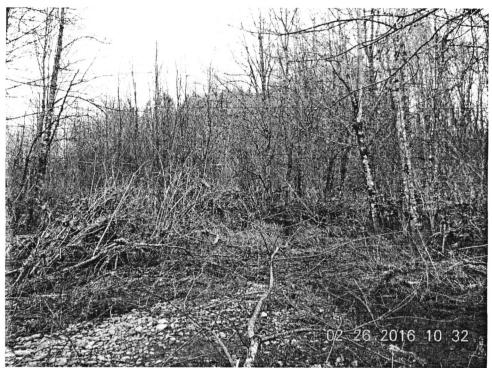
Photo 7. Looking north from Location #4 at overflow channel from E.F. Lewis River into County Pond #2.

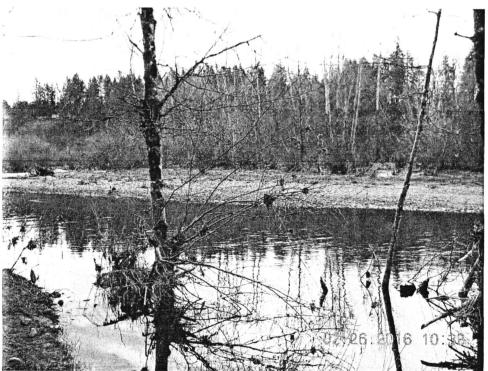
Photo 8. Looking south from Location #4 at upstream end of overflow channel from E.F. Lewis River into County Pond #2. Recently abandoned E.F. Lewis River channel in background.

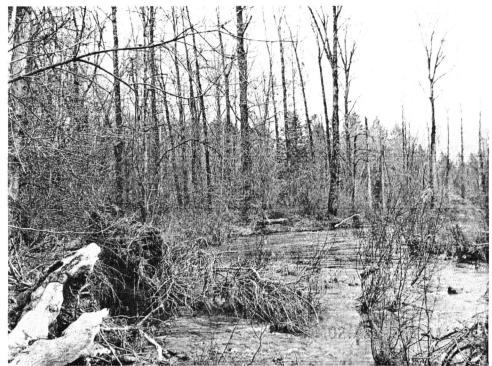
Photo 9A. Looking northeast northeast from Location #5A at right bank of recently abandoned section of E.F. Lewis River at location of overflow channel that leads to County Pond #2.

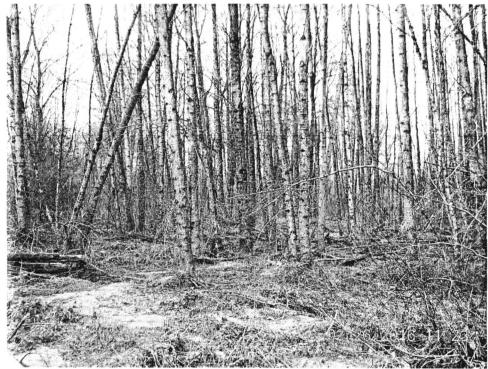
Photo 10A. Looking northwest from Location #5A at upstream end of secondary channel.

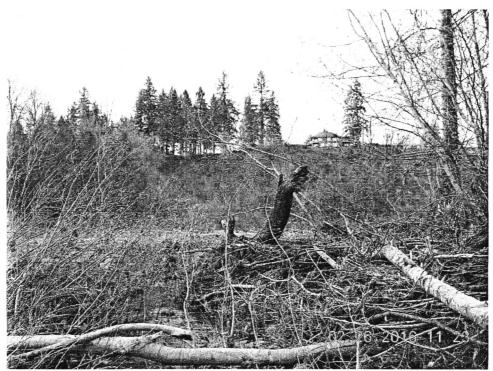
Photo 11A. Looking south from Location #5A at downstream end of recently abandoned section of E.F. Lewis River.

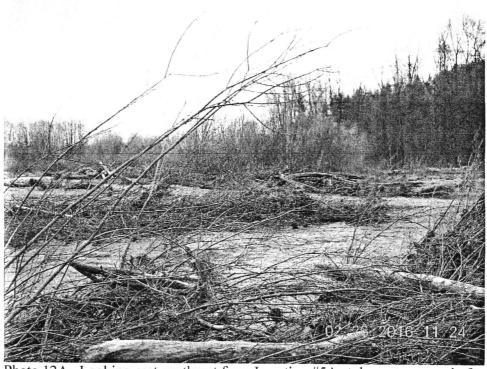
Photo 12A. Looking east southeast from Location #5A at downstream end of second E.F. Lewis meander cutoff channel.

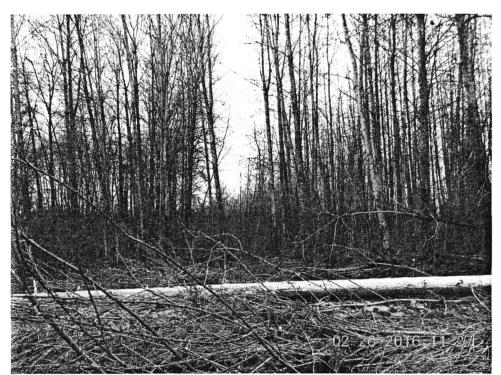
Photo 18. Looking west from Location #6 at upstream end of secondary floodplain channel.

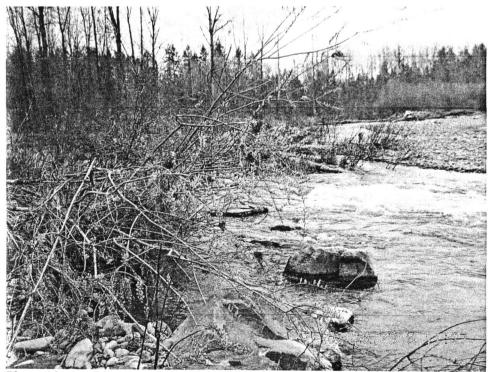
Photo 19. Looking north northeast from Location #6 at rock vane located along the right bank of recently abandoned section of E.F. Lewis River.

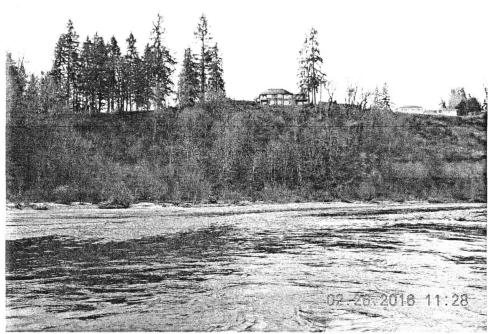
Photo 20. Looking southeast from Location #6 at downstream end of recently abandoned section of E.F. Lewis River. Note first cutoff channel at left side of photo.

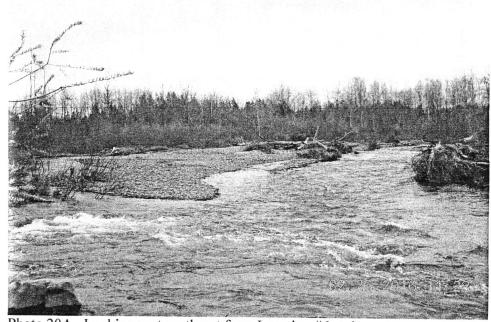
Photo 20A. Looking east northeast from Location #6 at downstream end of second E.F. Lewis River meander cutoff channel.

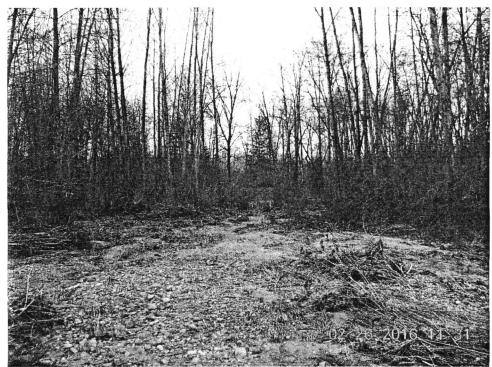
Photo 21. Looking northwest from Location #7 at upstream end of secondary floodplain channel.

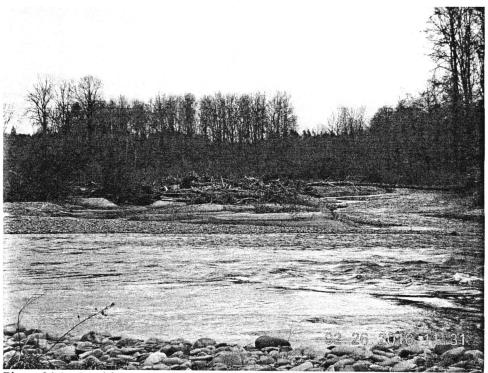
Photo 21A. Looking east southeast from Location #7 at downstream end of first E.F. Lewis River meander cutoff channel.

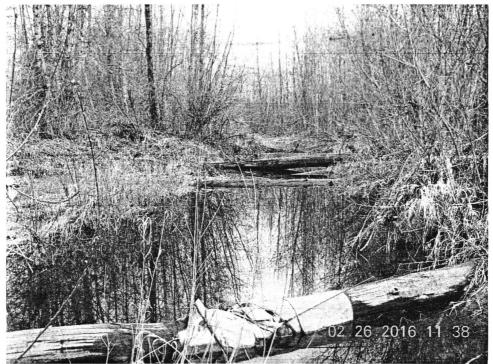
Photo 22. Looking east northeast from Location #8 at downstream end of secondary floodplain channel.

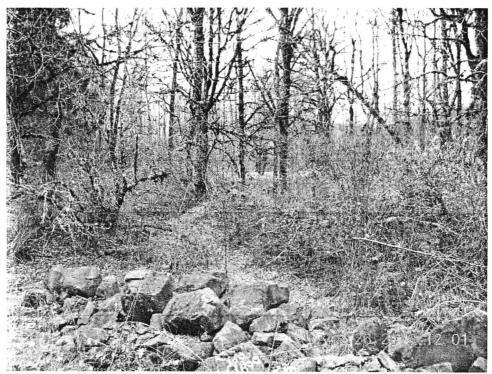
Photo 23. Looking southeast from Location #9 in direction of floodplain overflow channel shown in Photo 1.

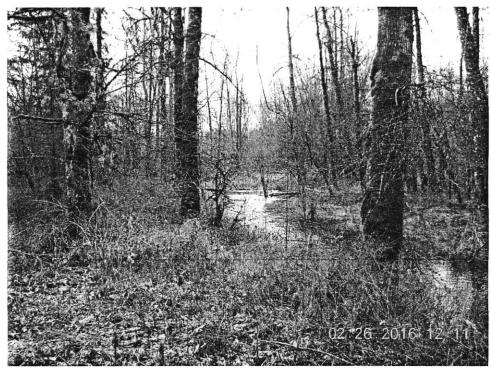
The secondary channel that parallels Storedahl Pit Road was conveying water at the time of the reconnaissance (see Photos 24-28 & 38-39). The flow in the East Fork Lewis River at Heisson was about 750 cfs during this time. During all previous site visits, this channel has been dry. Flow in the East Fork during the previous visits ranged from 135 cfs to 1,250 cfs. This indicates that an increase in the bed elevation of the main channel near the head of the secondary channel and/or changes to the geometry of the head of the secondary channel may have occurred during the December 2015 flood event. This has subsequently resulted in greater amounts of flow entering the secondary channel compared to previous years. The connectivity of this secondary channel with the main channel will continue to be monitored during subsequent field reconnaissance efforts.

Photo 24. Looking southeast from Location #10 at floodplain adjacent to Storedahl Pit Road. Historic location of E.F. Lewis River channel.

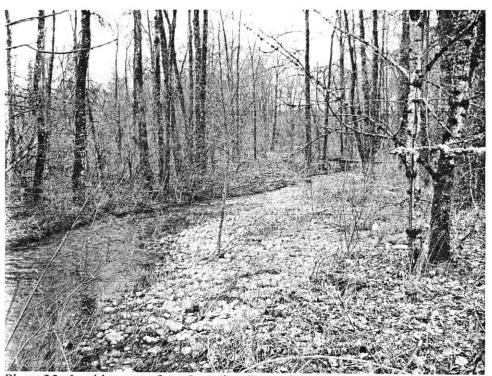
Photo 25. Looking west from Location #10 at floodplain adjacent to Storedahl Pit Road. Historic location of E.F. Lewis River channel.

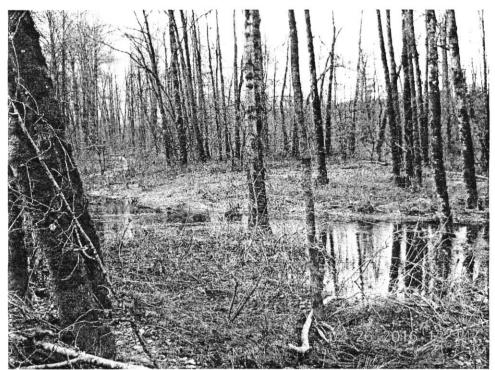
Photo 26. Looking southeast from Location #11 at floodplain adjacent to Storedahl Pit Road. Historic location of E.F. Lewis River channel.

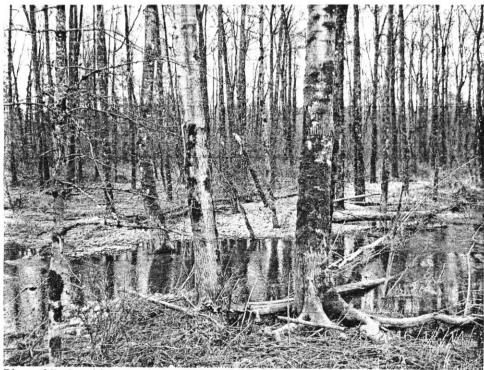
Photo 27. Looking south from Location #11 at floodplain adjacent to Storedahl Pit Road. Historic location of E.F. Lewis River channel.

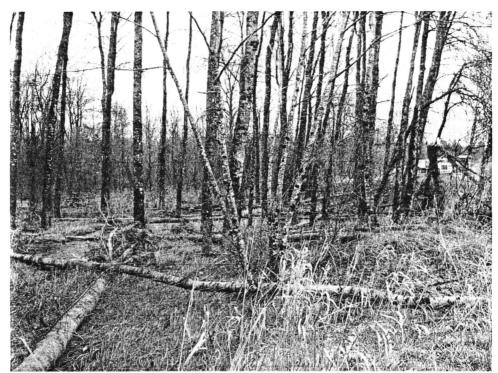
Photo 28. Looking west southwest from Location #11 at floodplain adjacent to Storedahl Pit Road. Historic location of E.F. Lewis River channel.

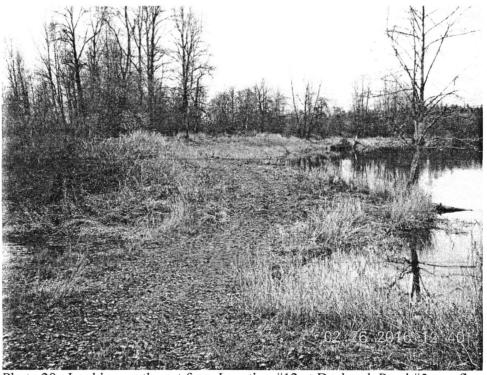
Photo 29. Looking northwest from Location #12 at Daybreak Pond #5 overflow into E.F. Lewis River floodplain.

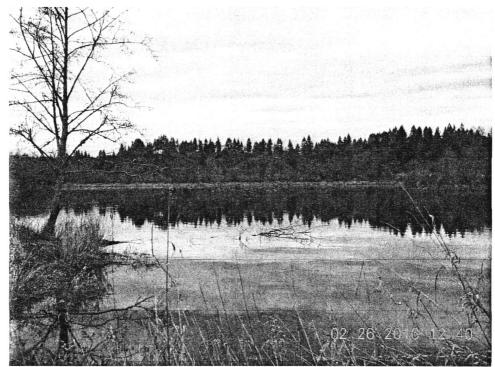
Photo 30. Looking northeast from Location # 12 at Daybreak Pond #5.

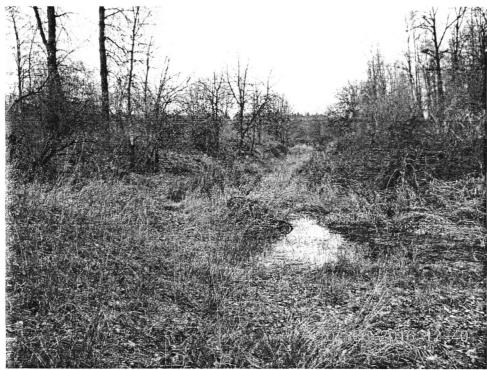
Photo 31. Looking west northwest from Location #12 at E.F. Lewis River floodplain.

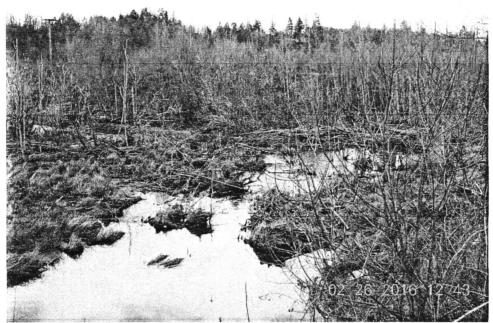
Photo 32. Looking west from Location #13 at E.F. Lewis River floodplain.

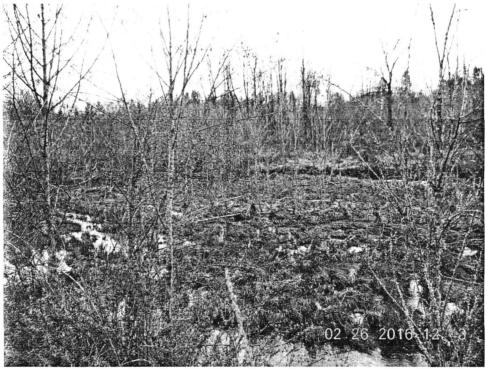
Photo 33. Looking southeast from Location #13 at E.F. Lewis River floodplain.

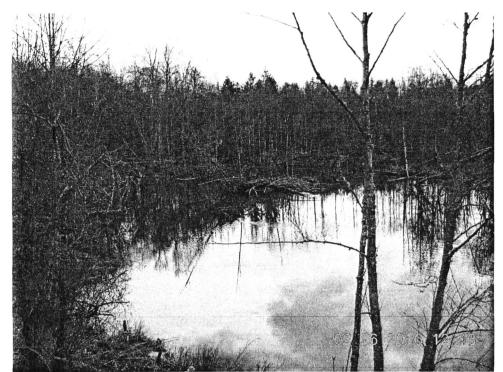
Photo 34. Looking south southeast from Location #14 at historic E.F. Lewis River channel.

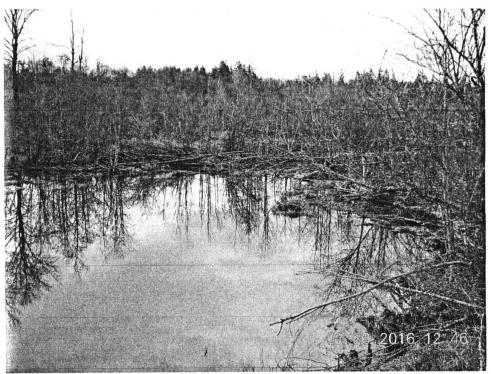
Photo 35. Looking west from Location #14 at historic E.F. Lewis River channel.

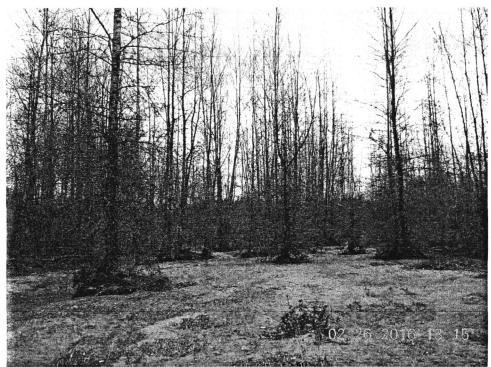
Photo 36. Looking north northeast from Location # 15 along alignment of historic E.F. Lewis River channel.

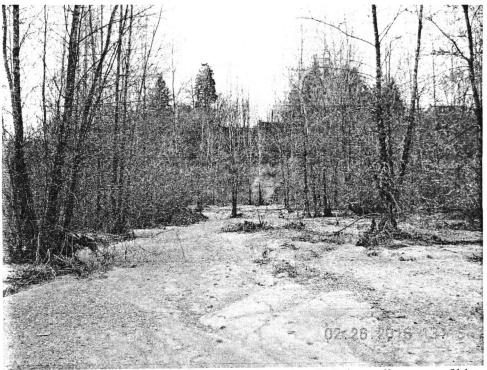
Photo 37. Looking south southwest from Location #15 along alignment of historic E.F. Lewis River channel.

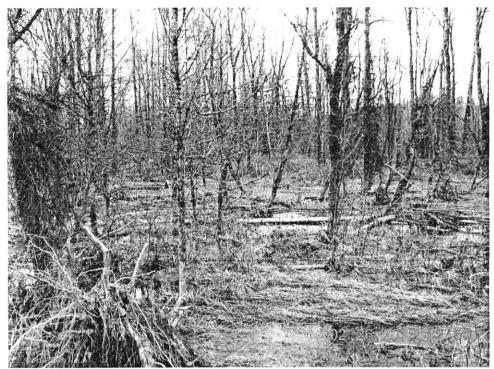
Photo 38. Looking east southeast from Location #16 at E. F. Lewis River floodplain. Historic location of E.F. Lewis River channel.

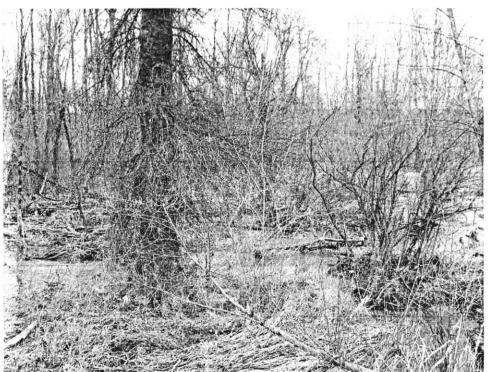
Photo 39. Looking west southwest from Location #16 at E.F. Lewis River floodplain. Historic location of E.F. Lewis River channel.
