# Technical Memo

## WEST Consultants, Inc.

**Name:** Kimball Storedahl  
**Company:** J.L. Storedahl & Sons, Inc.  
**Date:** July 6, 2017  
**From:** Hans R. Hadley, P.E.  
Senior Hydraulic Engineer  
**Subject:** MEM-07 Monitoring Report – June 28, 2017 Field Reconnaissance

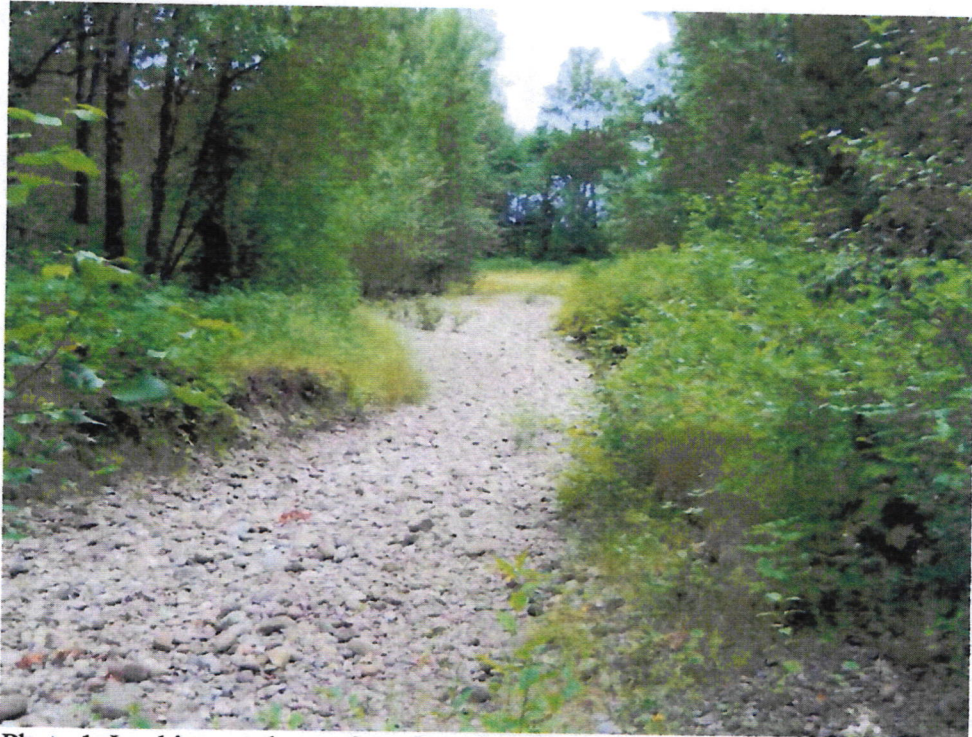
Photo 1. Looking northwest from Location #1 along secondary floodplain channel.

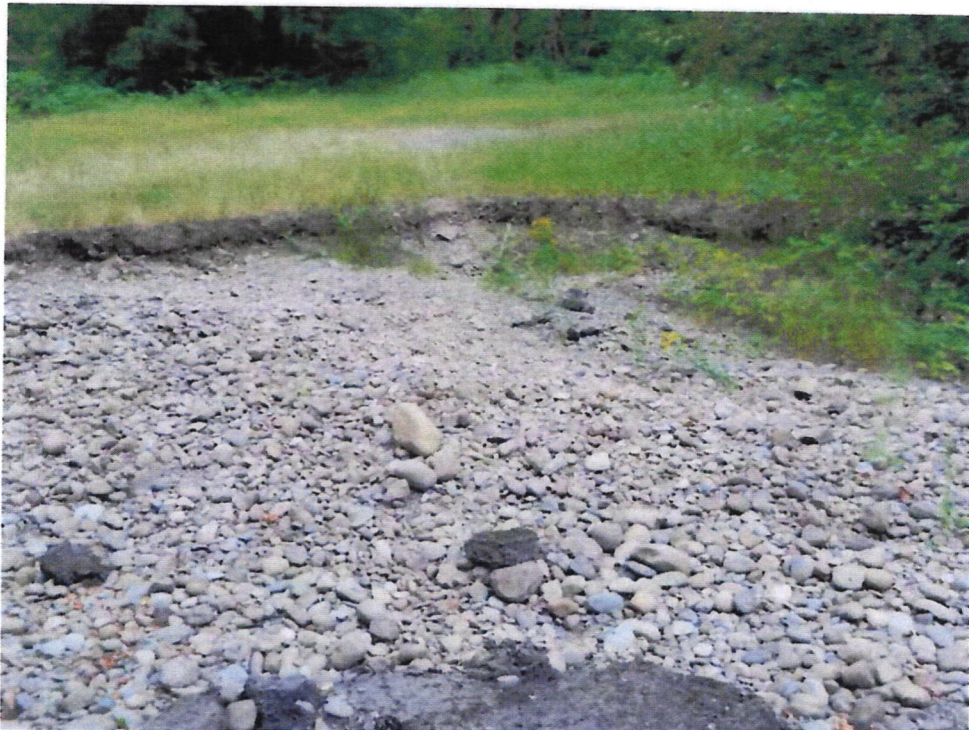
Photo 2. Looking southwest from Location #1 at headcut nick point located at upstream end of secondary floodplain channel.

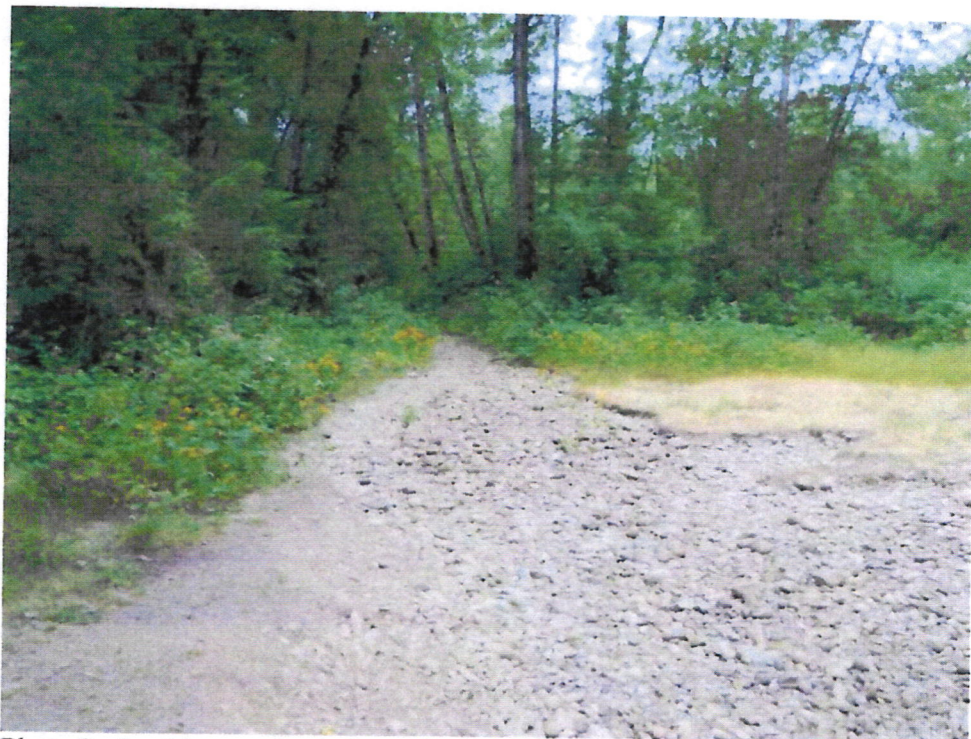
At Location #1, the existing headcut does not appear to have changed significantly since the observation in February 2016 (see Photo 3). The secondary channel that parallels Storedahl Pit

Photo 3. Looking south southeast from Location #1 toward County Pond #2.

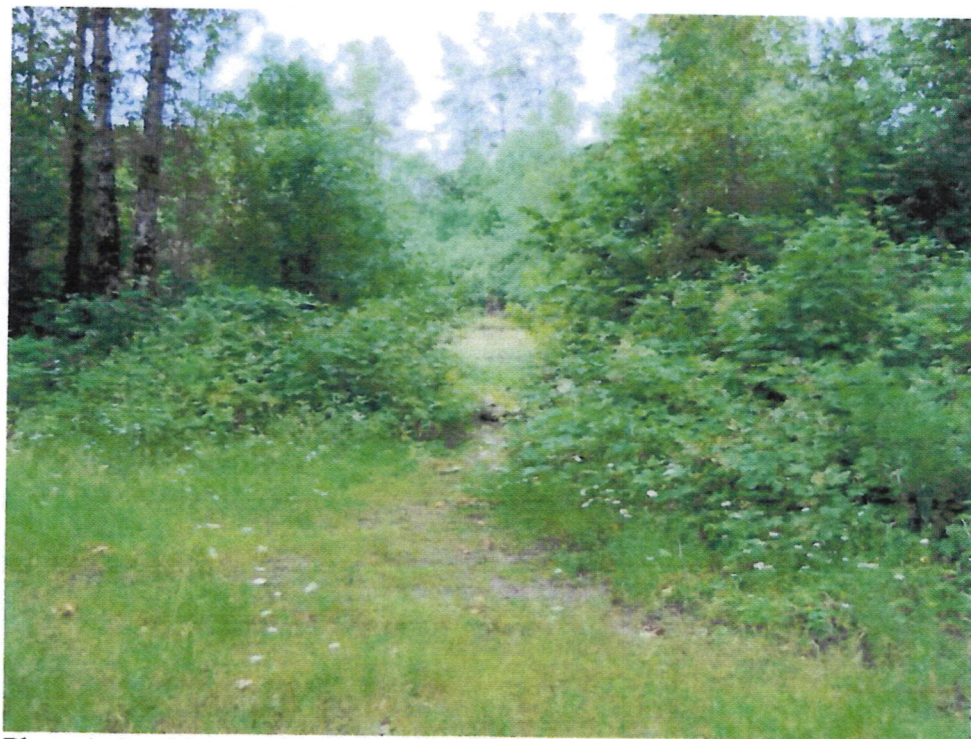
Photo 4. Looking southeast from Location #2 at overflow path from County Pond #2.

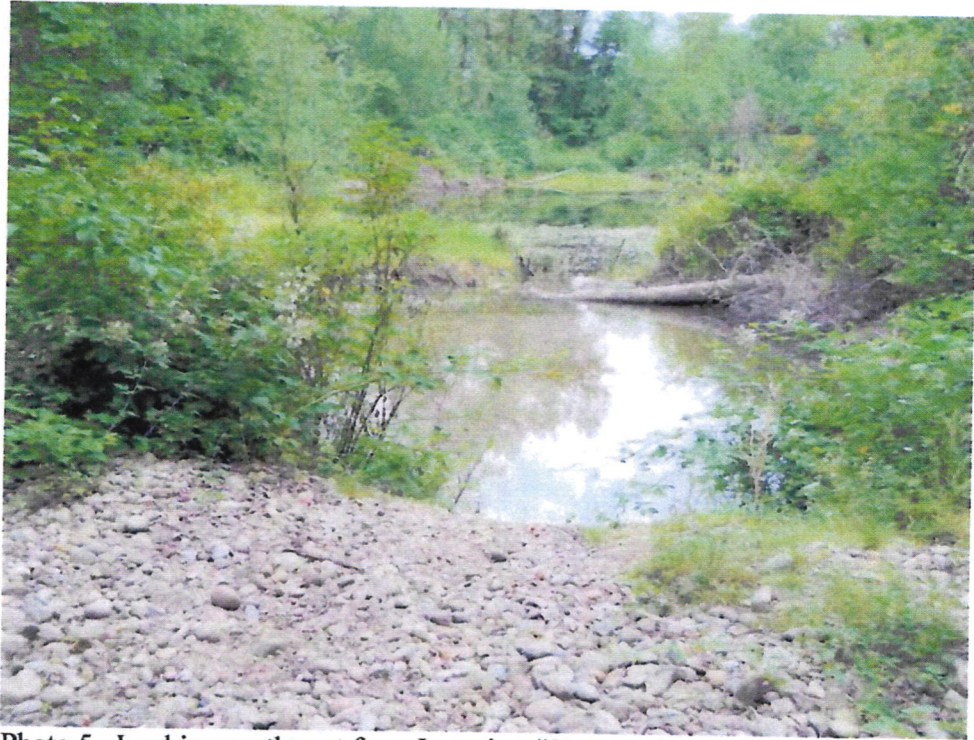
Photo 5. Looking northwest from Location #3 at overflow channel into County Pond #1.

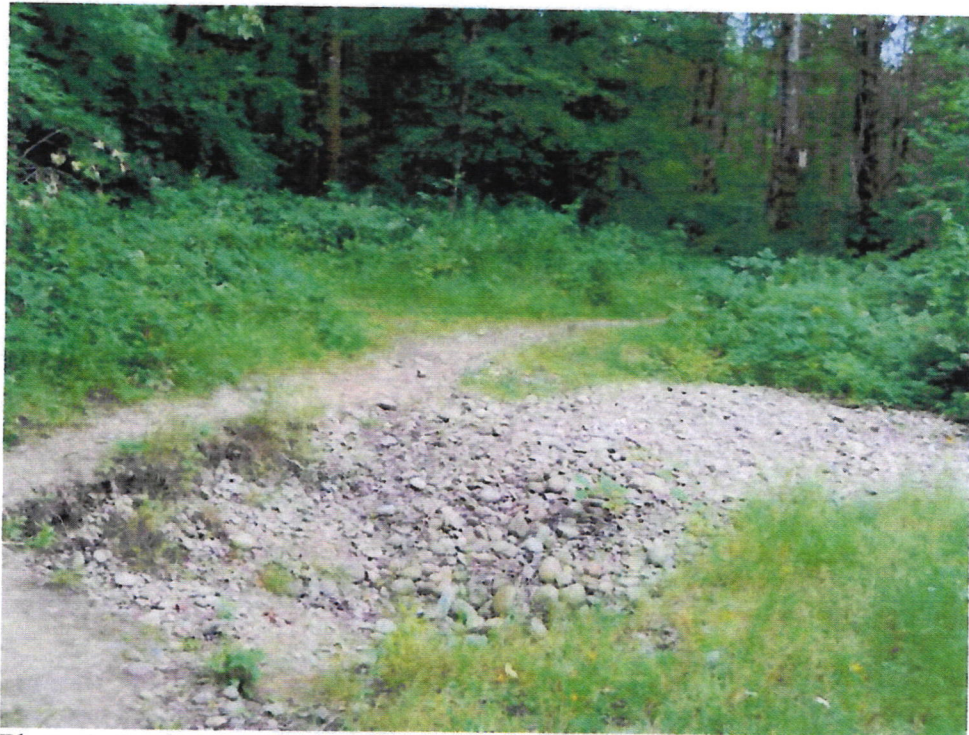
Photo 6. Looking southwest from Location #3 at headcut nick point located at upstream end of overflow channel into County Pond #1.

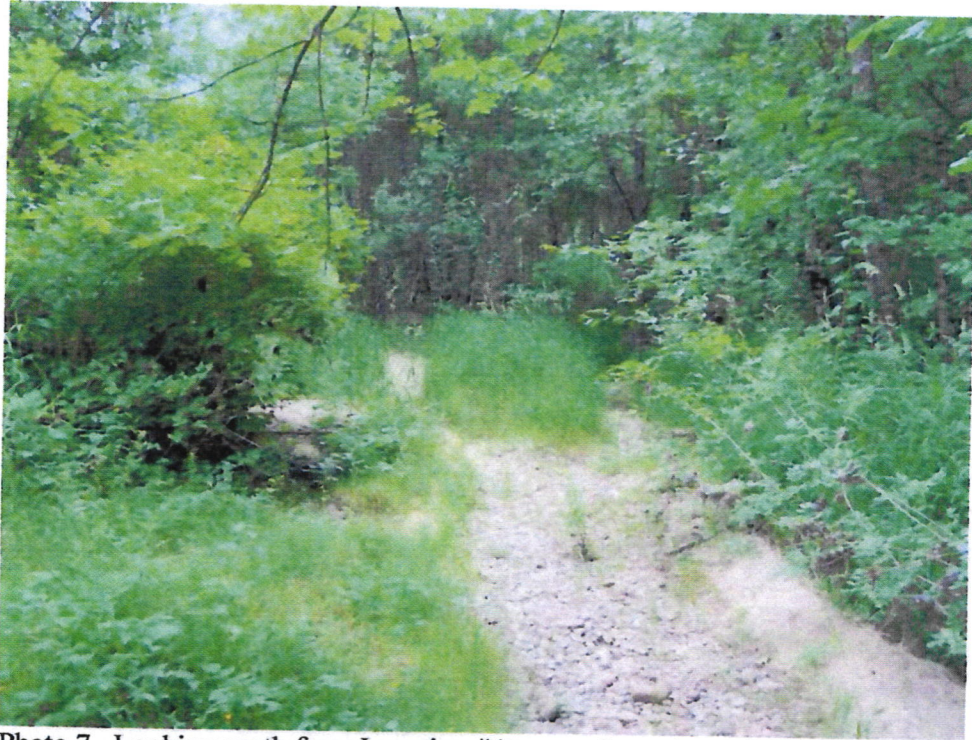
Photo 7. Looking north from Location #4 at overflow channel from E.F. Lewis River into County Pond #2.

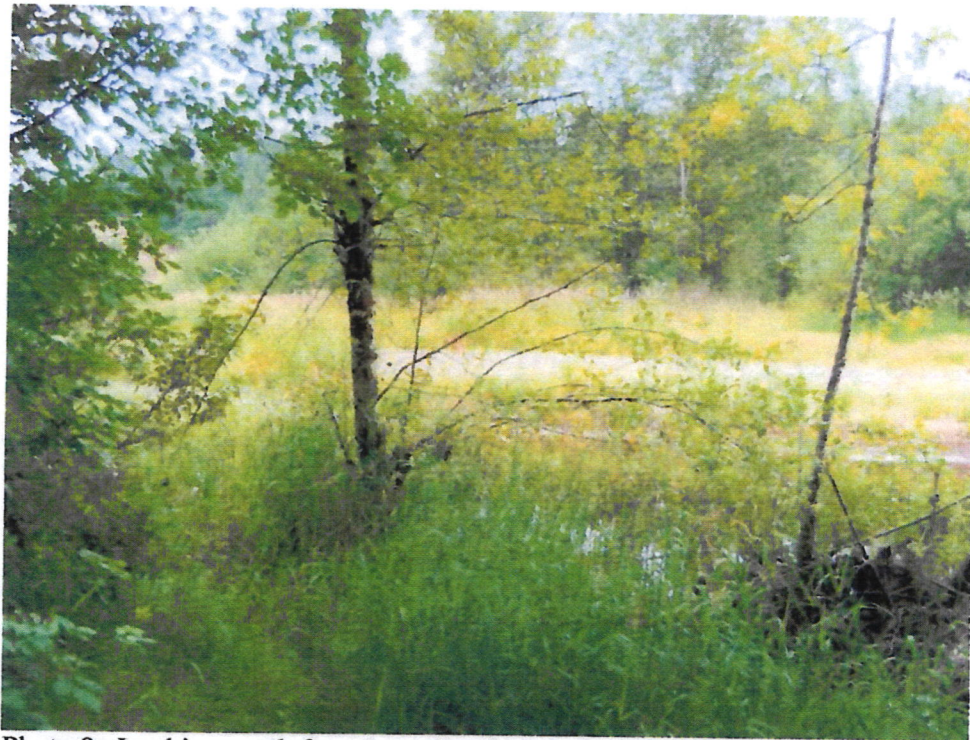
Photo 8. Looking south from Location #4 at upstream end of overflow channel from E.F. Lewis River into County Pond #2. Recently abandoned E.F. Lewis River channel in background.

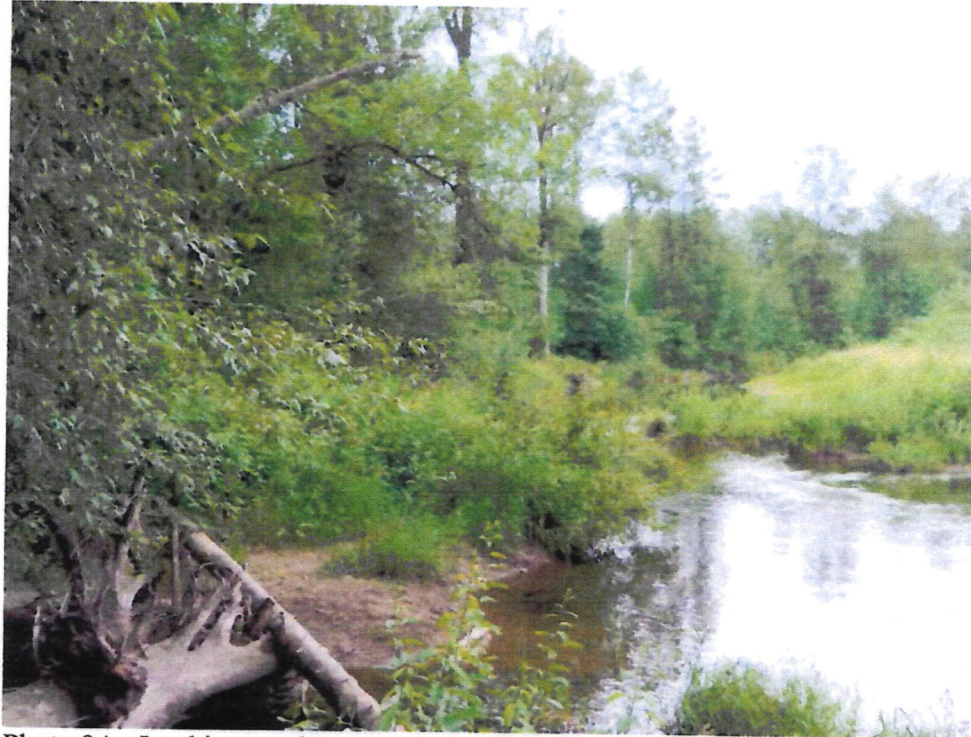
Photo 9A. Looking northeast northeast from Location #5A at right bank of recently abandoned section of E.F. Lewis River at location of overflow channel that leads to County Pond #2.

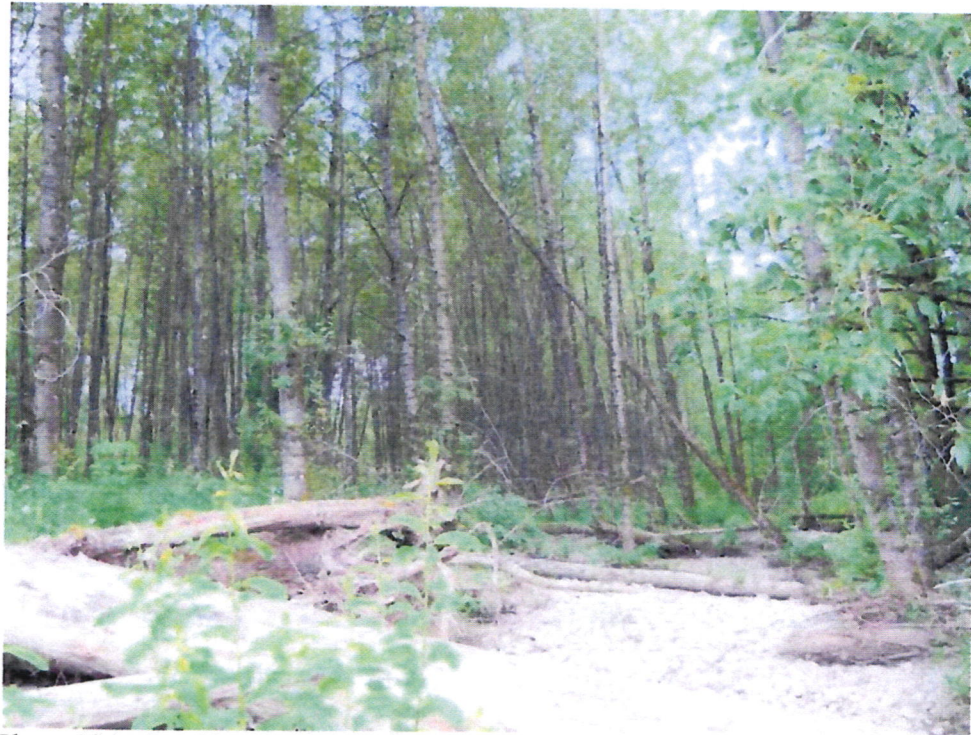
Photo 10A. Looking northwest from Location #5A at upstream end of secondary channel.

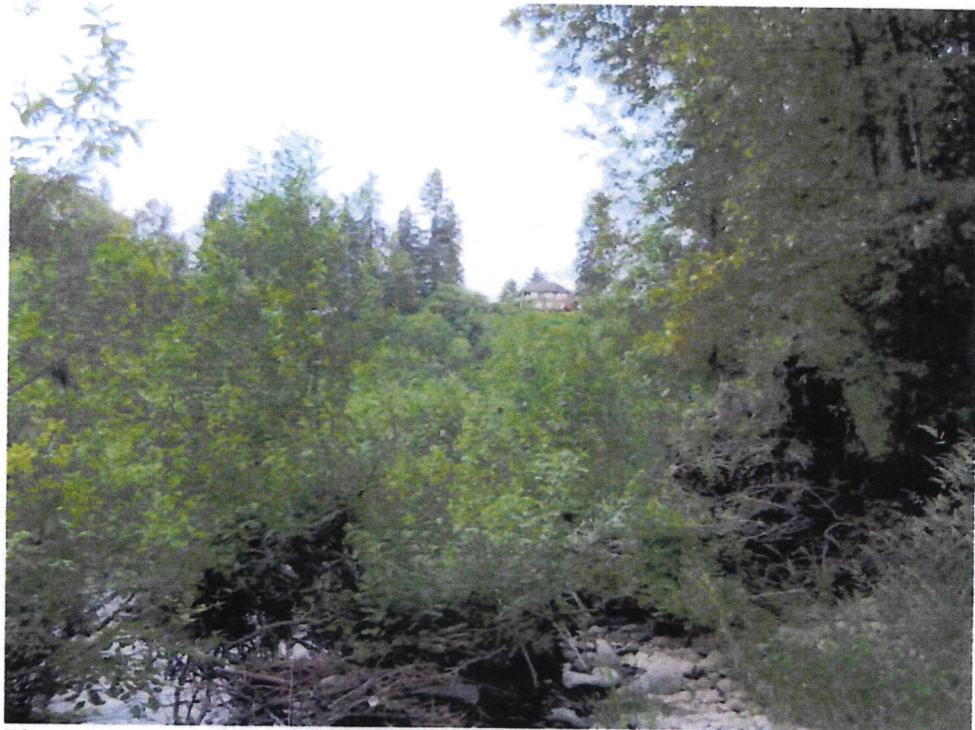
Photo 11A. Looking south from Location #5A at downstream end of recently abandoned section of E.F. Lewis River.

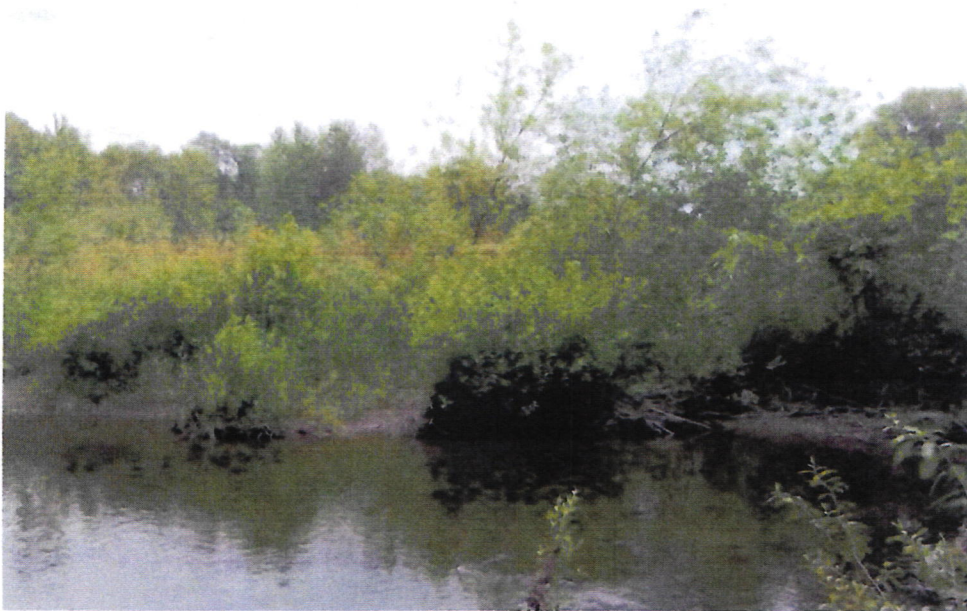
Photo 12A. Looking east southeast from Location #5A at downstream end of second E.F. Lewis meander cutoff channel.

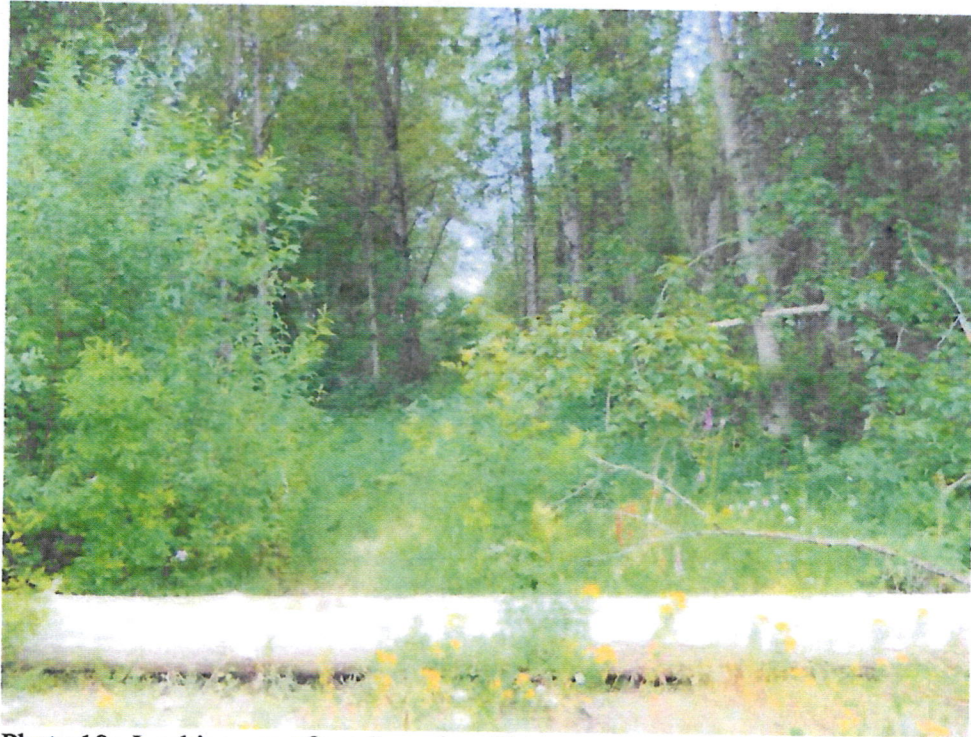
Photo 18. Looking west from Location #6 at upstream end of secondary floodplain channel.

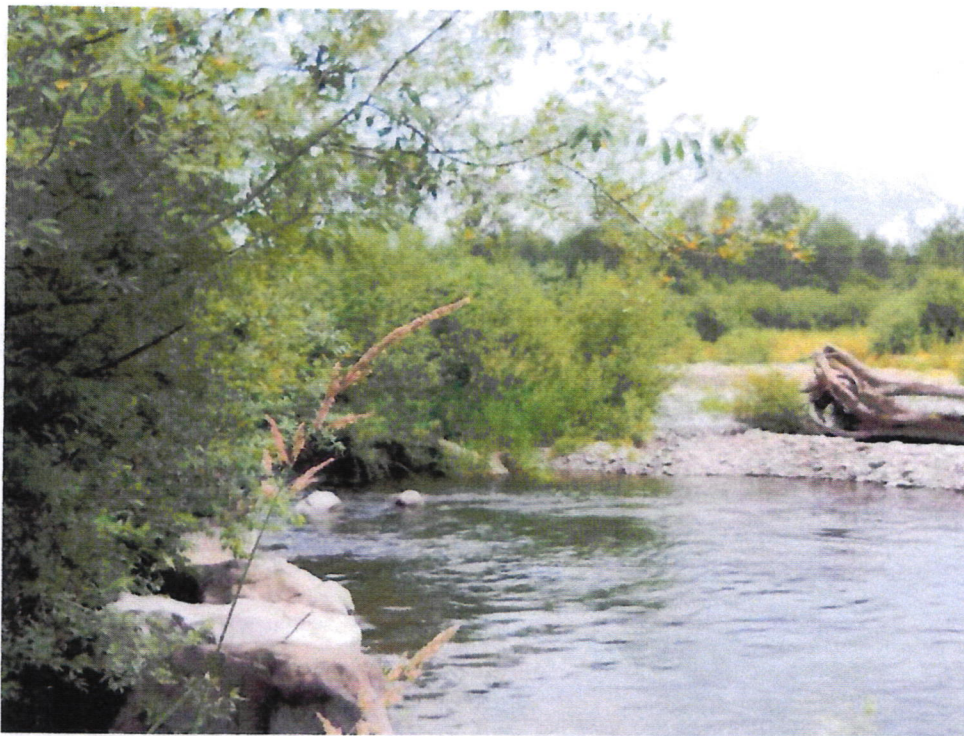
Photo 19. Looking north northeast from Location #6 at rock vane located along the right bank of recently abandoned section of E.F. Lewis River.

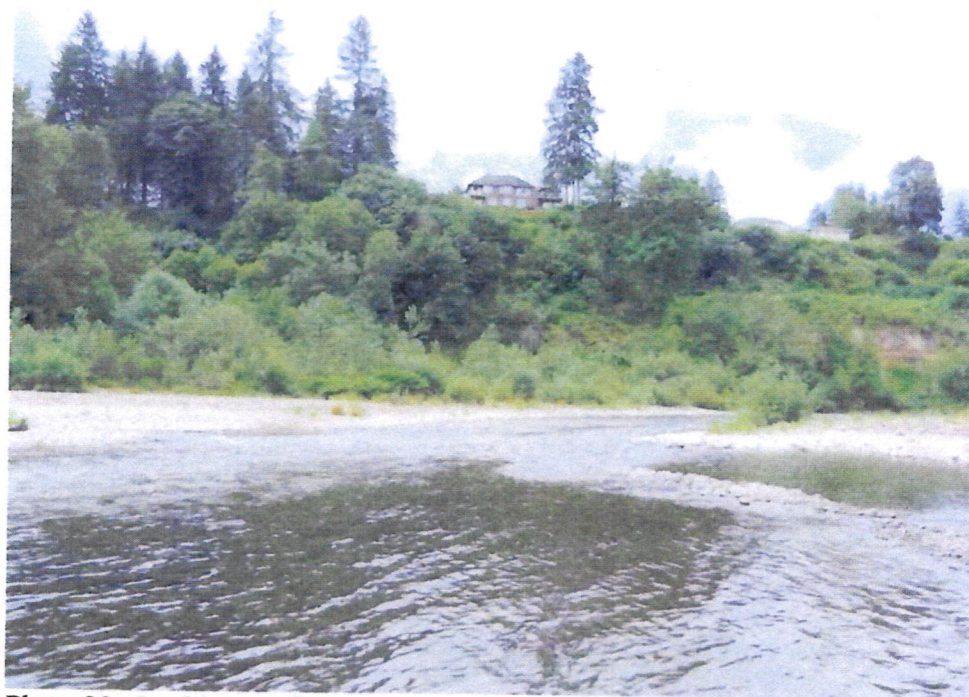
Photo 20. Looking southeast from Location #6 at downstream end of recently abandoned section of E.F. Lewis River. Note first cutoff channel at left side of photo.

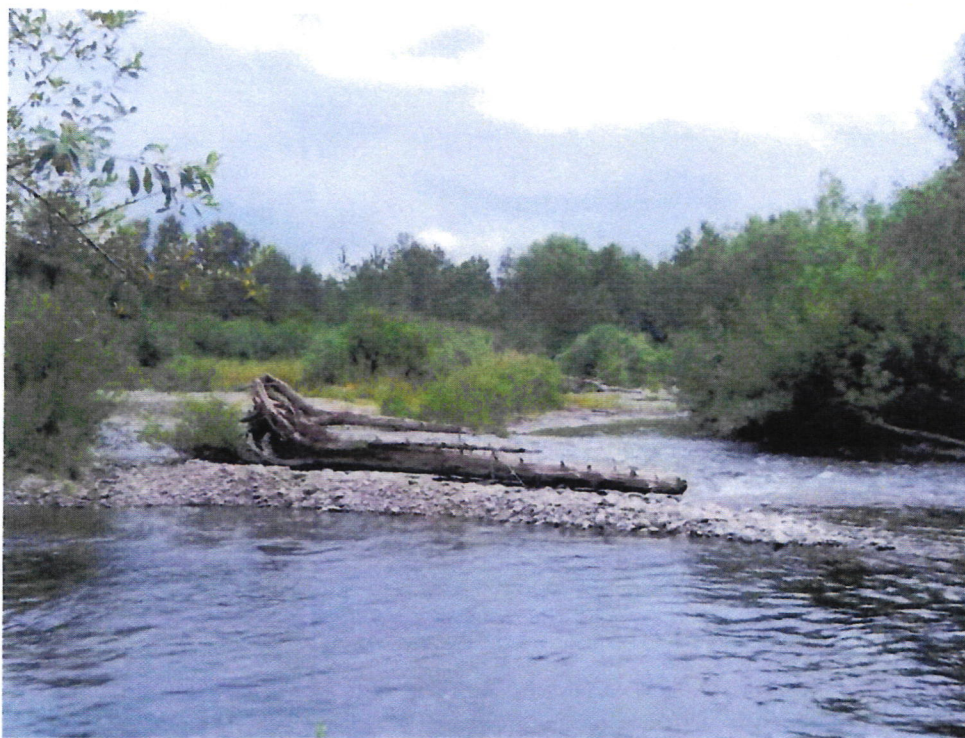
Photo 20A. Looking east northeast from Location #6 at downstream end of second E.F. Lewis River meander cutoff channel.

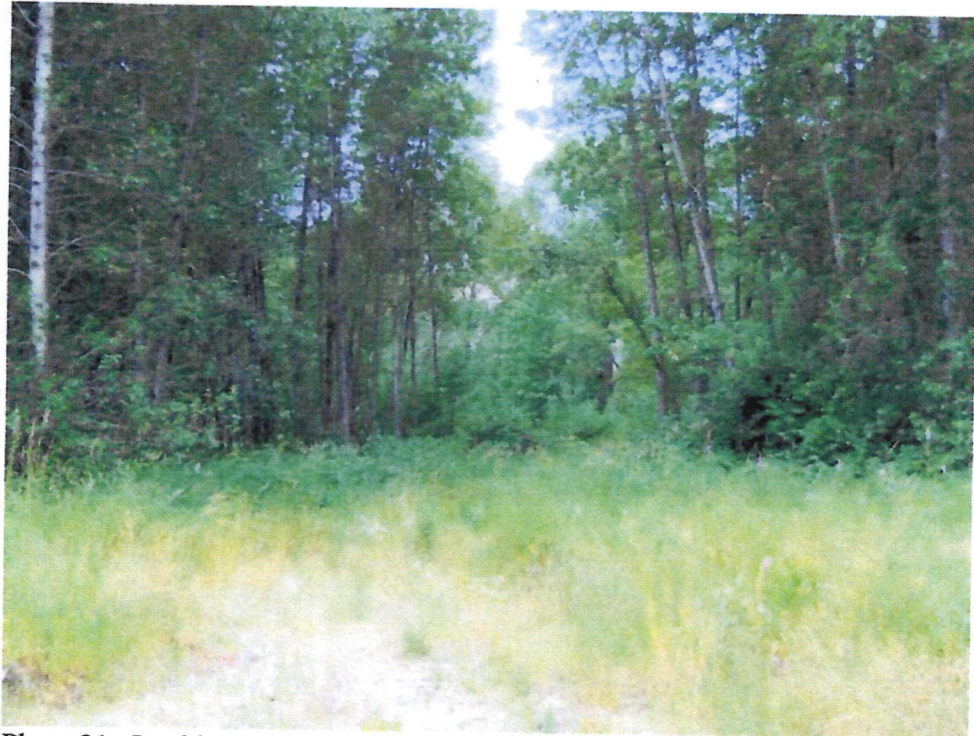
Photo 21. Looking northwest from Location #7 at upstream end of secondary floodplain channel.

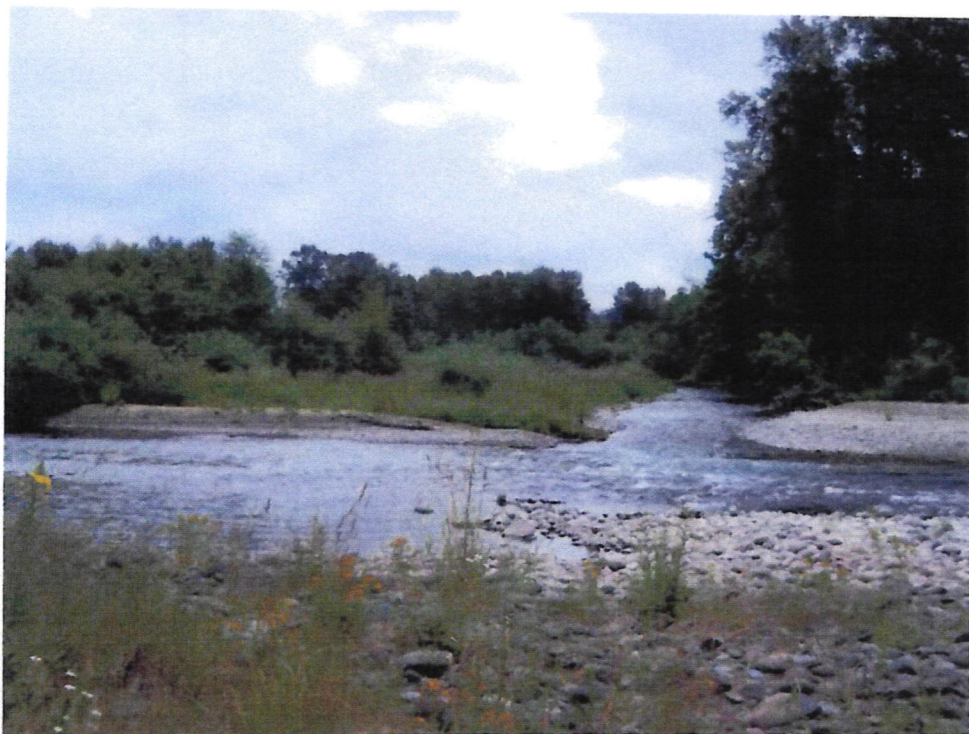
Photo 21A. Looking east southeast from Location #7 at downstream end of first E.F. Lewis River meander cutoff channel.

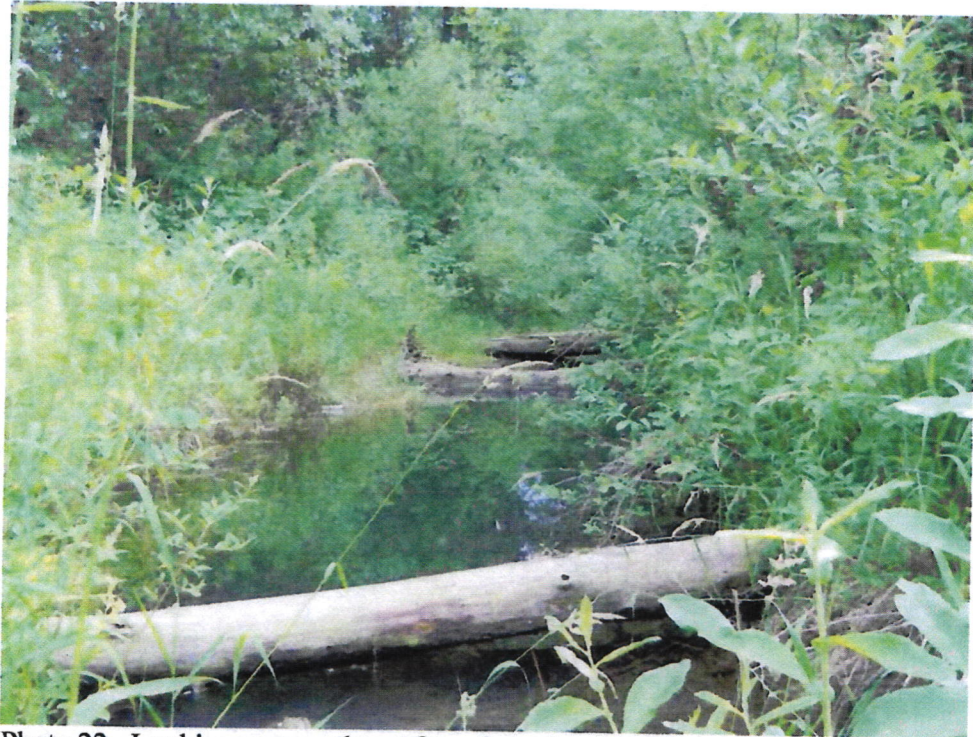
Photo 22. Looking east northeast from Location #8 at downstream end of secondary floodplain channel.

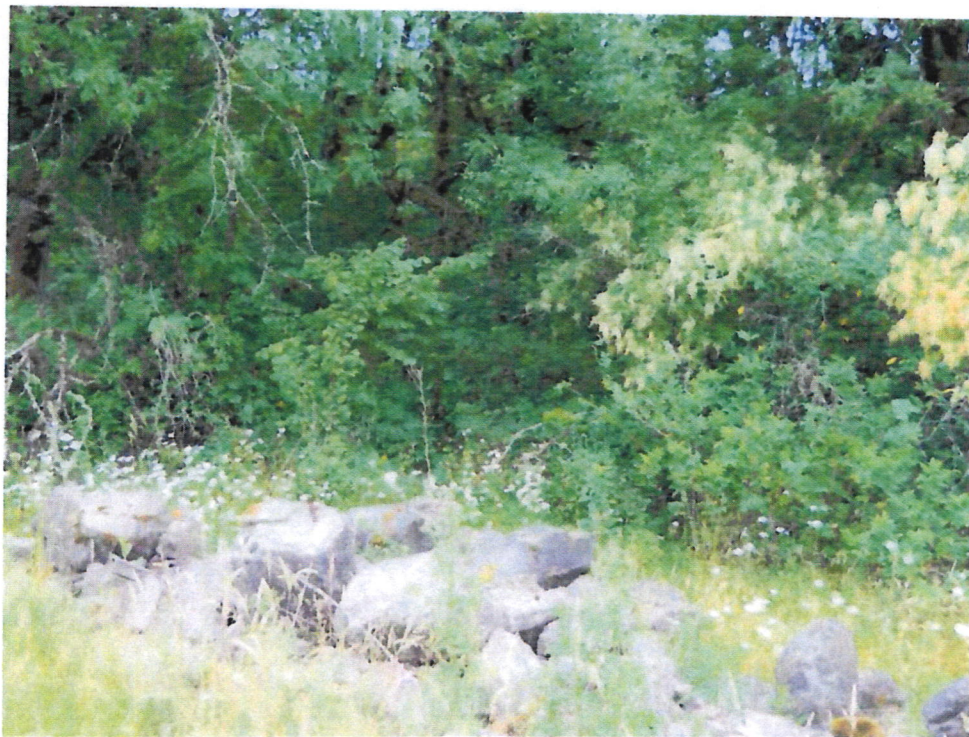
Photo 23. Looking southeast from Location #9 in direction of floodplain overflow channel shown in Photo 1.

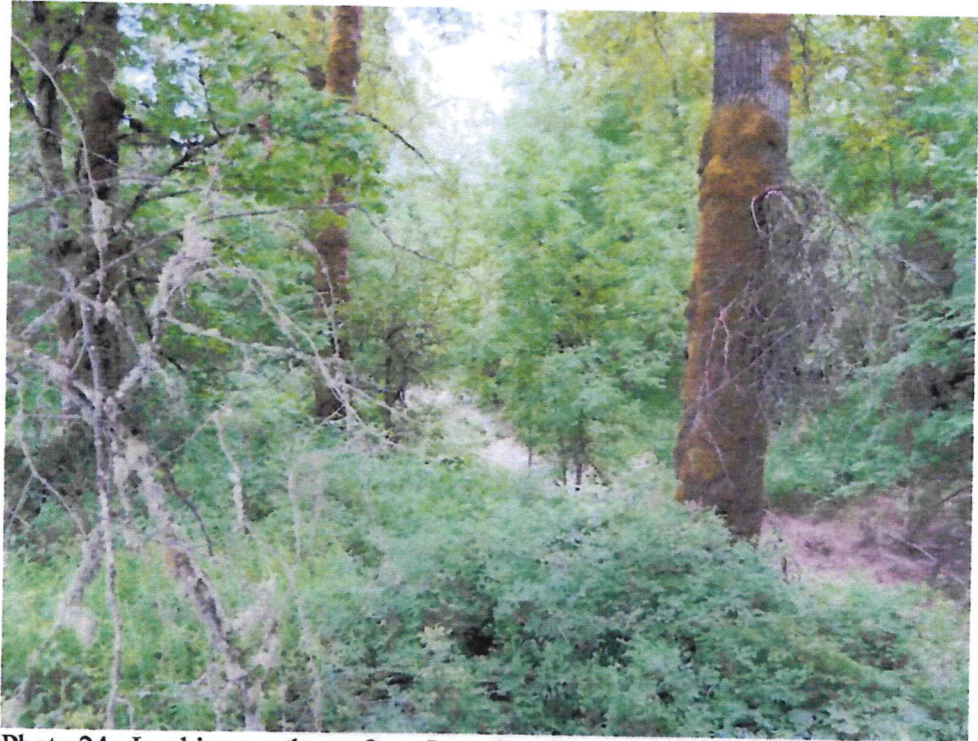
Road was not conveying water at the time of the reconnaissance (see Photos 24-28 & 38-39). The flow in the East Fork Lewis River at Heisson was about 250 cfs during this time. The connectivity of this secondary channel with the main channel will continue to be monitored during subsequent field reconnaissance efforts.

Photo 24. Looking southeast from Location #10 at floodplain adjacent to Storedahl Pit Road. Historic location of E.F. Lewis River channel.

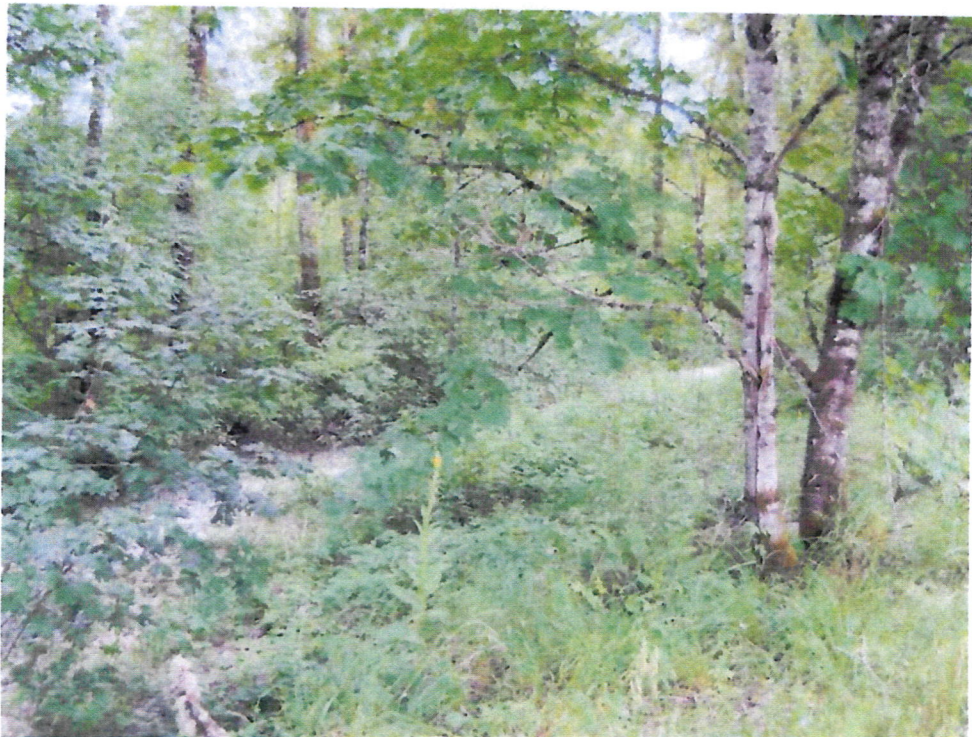
Photo 25. Looking west from Location #10 at floodplain adjacent to Storedahl Pit Road. Historic location of E.F. Lewis River channel.

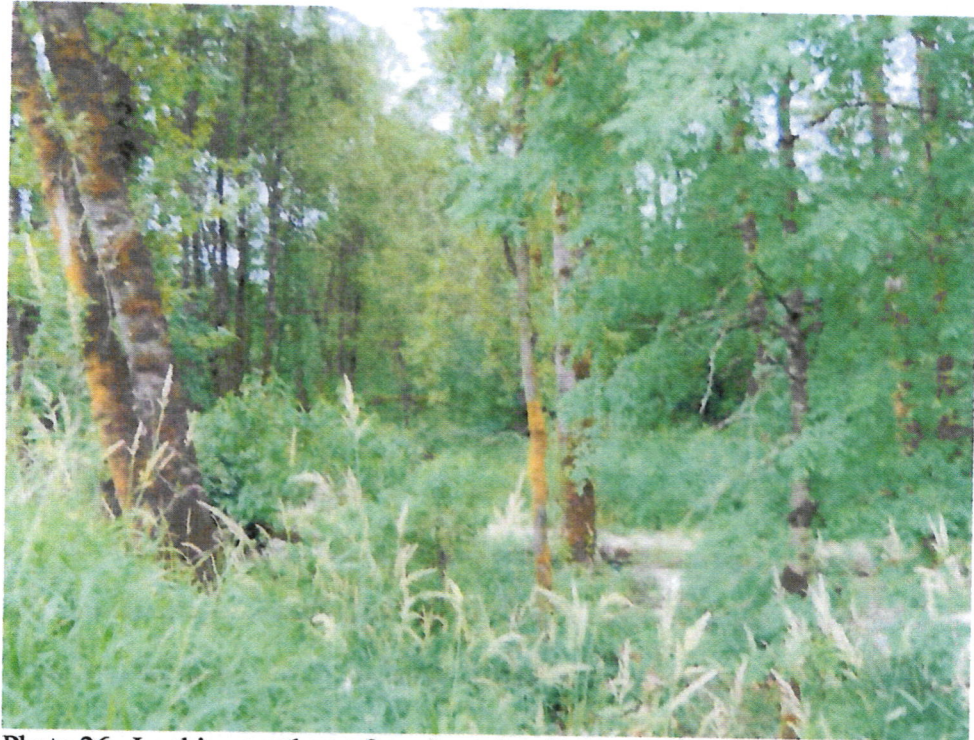
Photo 26. Looking southeast from Location #11 at floodplain adjacent to Storedahl Pit Road. Historic location of E.F. Lewis River channel.

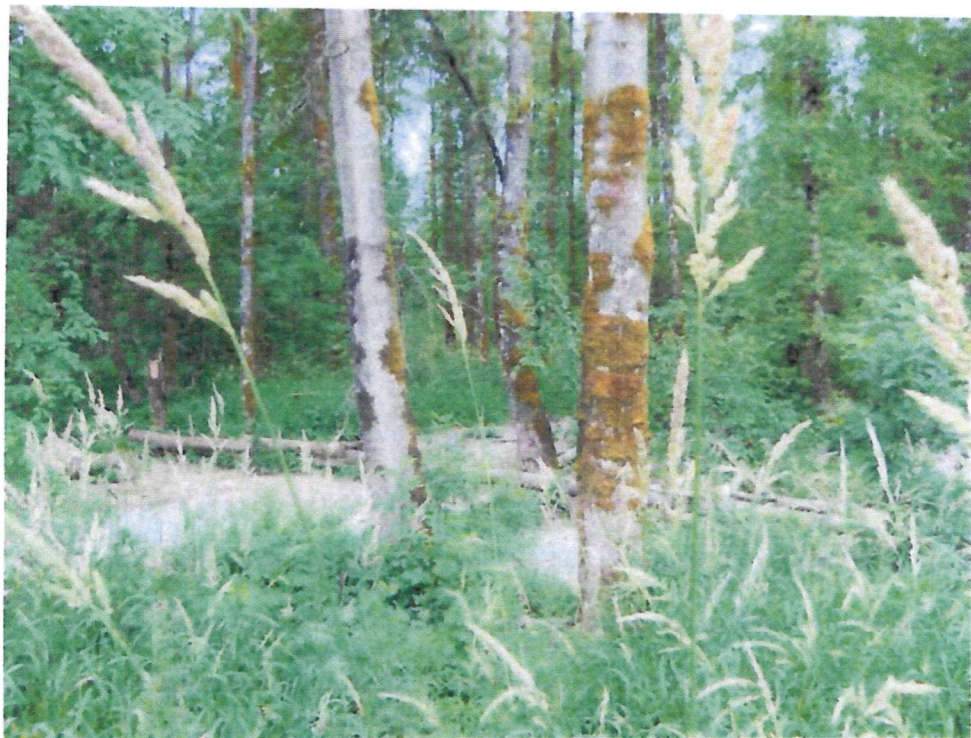
Photo 27. Looking south from Location #11 at floodplain adjacent to Storedahl Pit Road. Historic location of E.F. Lewis River channel.

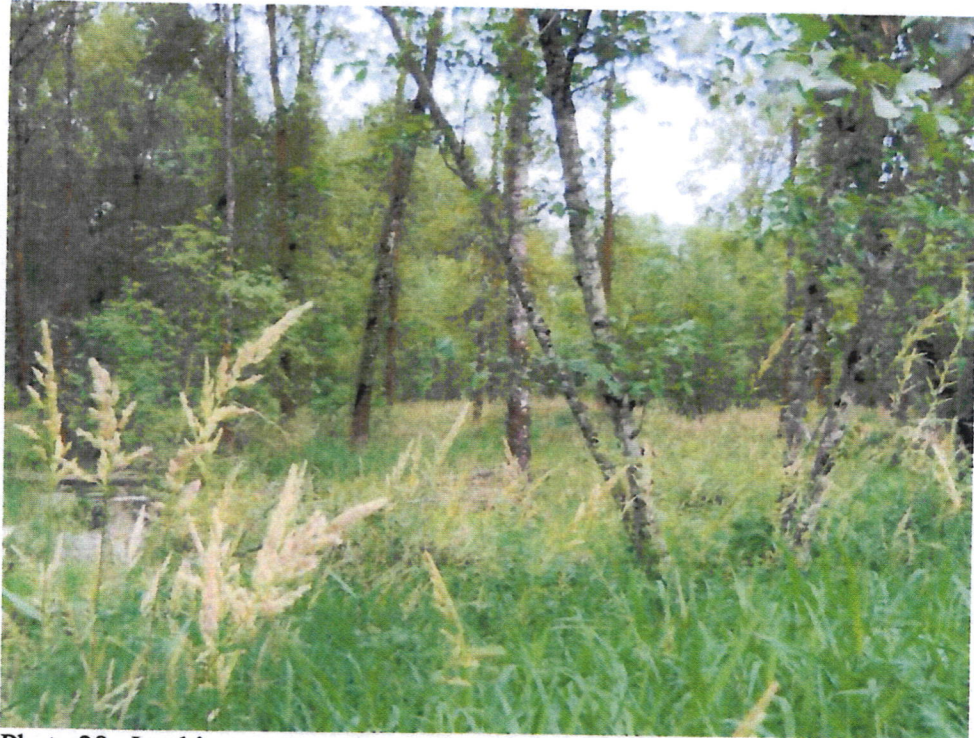
Photo 28. Looking west southwest from Location #11 at floodplain adjacent to Storedahl Pit Road. Historic location of E.F. Lewis River channel.

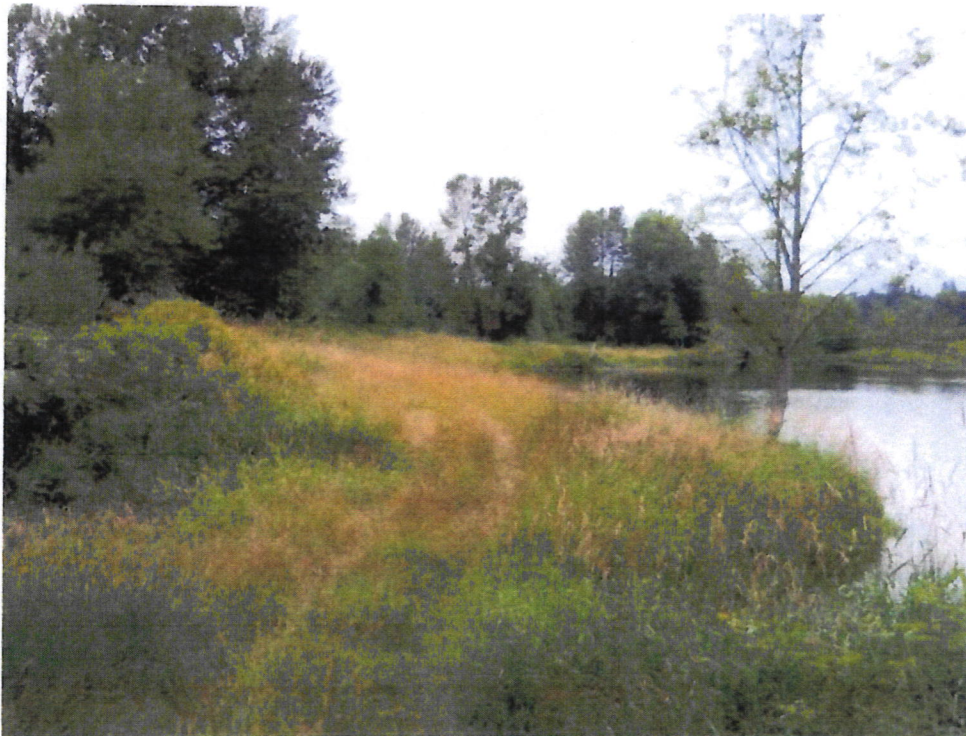
Photo 29. Looking northwest from Location #12 at Daybreak Pond #5 overflow into E.F. Lewis River floodplain.

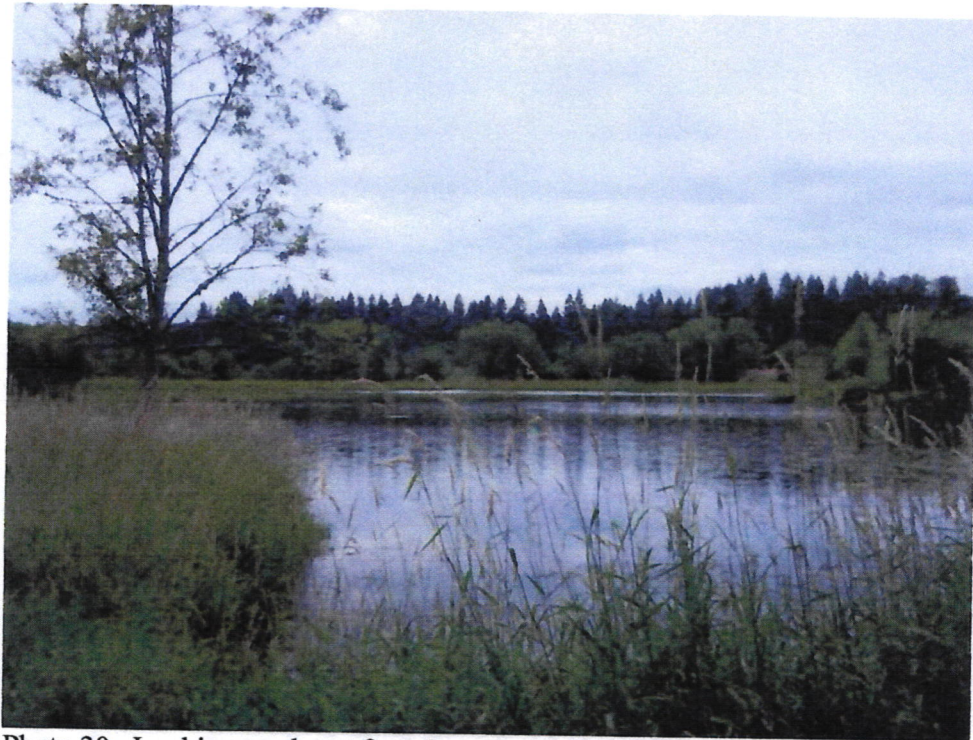
Photo 30. Looking northeast from Location # 12 at Daybreak Pond #5.

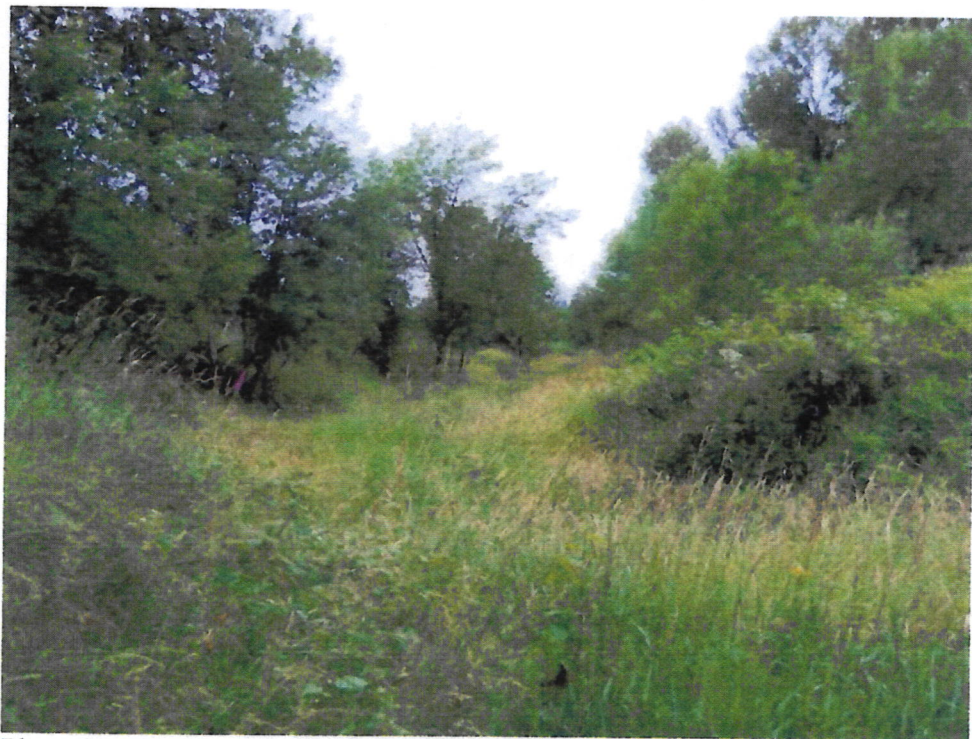
Photo 31. Looking west northwest from Location #12 at E.F. Lewis River floodplain.

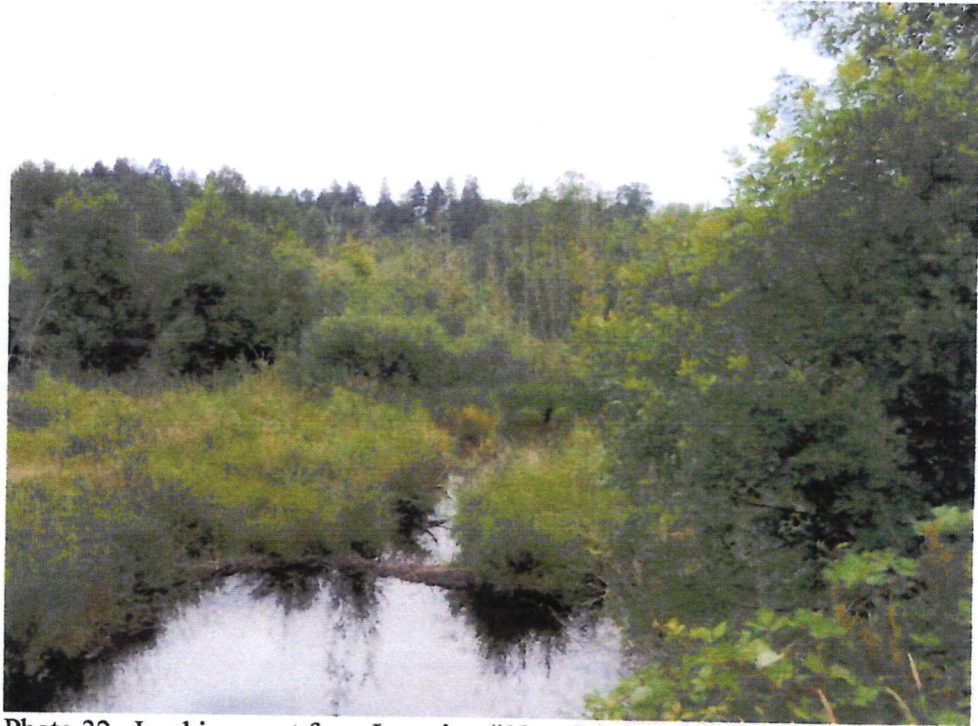
Photo 32. Looking west from Location #13 at E.F. Lewis River floodplain.

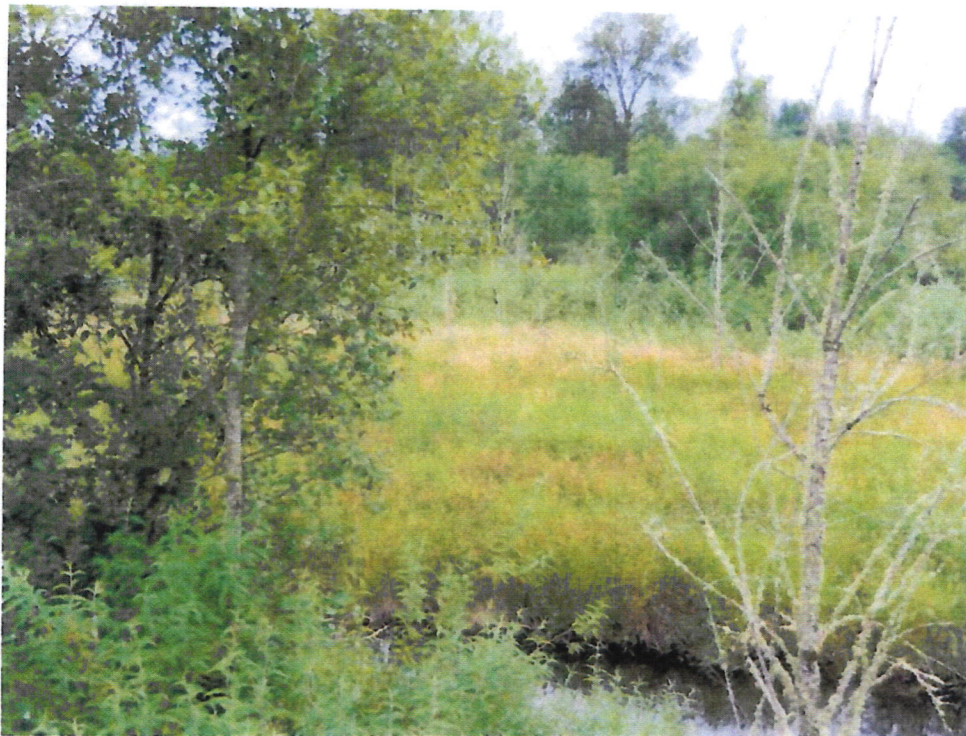
Photo 33. Looking southeast from Location #13 at E.F. Lewis River floodplain.

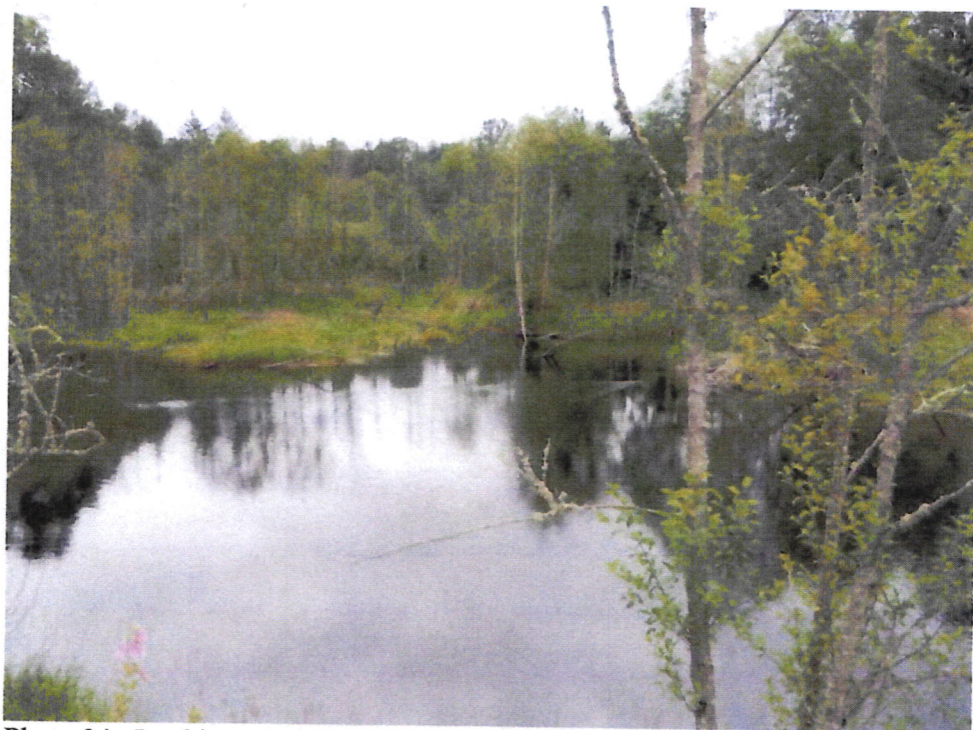
Photo 34. Looking south southeast from Location #14 at historic E.F. Lewis River channel.
