# Technical Memo

## WEST Consultants, Inc.

**Name:** Kimball Storedahl  
**Company:** J.L. Storedahl & Sons, Inc.  
**Date:** July 6, 2017  
**From:** Hans R. Hadley, P.E.  
Senior Hydraulic Engineer  
**Subject:** MEM-07 Monitoring Report – June 28, 2017 Field Reconnaissance

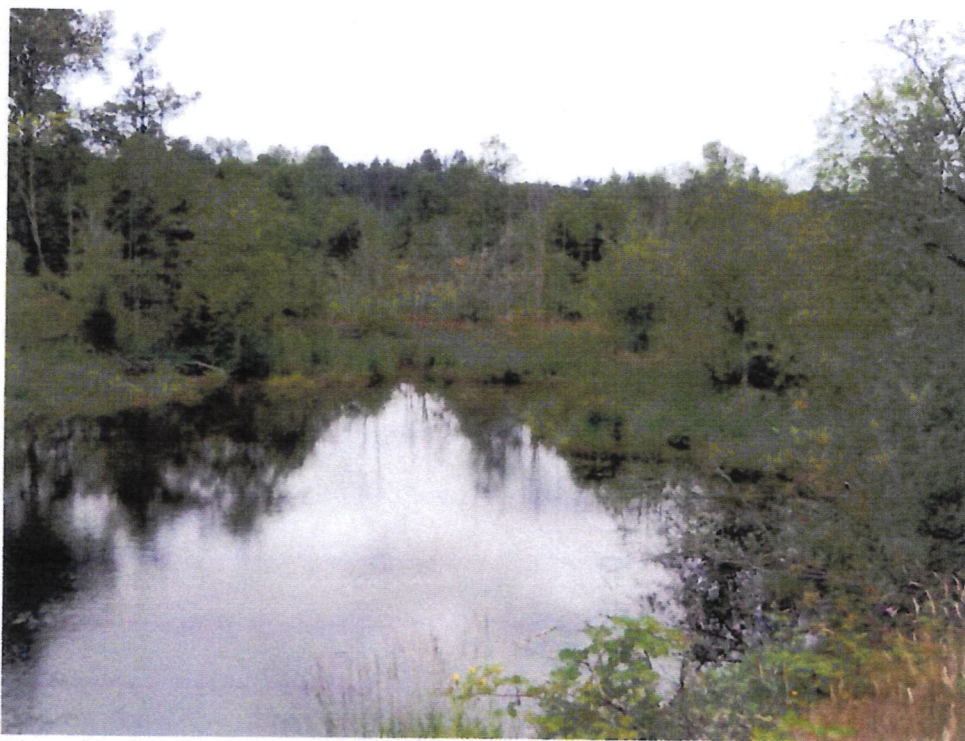
Photo 35. Looking west from Location #14 at historic E.F. Lewis River channel.

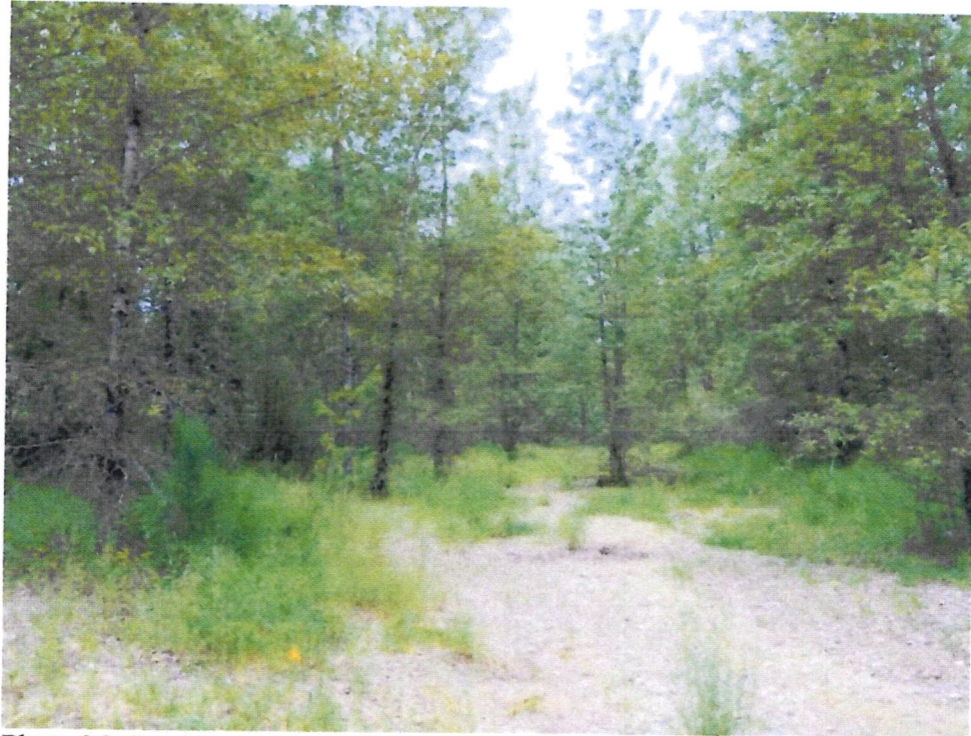
Photo 36. Looking north northeast from Location # 15 along alignment of historic E.F. Lewis River channel.

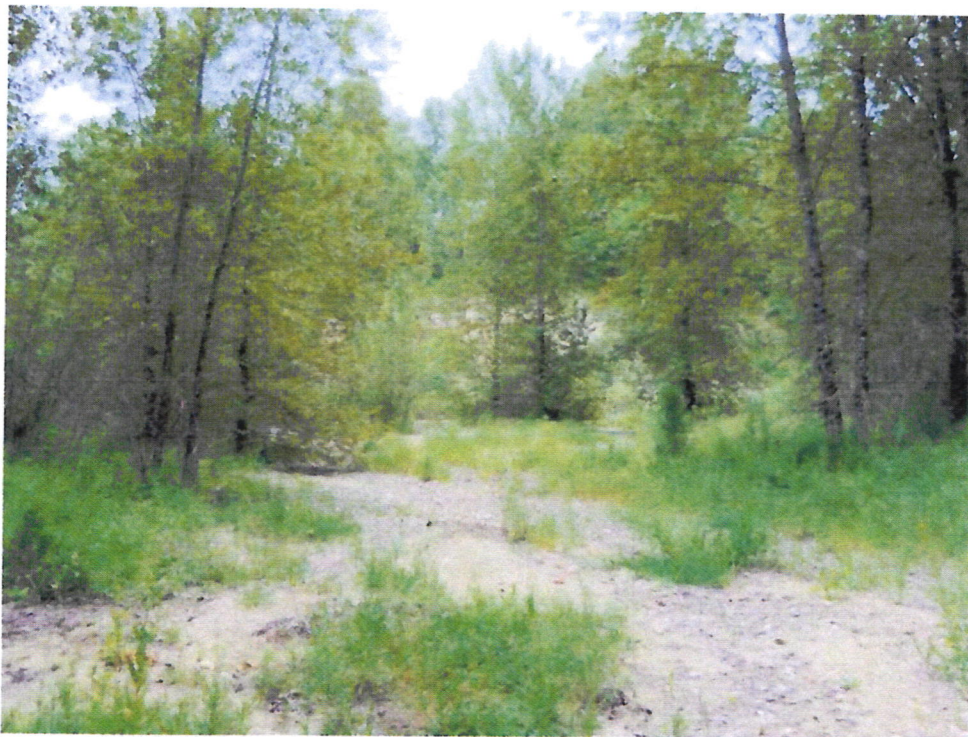
Photo 37. Looking south southwest from Location #15 along alignment of historic E.F. Lewis River channel.

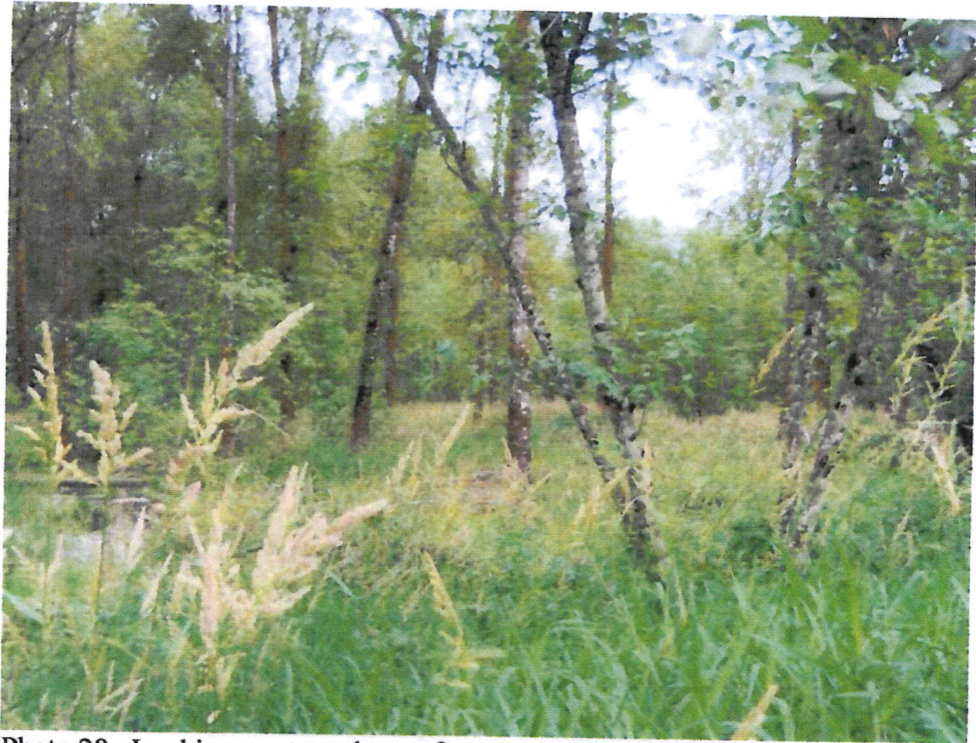
Photo 28. Looking west southwest from Location #11 at floodplain adjacent to Storedahl Pit Road. Historic location of E.F. Lewis River channel.

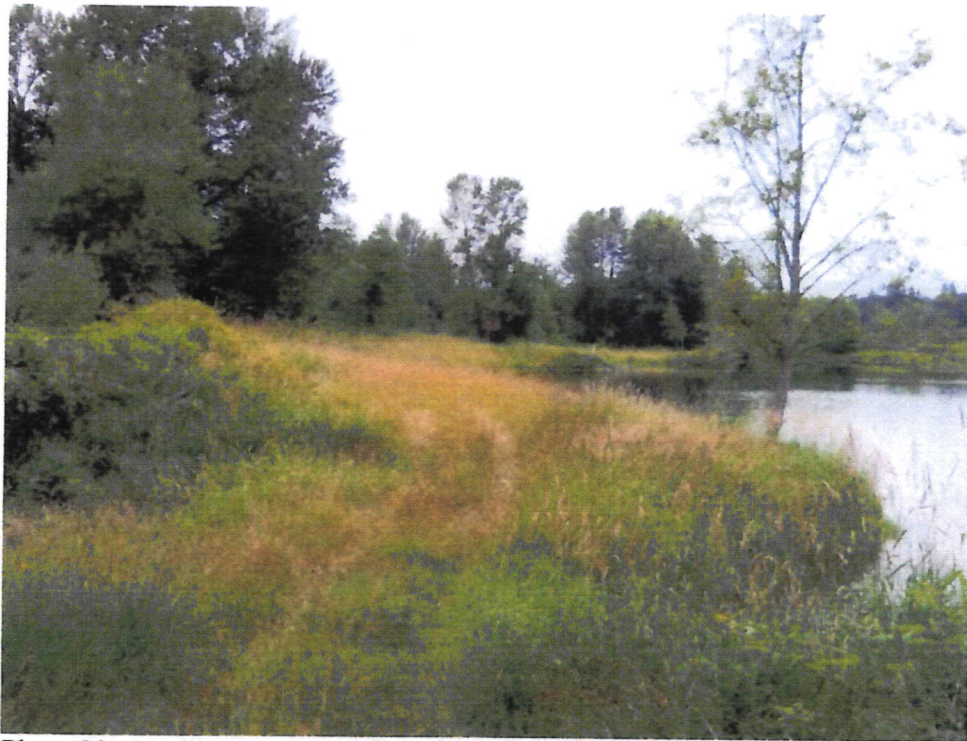
Photo 29. Looking northwest from Location #12 at Daybreak Pond #5 overflow into E.F. Lewis River floodplain.
