**East Fork Lewis River (RM 13 to RM 6),  
Including  
West Daybreak Park Project Reach**

**Fluvial Geomorphology and  
Erosion and Sediment Evaluation**

Dr. Frank Reckendorf  
Fluvial Geomorphologist  
Reckendorf and Associates  
Salem, Oregon  
March 4, 2010

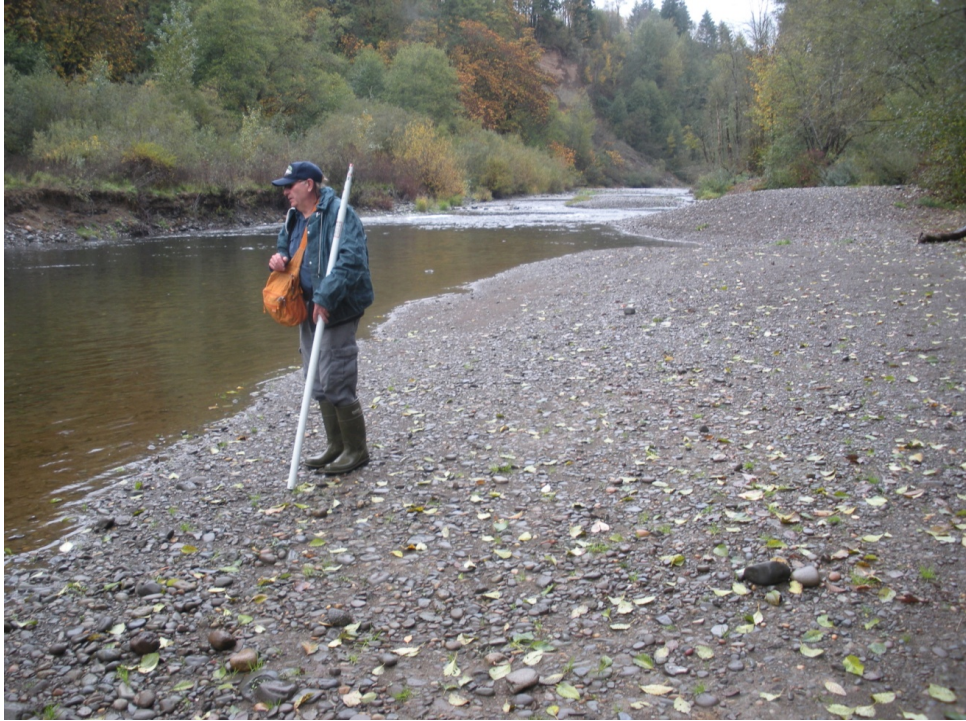
Figure 3. Gravel bar at RM 10.2 and below the high bar at RM 10.25. Looking upstream of the former pre avulsion bar in the foreground that is overlain by the higher avulsion created bar in the background. The former main channel is to the left of photograph.

The coarser high bar in the background of Figure 3 is downstream of recent partial avulsions in 2008 - 2009 runoff year. The 2008-2009 winter runoff partial avulsion occurred below RM 11, and created the bar immediately downstream starting at about RM 10.25. This high bar has a  $d_{50}$ 's of 43.92 mm-verses the adjacent bar (RM 10.2) with a  $d_{50}$ 's of 19.3 mm. This left bank bar is shown in Figure 3, occurs at the mouth of where the avulsion channel meet the mouth of the former main channel. Figure 4 looks up the avulsion channel at the mouth with the main channel and Figure 5 looks down the avulsion channel a few hundred feet upstream of the mouth of the avulsion. Figure 4 shows a coarse cobble material at the mouth of the avulsion channel and Figure 5 shows the downcut through the former point bar. The avulsion occurred between RM 10.75 and 10.25 along and old channel and was a neck cutoff. The river not only developed a straighter channel, but a change in grade was created. The avulsion would have created a headcut at the bottom end that migrated upstream across the neck cutoff and created the downcut of 2.5 -3.5 feet down into the former point bar material shown in Figure 5.

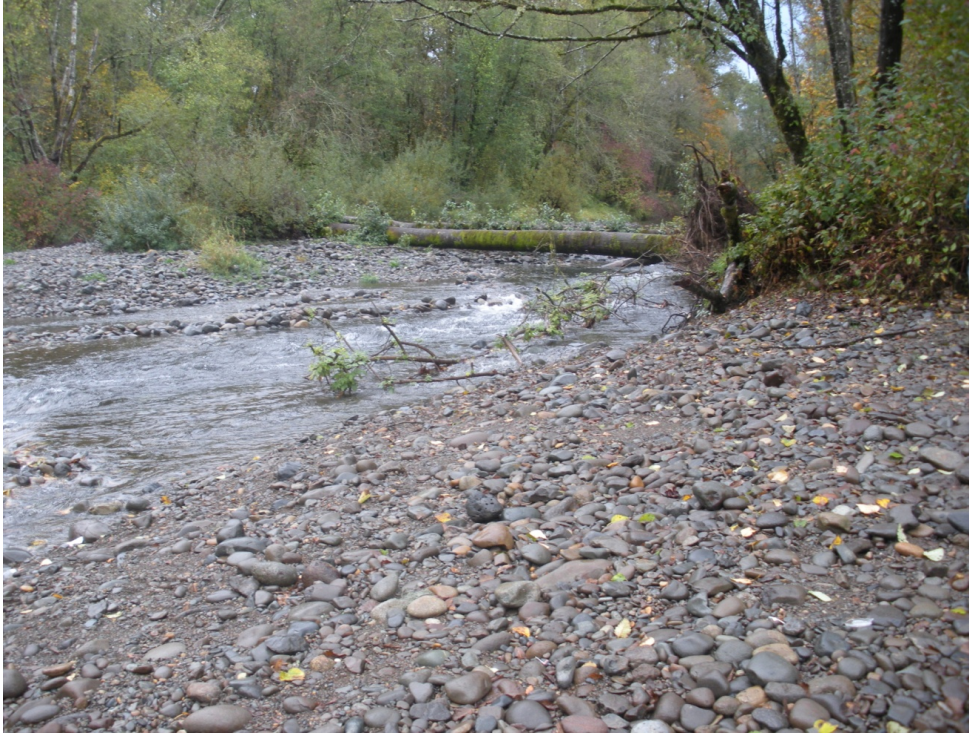
Figure 4 is an upstream view from the avulsion deposition bar across the avulsion.

The large bar in the background of Figure 4 at RM 10.25 has a d50 of 43.92mm. The d50 in the foreground of Figure 4. at RM 10.2 is 19.3mm . In other words there was a large dump on the bar with smaller bar material . The large new bar from the avulsion both smothers prior spawning beds, in channel that are not readily recovered because of the coarse deep sediment, but also removes stream capacity to carry flood flow, so causes opposite stream erosion. The magnitude of the flood and its duration has some significance in this process, as wood local accumulations of LWD. Streambank erosion, particularly of the fine sand loam textured streambanks, provide local large quantities of sediment for sediment intrusion into spawning gravels. As shown Reckendorf and Van Liew, (1989), the sand fraction of sediment intrusion, is enough to pack the redds such that lethal levels of dissolved oxygen occur next to the eggs.

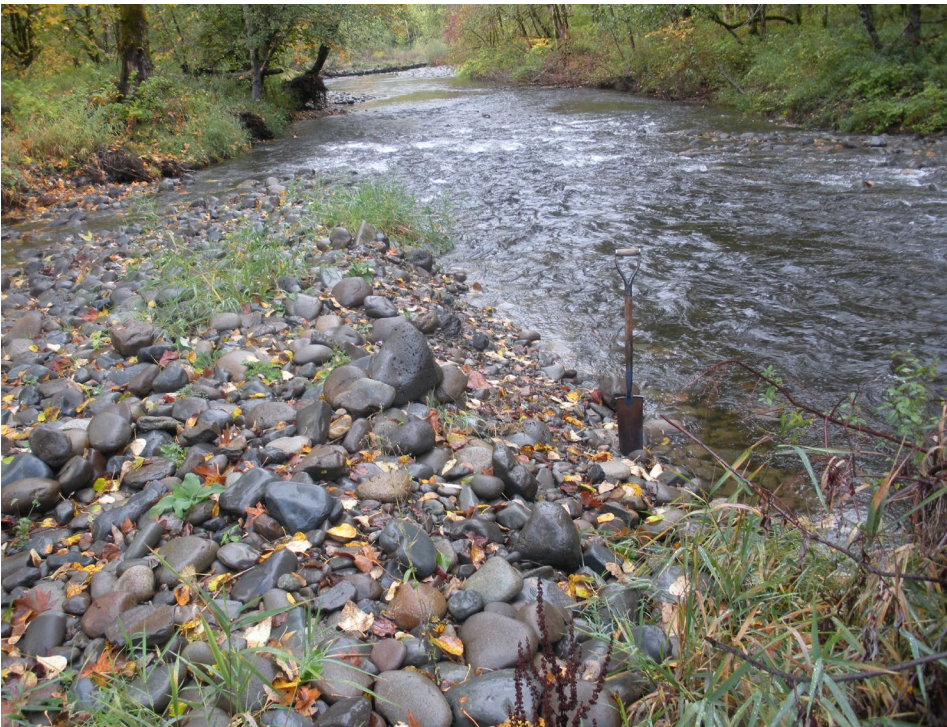
Figure 5 of partial avulsion channel downcutting between RM 10.75 and 10.25 Avulsion is partial because there is still flow in the main channel in the background.

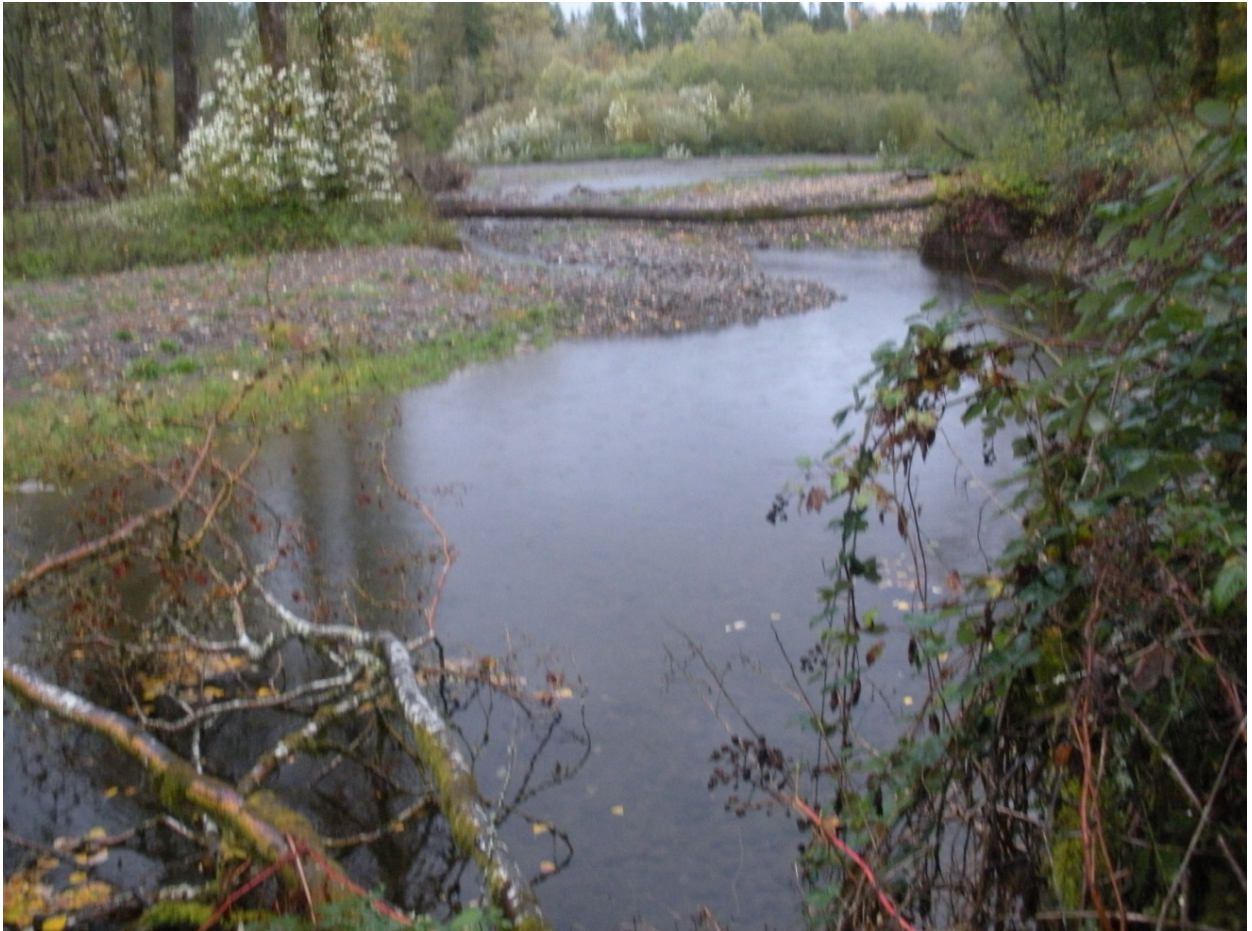
Figure 6 looks upstream along the upstream reach of the avulsion. Downstream and across from the avulsion caused bar at RM 10.25 the right bank streambank is severely eroded (Figure 3 and 7). This is possibly because it was easier to wash out the fines and sands of the streambank gravel than to erode and transport the coarse the sediment load from the avulsion channel. The bank erosion is shown in Figure 7 along right streambank of the main channel.

Figure 6. Upstream end of the avulsion between RM 10.75 and 10.25.

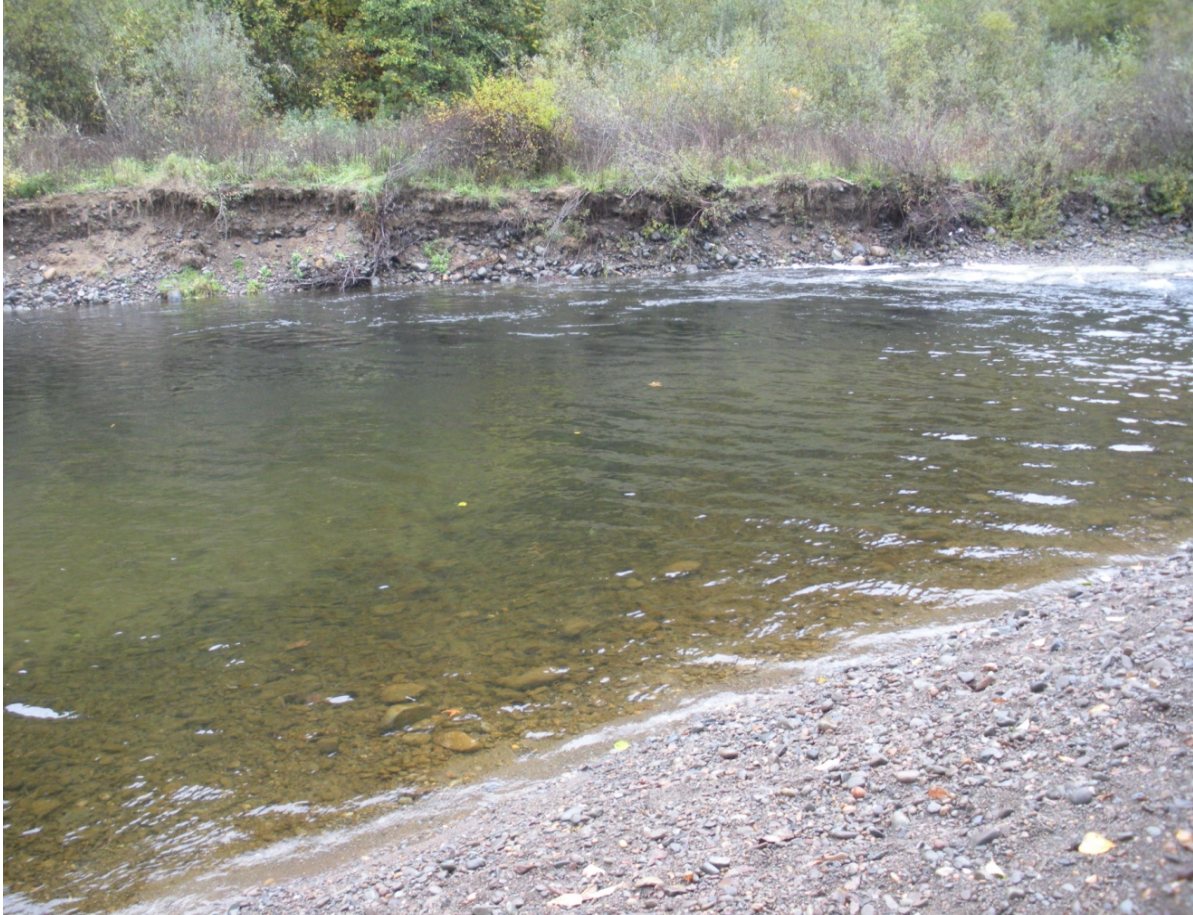
Figure 7. Streambank erosion with stratigraphic cantilever failure at RM 10.25 across for the flood deposition bar created from the avulsion.

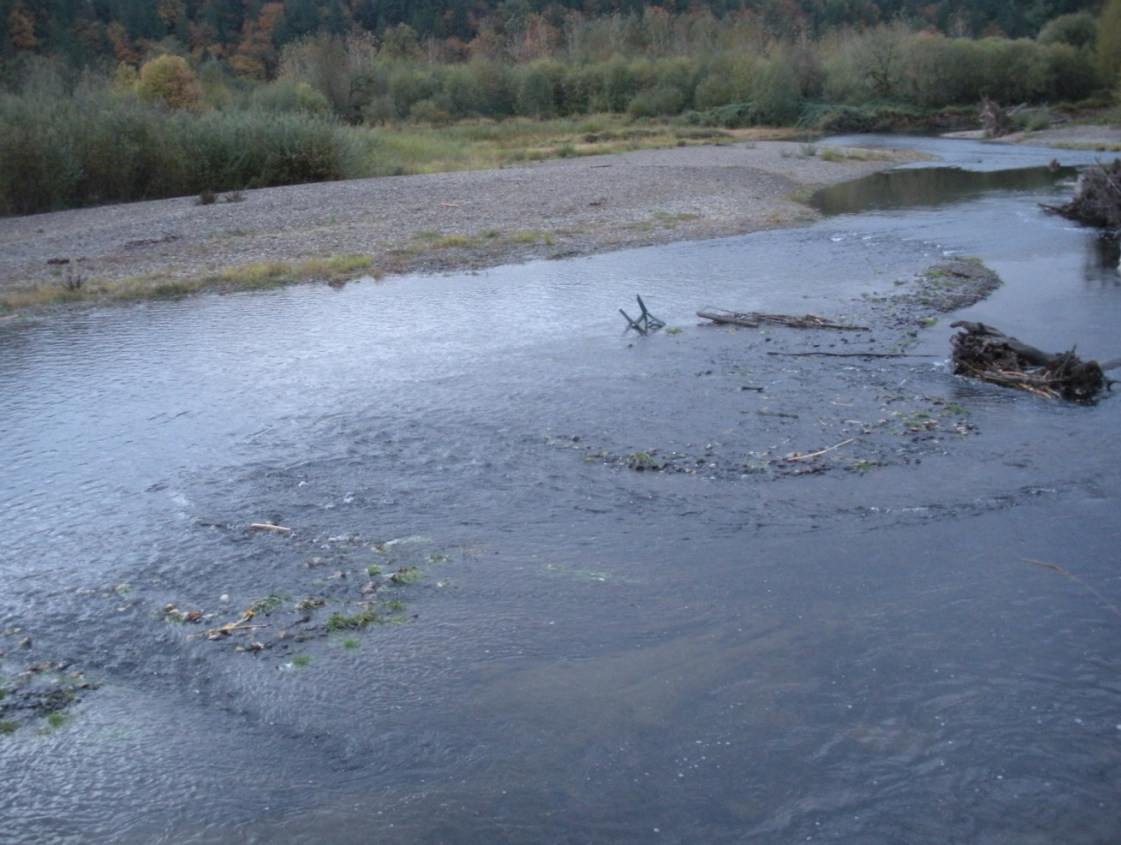
Another example of an avulsion leaving a coarse high bar occurs at the lower end of the project at about RM 6.8 (Figure 8).

Figure 8. Sediment deposition at RM 6.2 in 2009, with  $d_{50}$  of 33.7 on high bar.

The fourth condition is a fsl bank at RM 6, across from a bi-modal bar in Figure 8. This finer textured material is being scoured down to create a steep slope, and tractive stresses during floods, causes bank erosion.

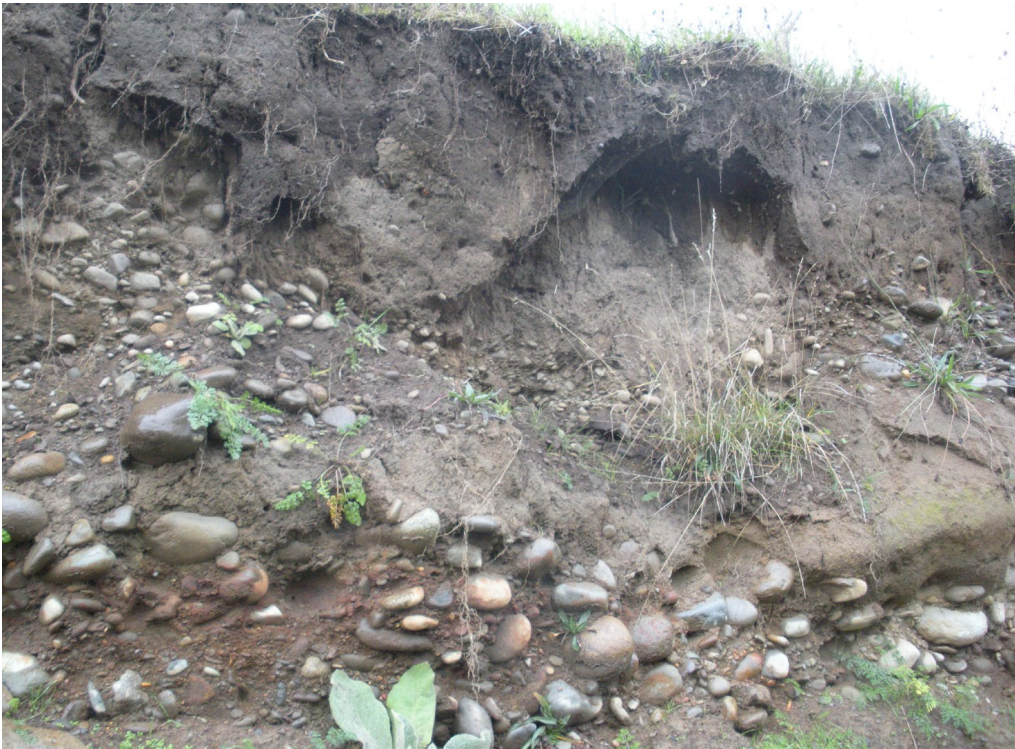
Figure 9. at RM 9.7 of silt loam over fine sandy loam over a cantilevered gravel that is cantilevered over another fine sandy loam.

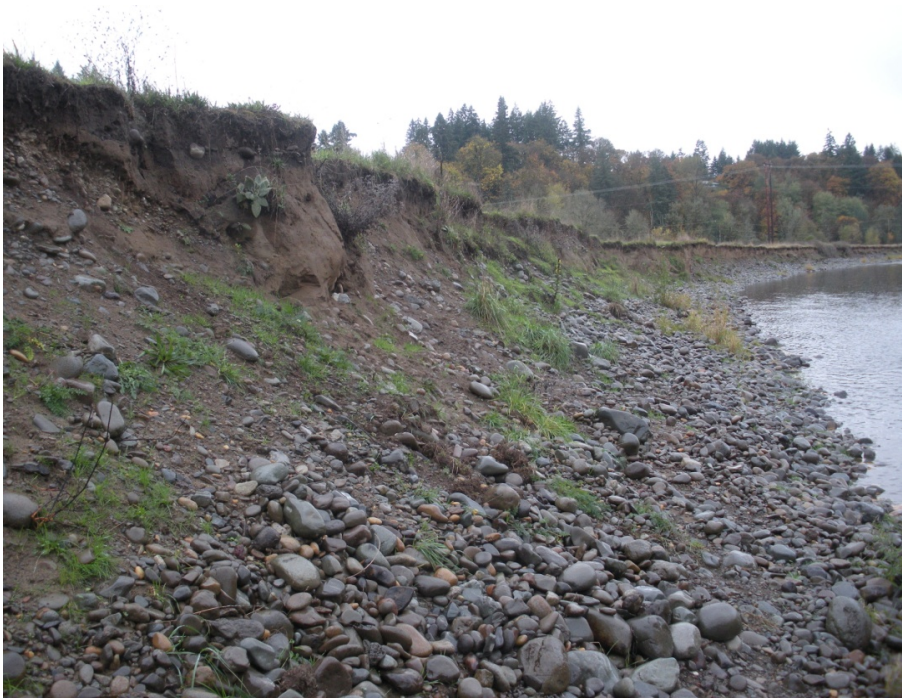
Figure 10 RM 9.7 cantilevered streambank gravels have been washed out at bankfull flows or higher flows and sluff to the angel of repose (rest).

The coarse material shown at the base of the slope in Figures 10 and Figure 11 was not sufficient to protect the toe slope to prevent 15 feet of cutback of this

streambank during the November 2008 through January 2009 flood events. The final flood peak on January 8, 2009 was 11,300 cfs. or about twice bankfull. This streambank roughly retreated 15 feet in that event (Dyrland, 2009a). This very wide reach has a very long pool/riffle spacing of between 8 and 10 bankfull widths (Table 5).

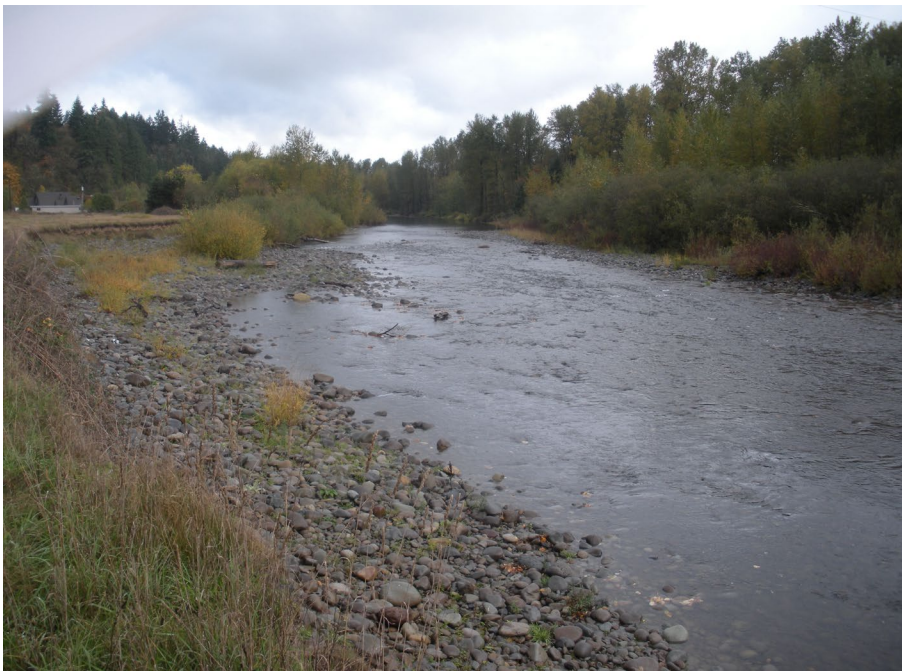
Figure 11. RM 9.7 – 9.8 with wide-shallow channel, and very long pool/riffle ratio, at 8 to 10 bankfull widths. Summer stream temperatures in this reach would be commonly above 74 degrees Fahrenheit and higher which becomes lethal to aquatic habitat as shown in Figure 25.

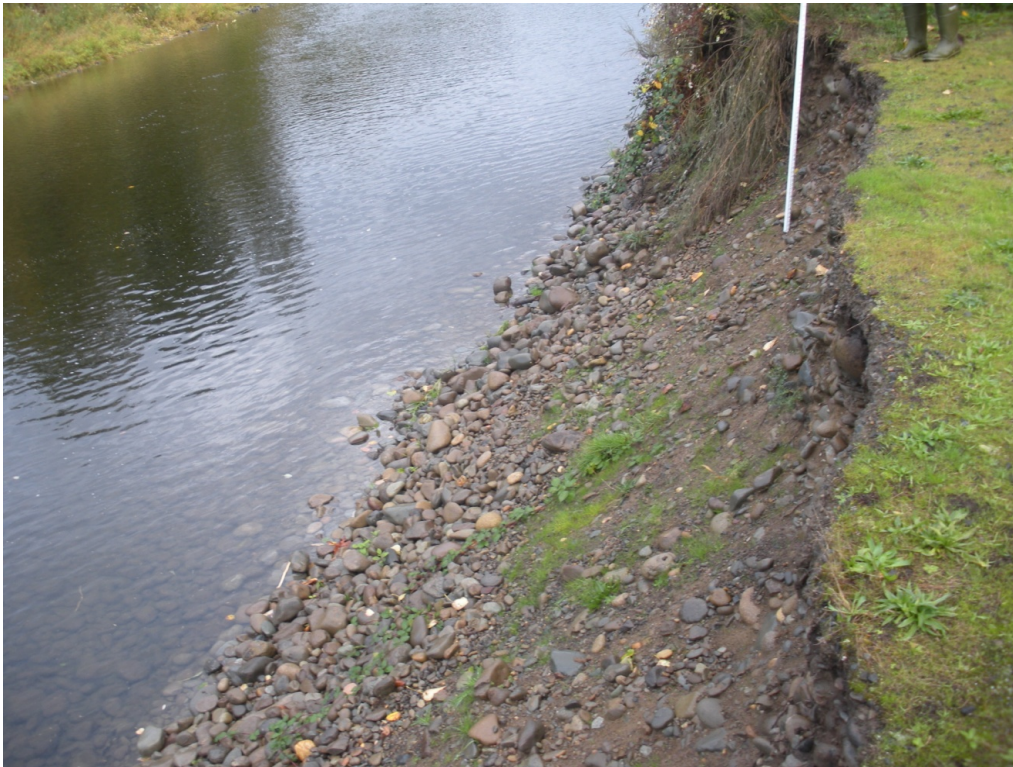
The second bank condition is where the entire streambank is gravel and as shown in Figure 12 at RM 9.8. This was severely cut back in Nov. 2007 through January 2008 events (Dyrland, 2009a). For the full gravel streambank, bankfull and higher flows washes out fines and sand from gravel which sluffs, but there may not be a cantilever, because bankfull flow reaches top of bank.

Figure 12 at about RM 9.8 shows a gravel streambank from top to bottom of slope that is failing because fines and sand are being washed out of the gravel and the loss of matrix material causes the streambank to fail. Gravel sloughs and lies at an angle of repose.

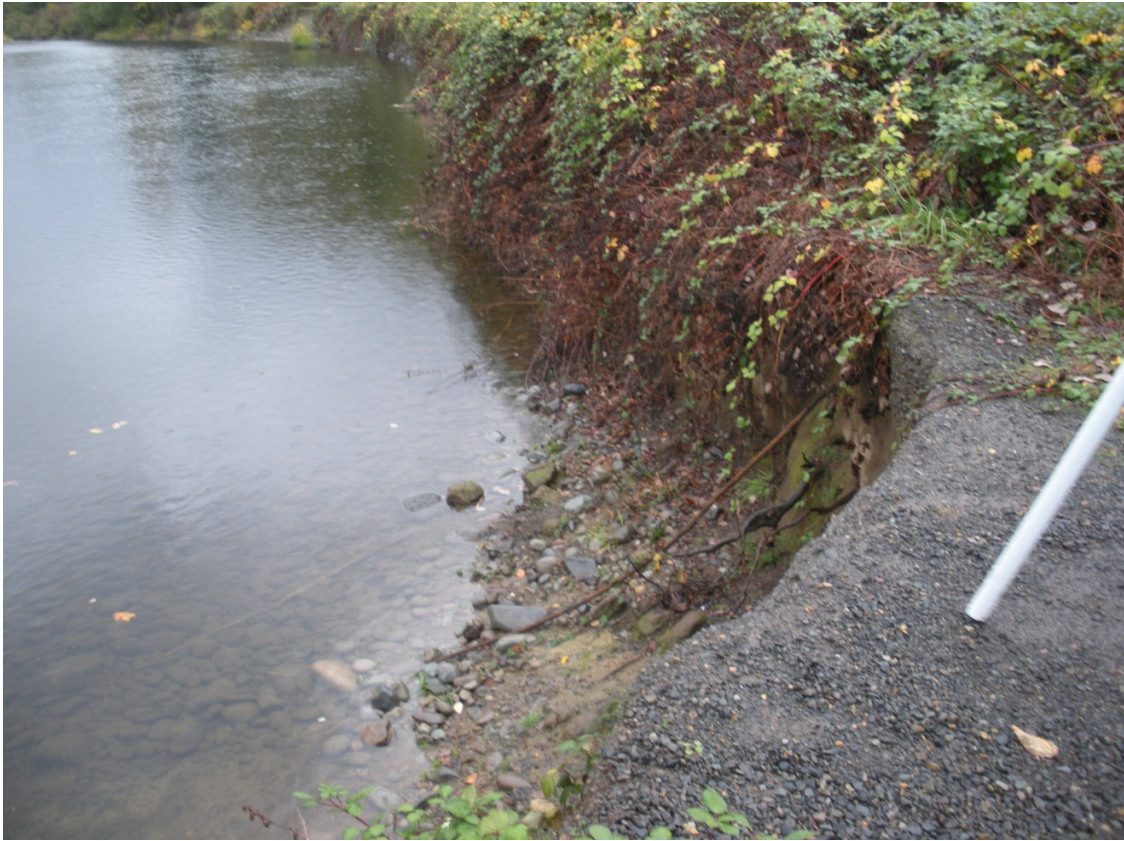
A third condition is where there is a fine sandy loam streambank with a gravel base. Scour of the gravel, likely from fines and sand matrix

material being washed out, keeps the upslope fsl actively failing. This condition is shown in Figure 13 at RM 10.9.

Figure 13, of fine sand loam streambank, along RM10.9. There is gravel at the base of the slope.

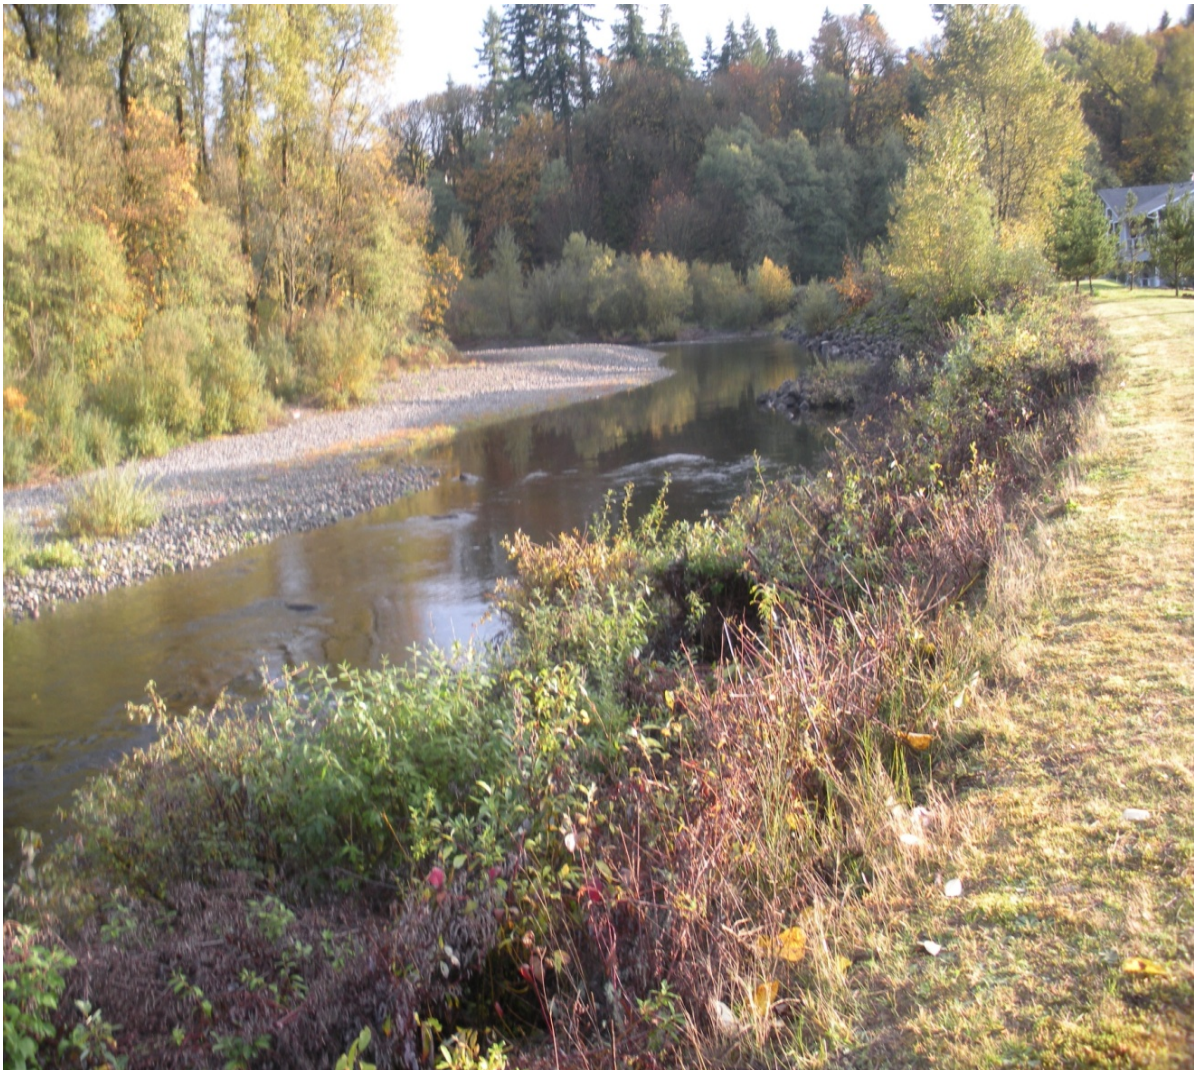
The sixth streambank condition is the rip-rapped built up dike section along RM's 11.6 to RM 11.7. This is shown on the right side of photo in Figure 14.

Figure 14 . Rip-rapped section along dike Rm11.6 to 11.7. Brush has been trimmed, but the bank has open areas in rock where one could joint plant or whole plant transplant, if a sufficient moisture regime can be established.

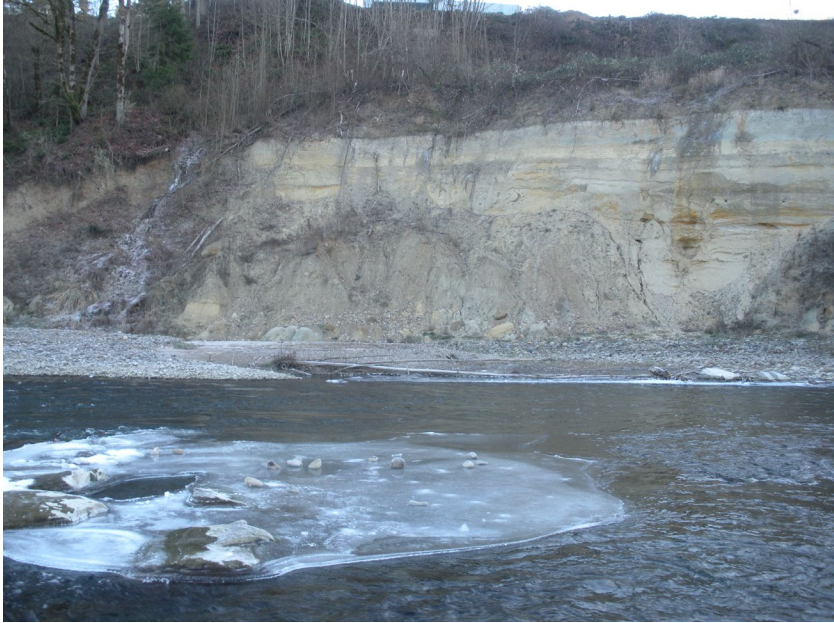
The fifth condition is the very high sandy textured streambank where the bank height exceeds a critical bank height such that a mass failure occurs. This occurs at Lewis River Ridge. High streambanks like at Lewis River Ridge (Figures 15 and 16) show evidence of mid slope seepage and gullies down the face of part of the steep bank. This condition which lends itself to mass wasting wedge failure as shown in Figure 16.

Figure 15. High cliff of sandy material at about RM 8.8 that shows seepage gullies on cliff face. Material has high pore pressure from drainage problems above the slope (Lewis River Ridge) likely contributes to bank instability.

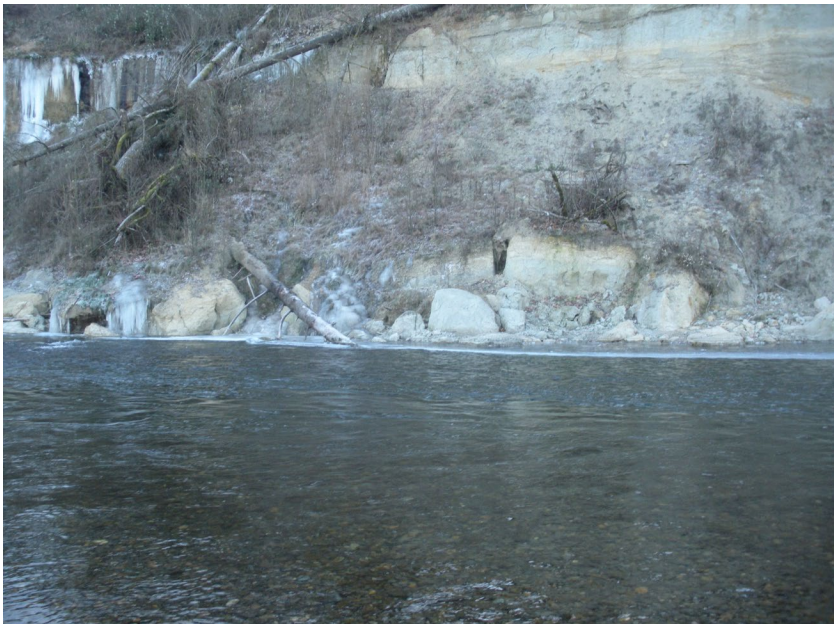
Figure 16. Wedge planer failure of large blocks of sandy material, that is readily reworked by river as part of sediment load. Placing a bankfull bench with J's or Vanes would re-direct flow away from the streambank and allow side slope materials such as shown in Figure 16 to deposit at the base of the slope and on the bankfull bench, such that off-site sedimentation would be greatly reduced.

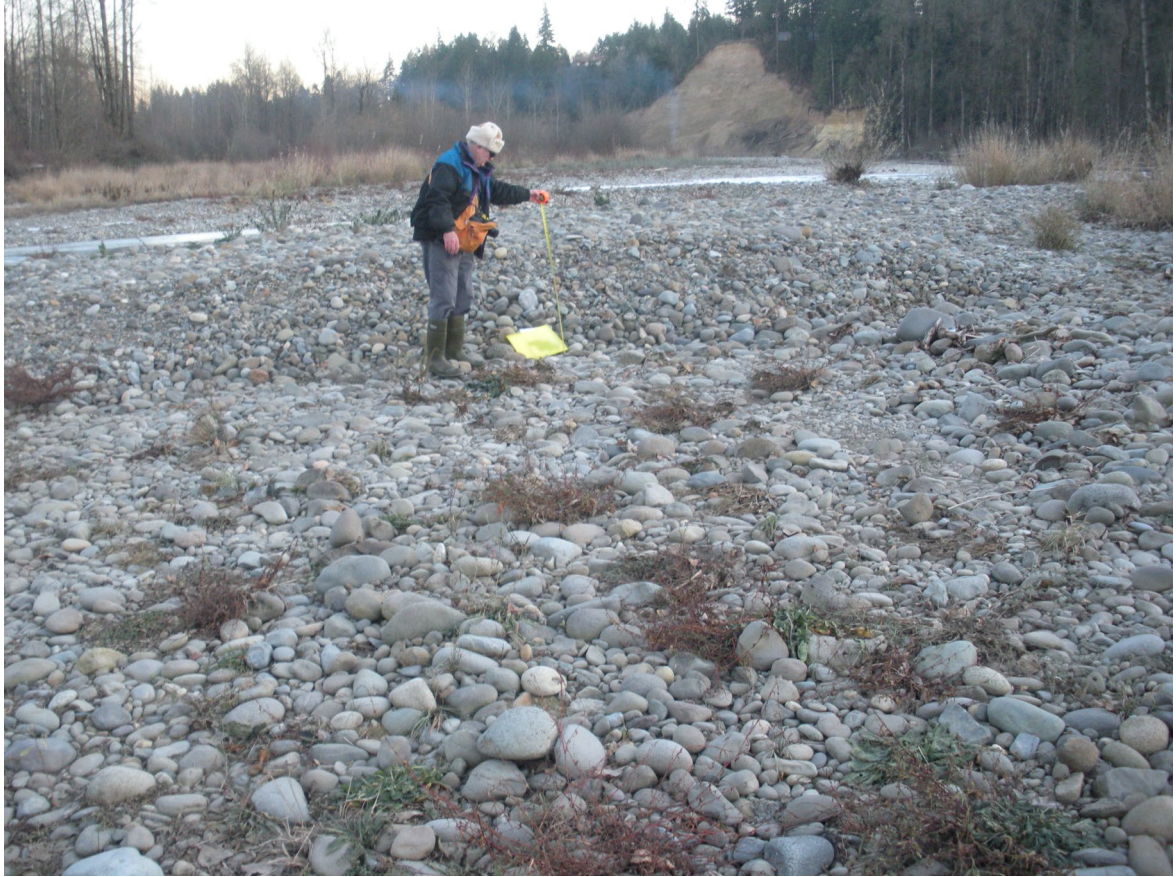
The second sediment dump from the avulsion at RM 9.2 , was immediately downstream along the main stem about 300 ft. The 2009 flood that blew out the avulsion had a discharge of about 11,300 cfs. which is about twice bankfull conditions. When the avulsion occurred about half the flow went across the avulsion between RM 9.2 and 8.7 . The other half of the flow went down the old main channel from 9.2 to about 9.1 ft. where the sediment dump of about 3.0 ft. occurred and is shown in Figure 17. The sediment is being dumped on a bar that had coarser sediment and that was found in 2007 to have a d50 of 53.68 mm. The particle size on the new sediment deposition is yet to be determined.. This sediment deposition is representative of the sediment load being carried by the East Fork River until the rivers sediment capacity (ability of the stream to transport its load), was suddenly reduced by removing half the discharge. The d50 of this sediment dump is similar to the smaller material presently overlying coarser material along the bar at RM 9.3 – 9.4.

Figure 17. This sediment dump occurred along the main channel at about RM 9.1 after the avulsion at RM 9.2 split the flow and sent about half the flow down the avulsion created channel. The coarser sediment in the foreground was found previously in 2007 to have a  $d_{50}$  of 53.68 mm

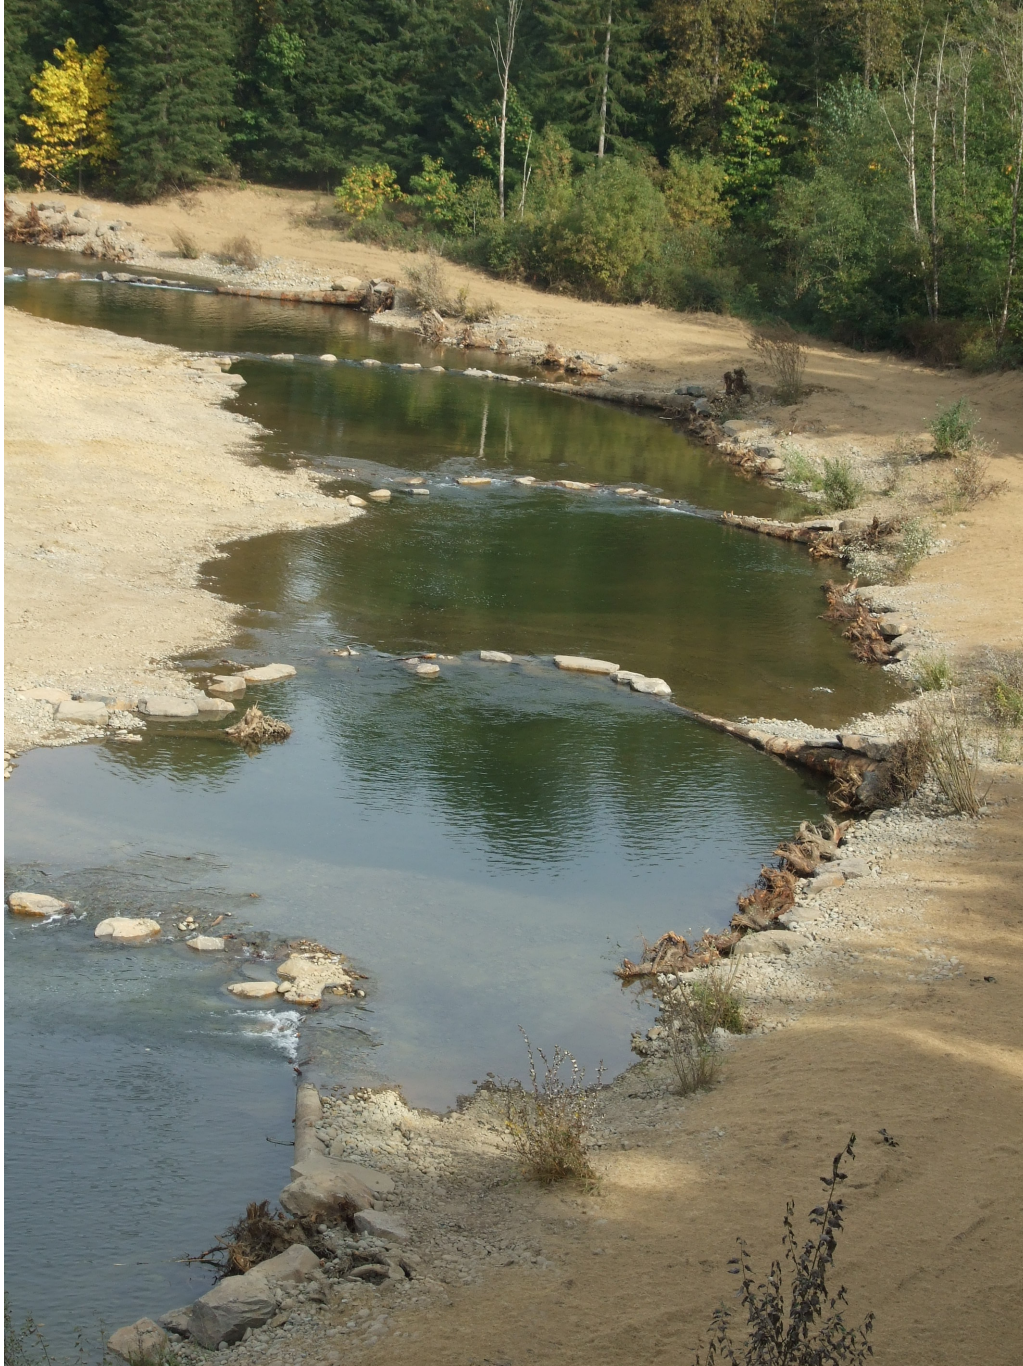
Figure 18. Lewis River Ridge, on 12/18/ 2008 with a flow of 387 cfs. This is after the flood of 10,900 cfs on 11/12/08, with a 2.8 yr. average recurrence interval event. No damage is apparent along the construction reach

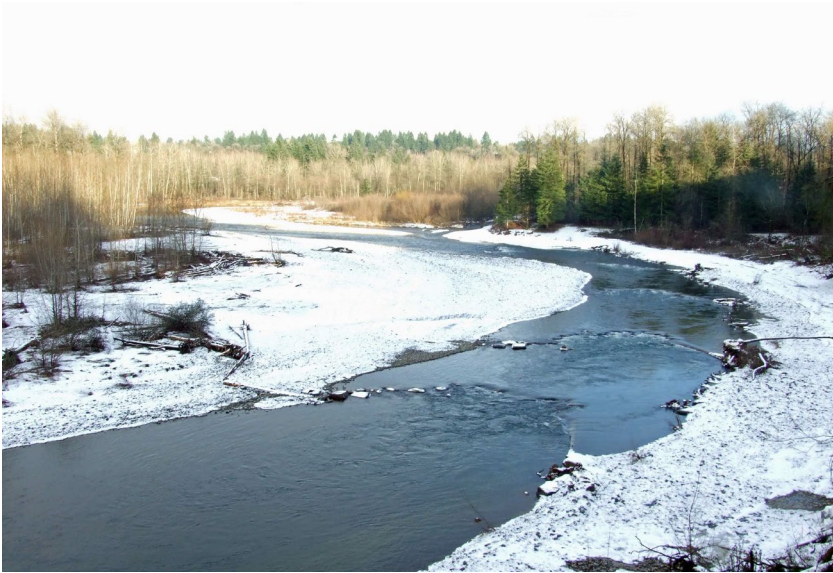
Figure 19. Lewis river Ridge on 12/18/2008 with a flow of 387 cfs. This is after the flood of 10,900 cfs. on 11/12/08, which is a 2.8 yr. average recurrence interval event. No damage is apparent along the construction.

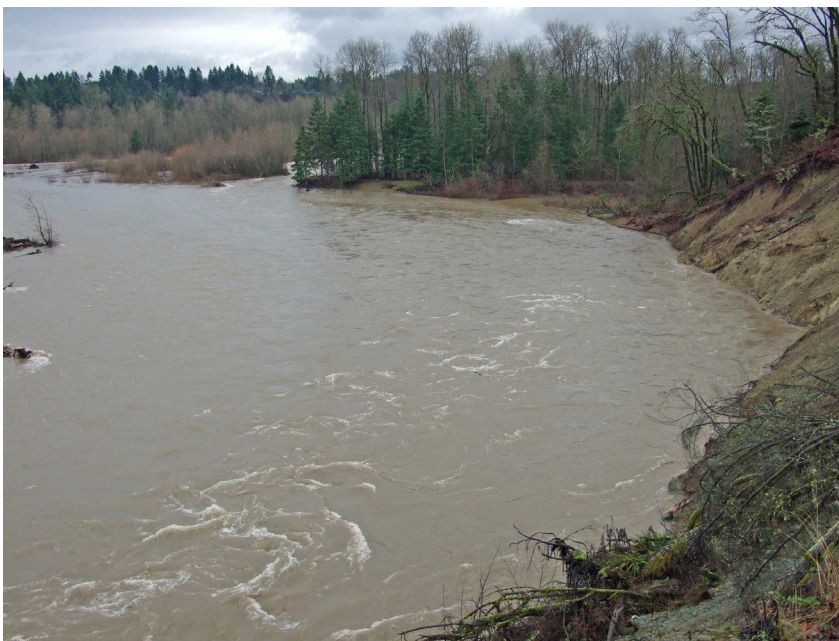
Figure 20. Lewis River Ridge on 1/8/09 at about 9,360 cfs. The peak reached 11,300 cfs at the Heisson Gage. The deep part of channel (thalweg) is shown by white current marks and J's are keeping deep channel away from high cliff, so no erosion is occurring along the cliff. Some sedimentation is occurring below mouth of avulsion channel, which can be observed at the upstream end of the tree line in the center of the photo.

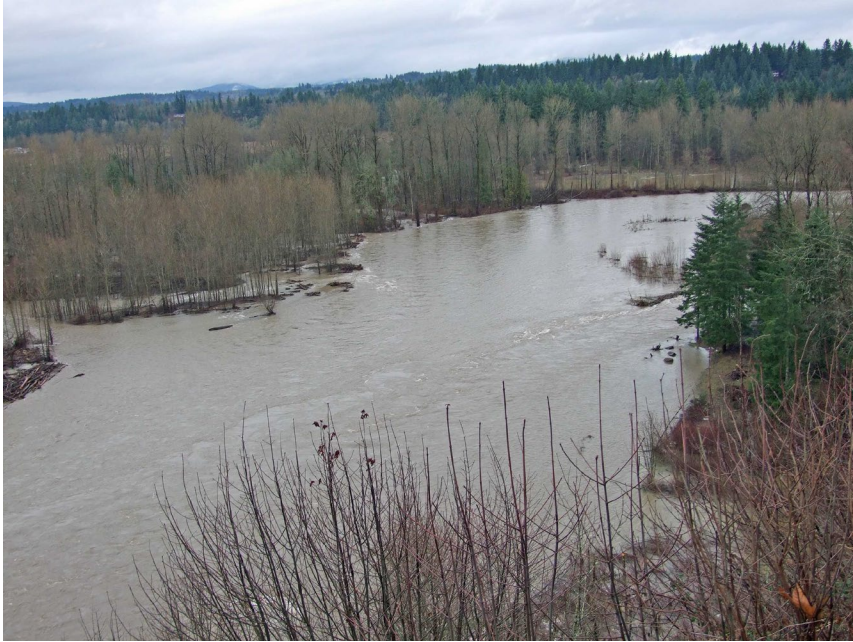
Figure 21. East Fork Lewis river at about 9,360 cfs, at next meander upstream of Lewis River ridge. Potential new avulsion channel for braided anabranch at RM 9.0 is shown in center of photo.

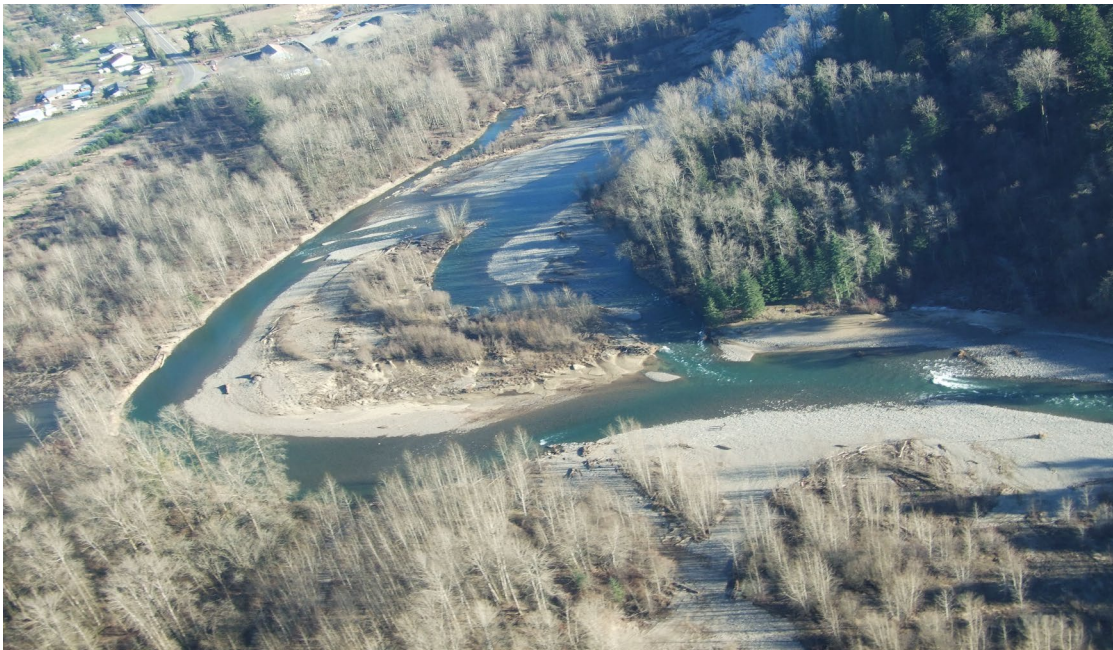
Figure 22. East Fork Lewis river after avulsion. Sedimentation in upper left of photos from loss of flow capacity, do to most of flow going down the avulsion channel. Avulsion channel (which is now wider than the former main channel), is shown as two flow paths around a center bar.

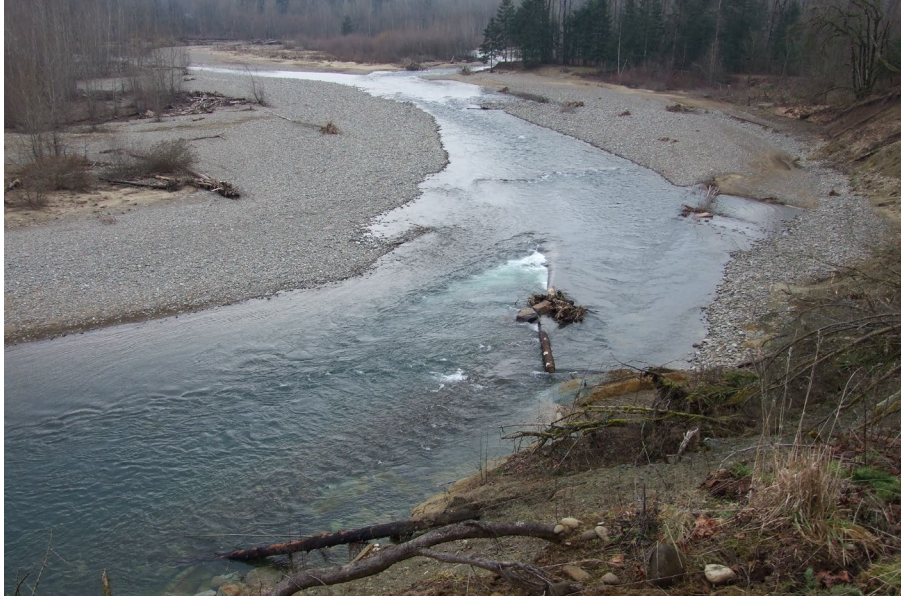
Figure 23. Sedimentation on bankfull bench has temporarily buried rootwad and boulder complex below outlet of avulsion and Log Vane/J-Hooks No. 1-4 and there is erosion around LV/J No. 5. LV/J No. 6 was washed out when the sedimentation caused a redirection of the former channel meander. There is also increased sedimentation on lower end of point bar, across from downstream J's as shown when comparing to Figure 19.

It would be desirable to continue into the next phase of the Lewis River Ridge project. First, replacement of the J washed out is needed, along with repair of the J presently at the downstream end of the bankfull bench. Then it is recommended that there be a continuation of the bankfull bench along the cliff. Much of the sediment is likely available in the sediment dump on the initial project. The excess sediment can be moved down to assist in finishing the bankfull bench, and reduce sedimentation from the cliff area.

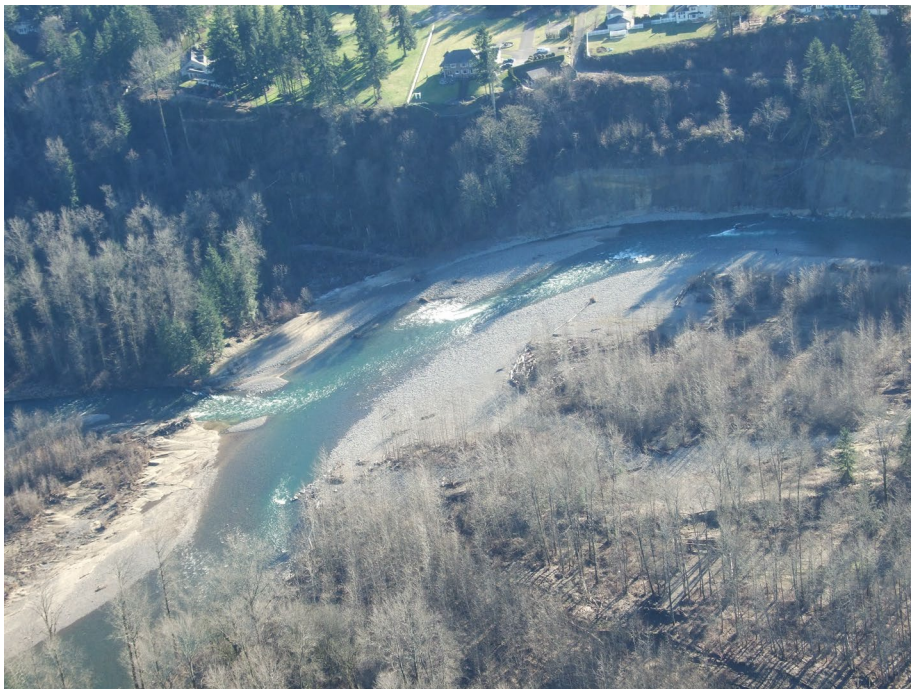
Figure 24. Post avulsion aerial view, showing avulsion channel at left, and new sedimentation along Lewis River Ridge project reach. Pre-project and project channel has shifted to the right (west).

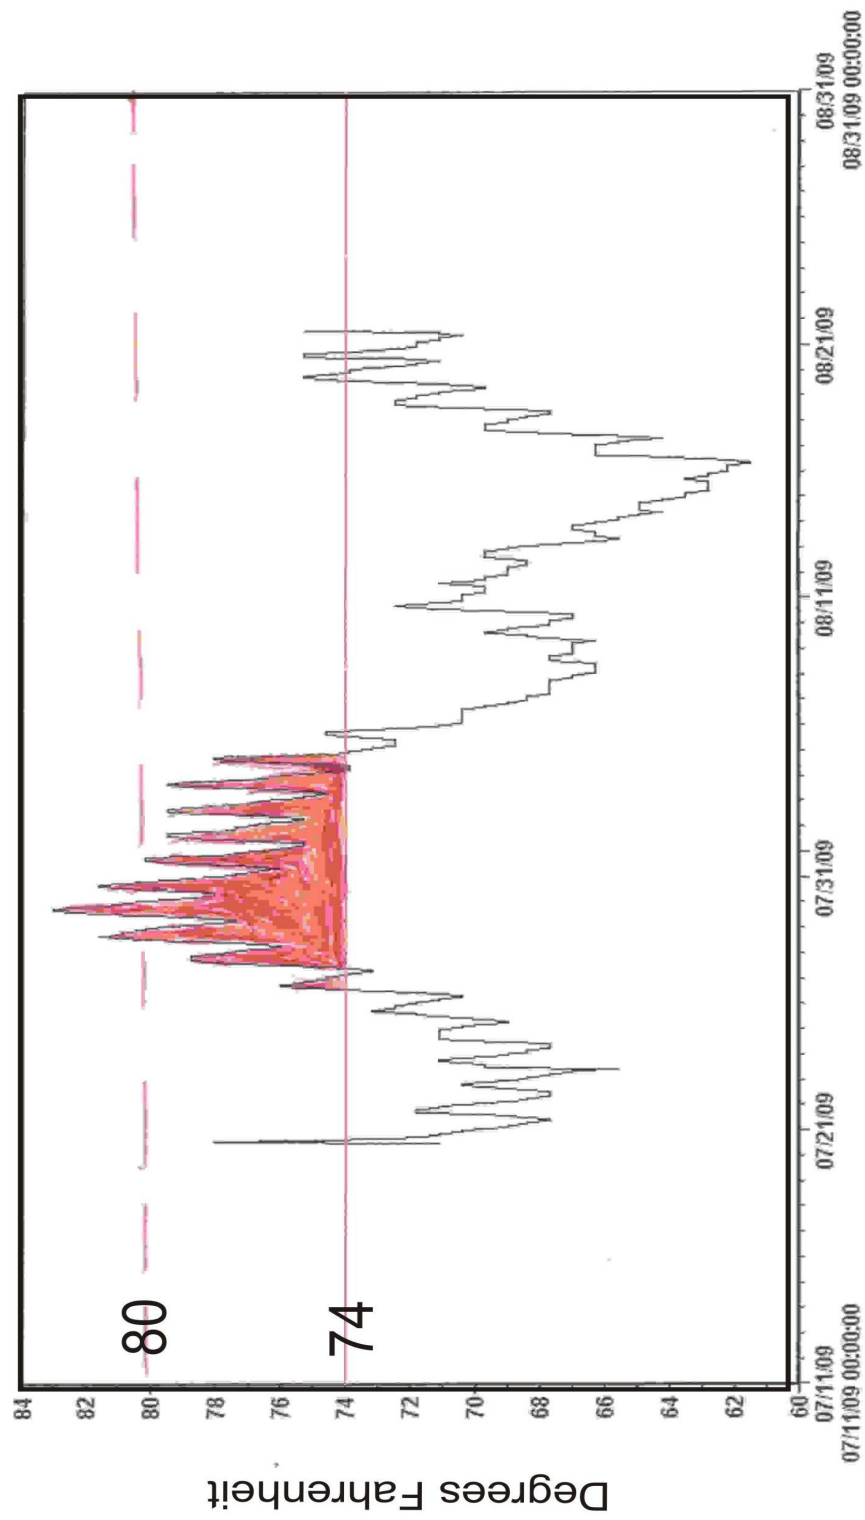
Figure 25. Summer Temperatures On Lower East Fork L. R.  
At Swanson Powerline Bend At RM-7: 2009

This wide shallow condition results in very high stream temperatures for June, July and August. As shown in Figure 25 or RM 7 there were 12 days in 2009 that were over 74 degrees Fahrenheit. Of these 12 days four days were more than 80 degrees Fahrenheit, which killed a lot of salmonid fry and smolts and even skulpins (Dyrland, 2009a). The flow at the Heisson gage varied from 45 to 70 cfs during the very high temperature days and flow was mostly less than 1.0 ft deep over the Hobo gage taking the measurements (Dyrland, 2009a)
