Re: Daybreak Habitat Conservation Plan (HCP) Annual Report

Daybreak Conservation Measures Annual Report for 2010

MEM-07 Monitoring Report – October 20, 2010 Field Reconnaissance

Subject: East Fork Lewis River Habitat Survey

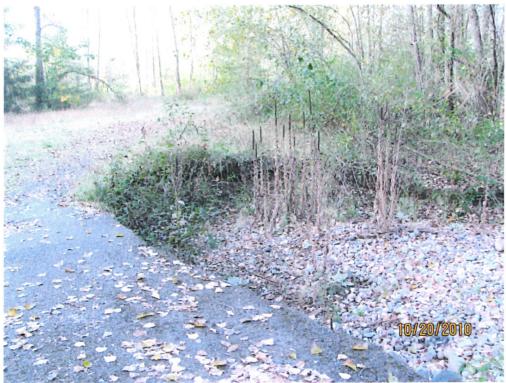
Photo 2. Looking southwest from Location #1at headcut nick point located at upstream end of secondary floodplain channel.

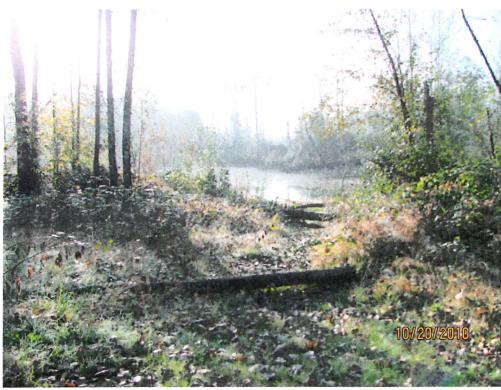
Photo 4. Looking southeast from Location #2 at overflow path from County Pond #2.

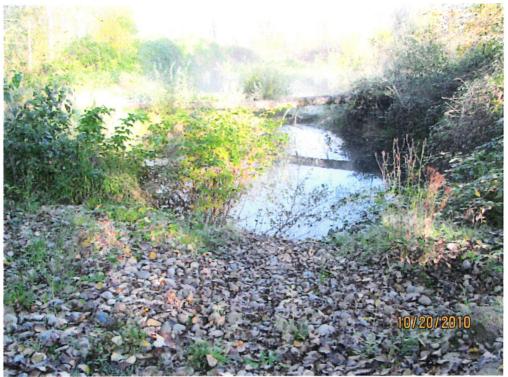
Photo 5. Looking northwest from Location #3 at overflow channel into County Pond #1.

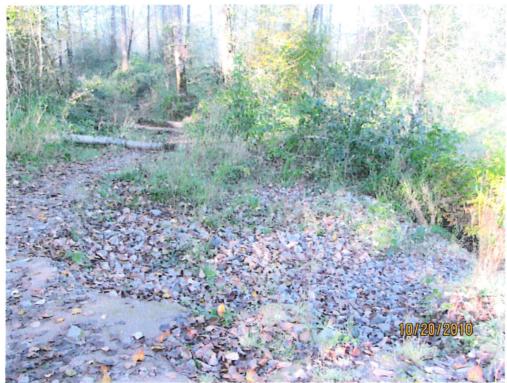
Photo 6. Looking southwest from Location #3 at headcut nick point located at upstream end of overflow channel into County Pond #1.

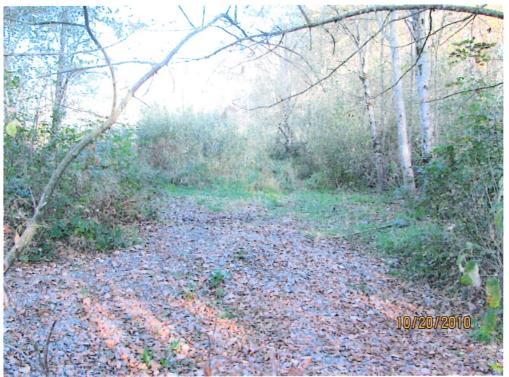
Photo 7. Looking north from Location #4 at overflow channel from E.F. Lewis River into County Pond #2.

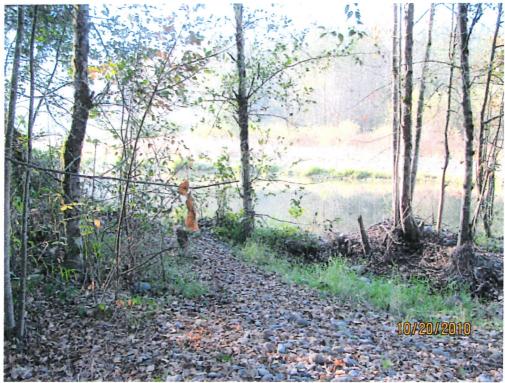
Photo 8. Looking south from Location #4 at upstream end of overflow channel from E.F. Lewis River into County Pond #2. Recently abandoned E.F. Lewis River channel in background.

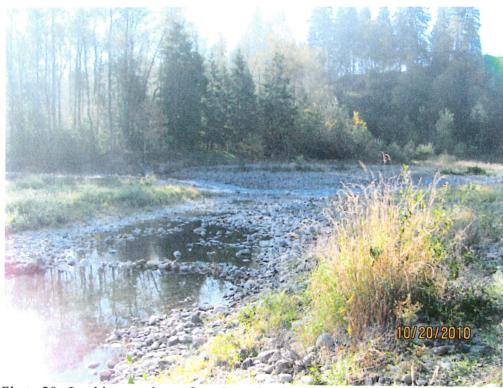
Photo 20. Looking southeast from Location #6 at downstream end of recently abandoned section of E.F. Lewis River. Note new channel at left side of photo.

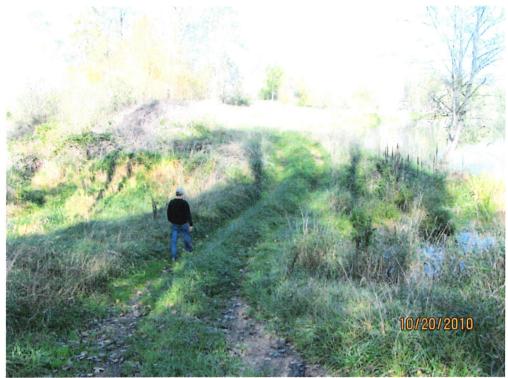
Photo 29. Looking northwest from Location #12 at Daybreak Pond #5 overflow into E.F. Lewis River floodplain.
