# East Fork Lewis River Ridgefield Pits Restoration

## Geomorphology Report

Lower Columbia Estuary Partnership

**January 2020**

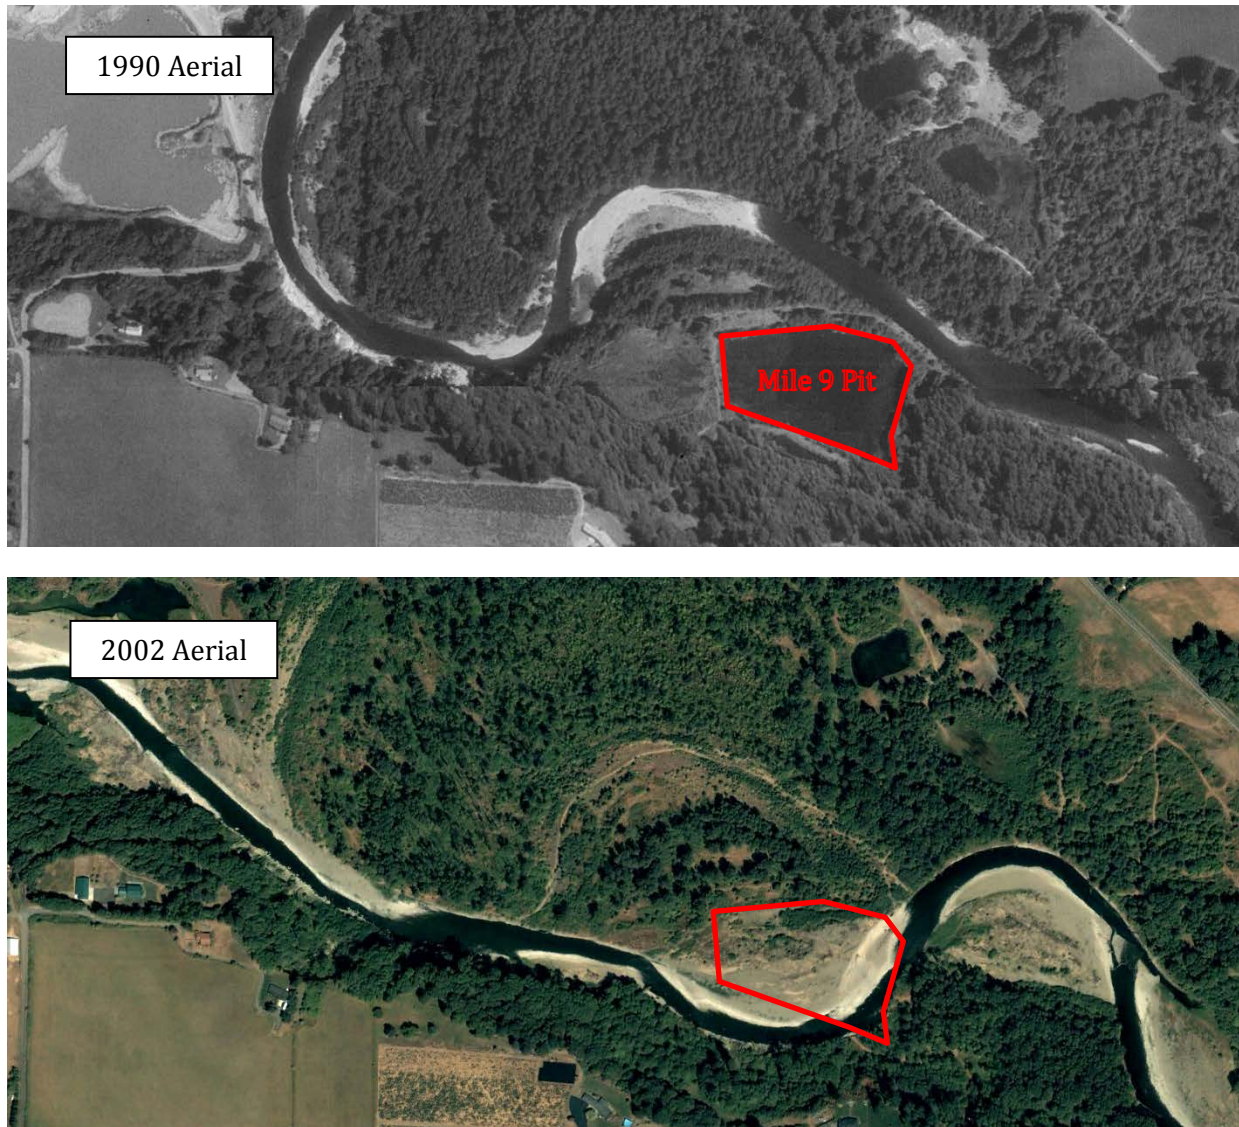
In November of 1995, the river avulsed through a floodplain gravel pit near RM 9. This is just upstream of the Ridgefield Pits. The location of the former pit is shown in the aerial photos in Figure 5.

**Figure 5. Location of the Mile 9 Pit avulsion, which occurred in November 1995.**

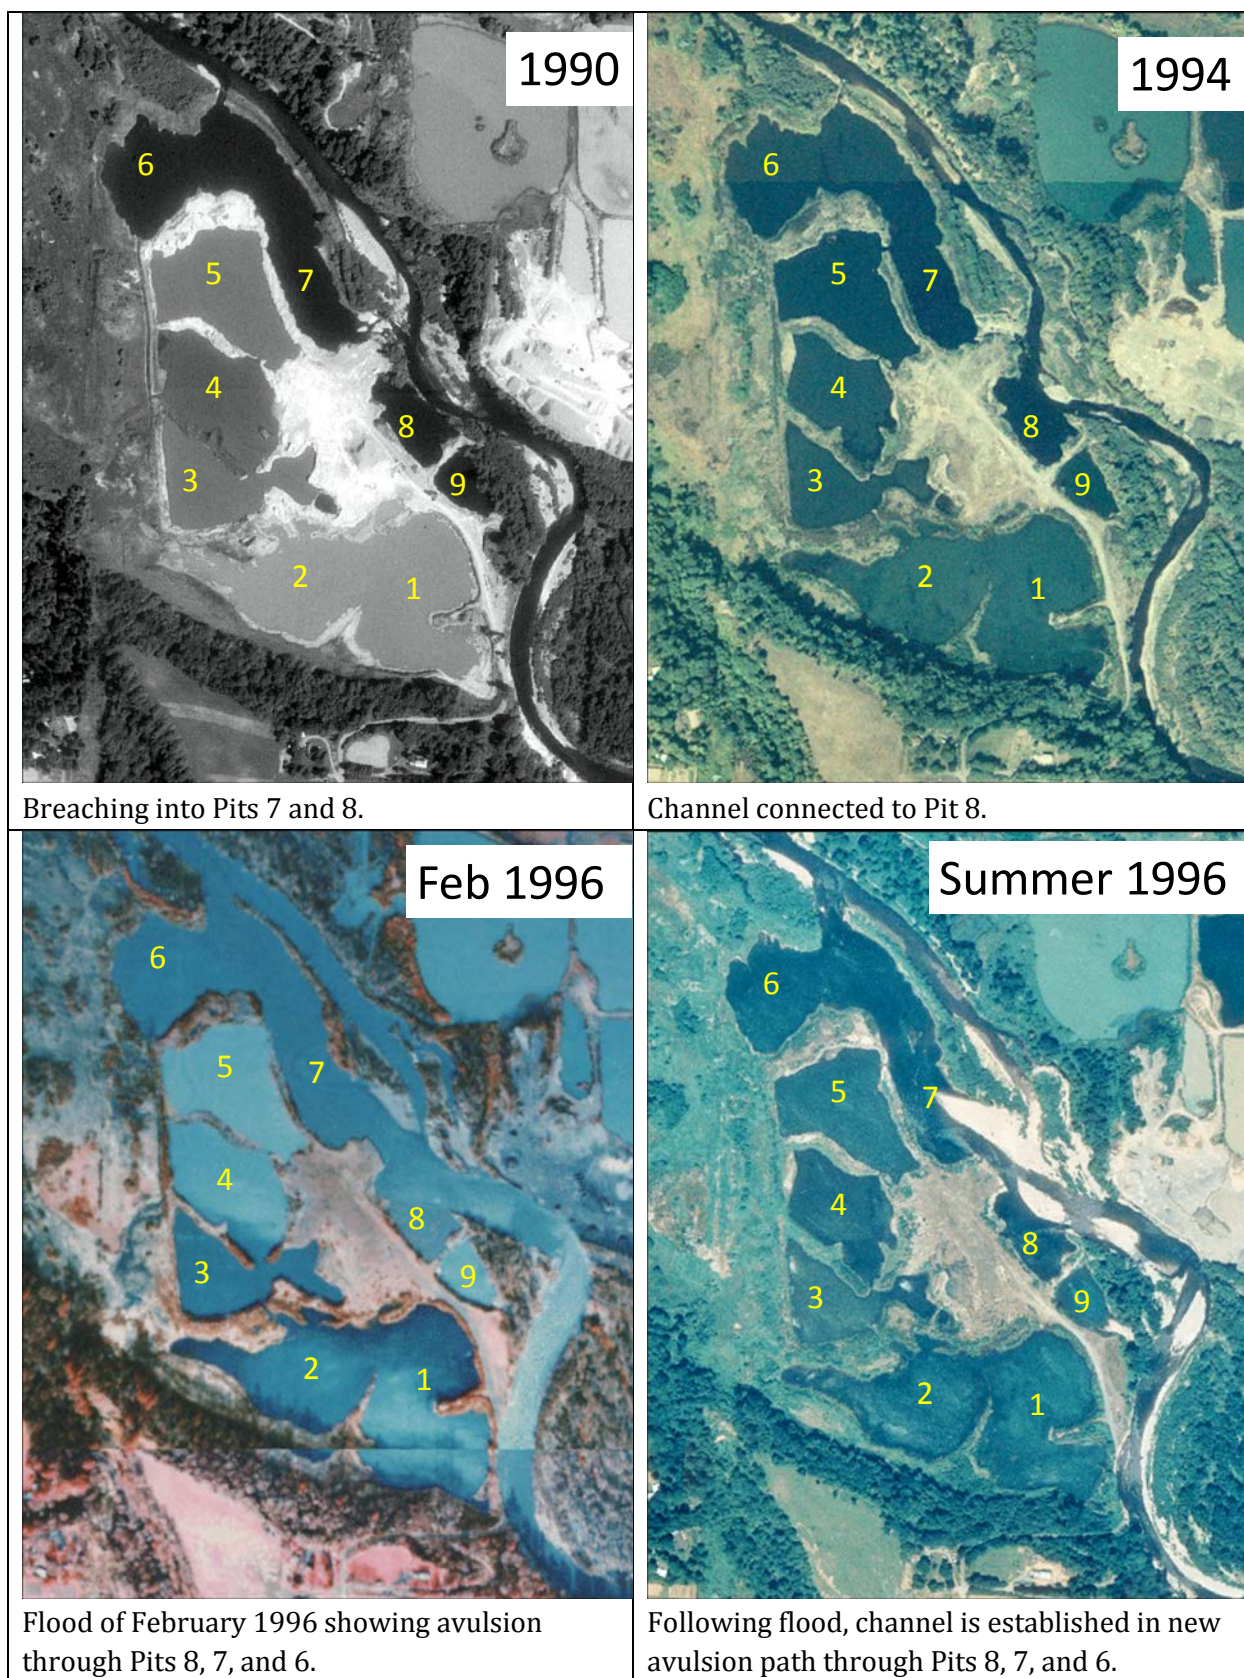
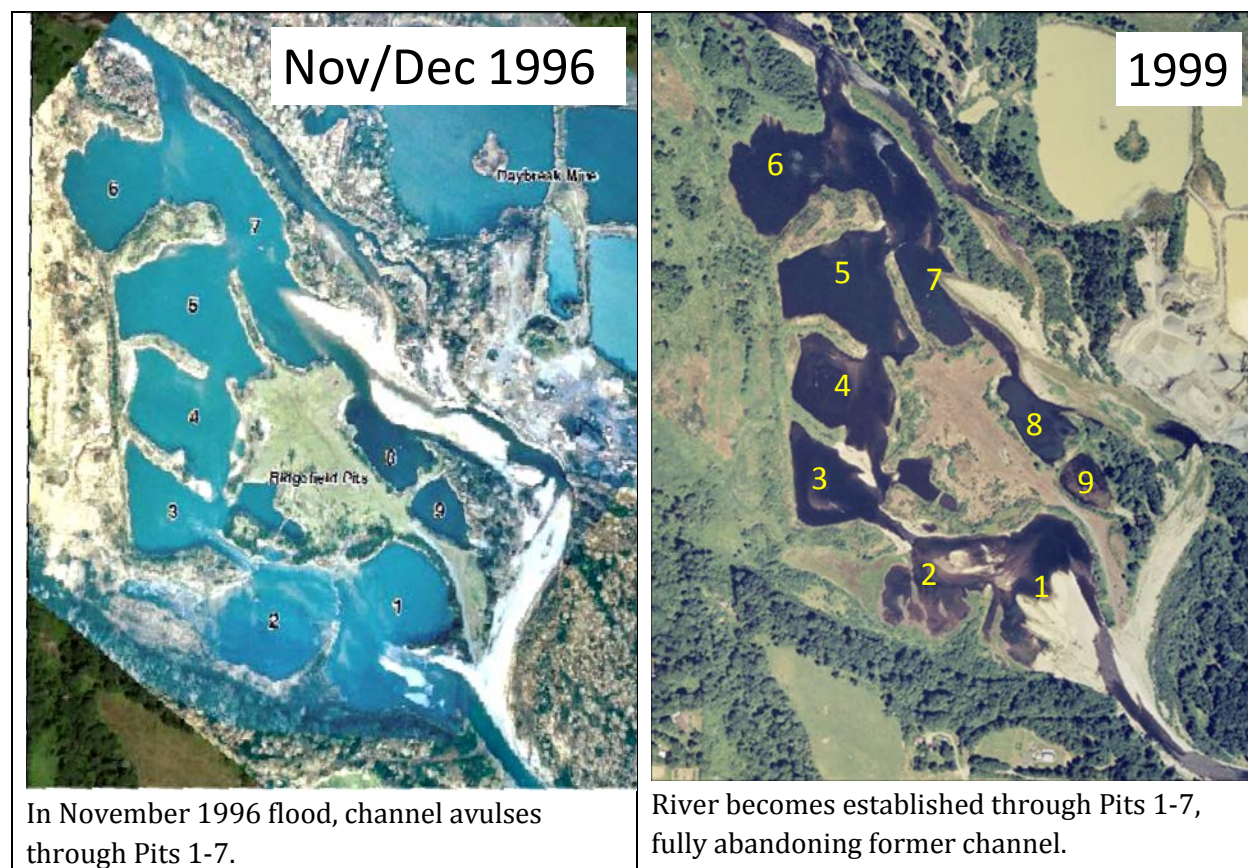
The Ridgefield Pits avulsion occurred over a longer period of time, with initial pit breaching occurring at least by 1990 and full avulsion through multiple pits in 1996. A sequence of the Ridgefield Pits breaching and avulsion is shown in Figure 6. Following full avulsion of the pits, 4,300 feet of former channel, which once contained high quality salmonid spawning and rearing habitat, was abandoned, and the channel then flowed through a series of slow-moving pools up to 30 feet deep.

**Figure 6. Breaching and avulsion sequence at the Ridgefield Pits.**

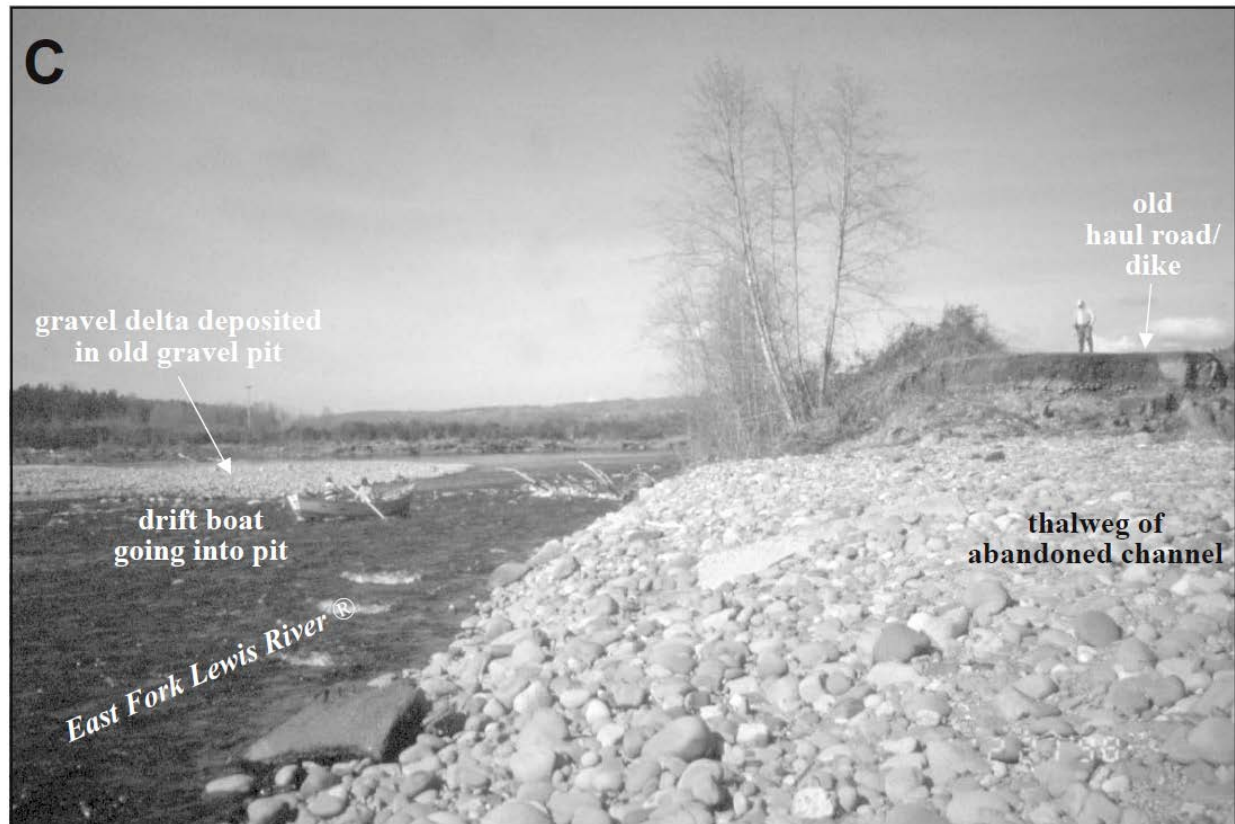
**Figure 7.** Re-print of Figure 20-C from Norman et al. 1998. This 1998 photo shows the elevation difference between the abandoned channel and the new avulsion channel just upstream of the entrance to Pit 1. This distance was estimated by the authors (Norman et al. 1998) as approximately 10 vertical feet.

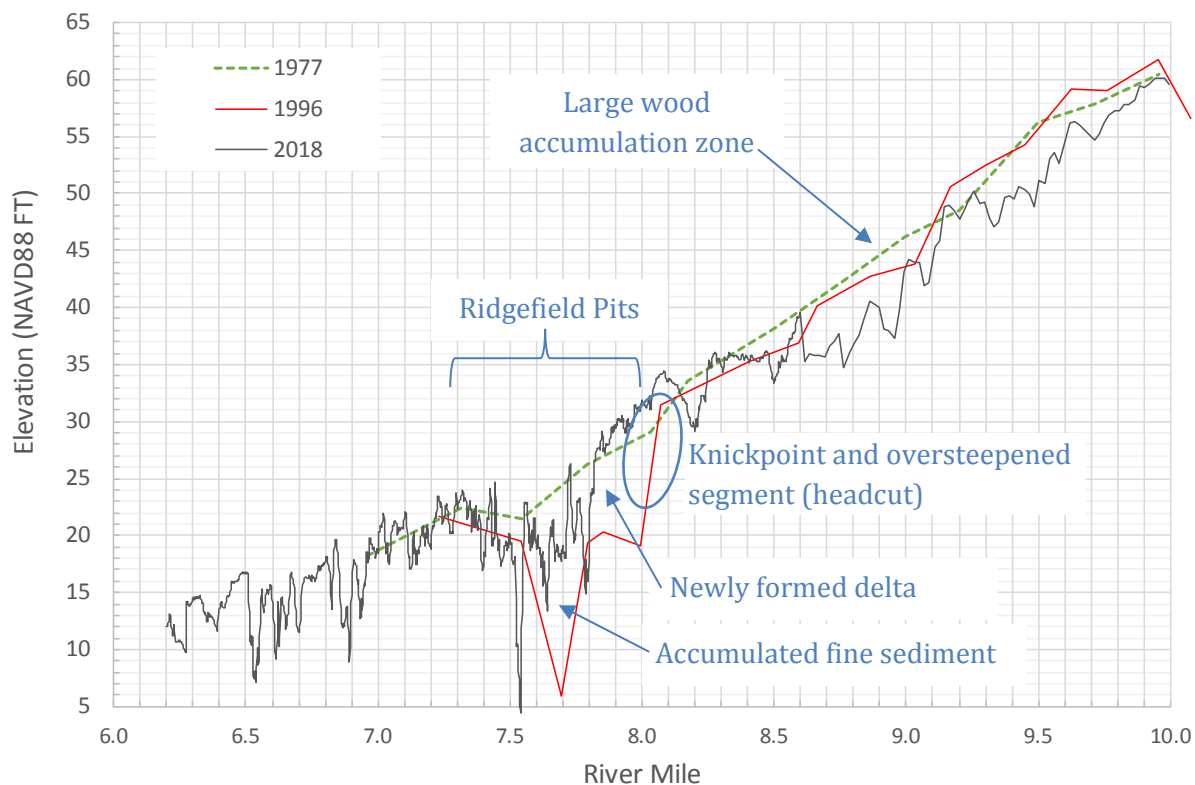
The profiles are depicted in Figure 8. Daybreak Bridge is just upstream of RM 10. There is a large wood accumulation zone at RM 9 (discussed later in Section 4.6), which may be causing a rise in the profile upstream to closer match the 1977 and 1996 profiles. The location of the Ridgefield Pits is identified for reference. The lower bed elevation in the pits is evident in the post-avulsion profiles, with the new delta forming in the pits evident in the 2018 profile between RMs 7.8 and 8.1. Additional accumulated sediments (fines) are evident in the more downstream portion of the pits. The 1977 profile, which represents the pre-avulsion condition, has an average overall slope of approximately 0.28%, which matches the slope upstream of the pits in 1996 (0.30%) and 2018 (0.27%), even though there is smaller-scale variation in these profiles. The slope within the pits is essentially flat for 1996, and also for 2018 (0.05%) for the portion downstream of the new delta. The slope downstream of the pits in 2018 is slightly flatter than the upstream segment, at 0.17%.

**Figure 8. Longitudinal profiles from 1977, 1996 and 2018, with relevant features noted.**

The immediate post-avulsion knickpoint and corresponding oversteepened segment can be clearly seen at the upstream end of the pits (RM 8.0-8.1) in the 1996 profile (Figure 8). This segment had a local slope of approximately 2.63% (over nearly 400 ft of channel); this is over 8 times that of the former reach-average slope. Observations described in Norman et al. (1998) indicated that this knickpoint moved upstream in the years following the avulsion.

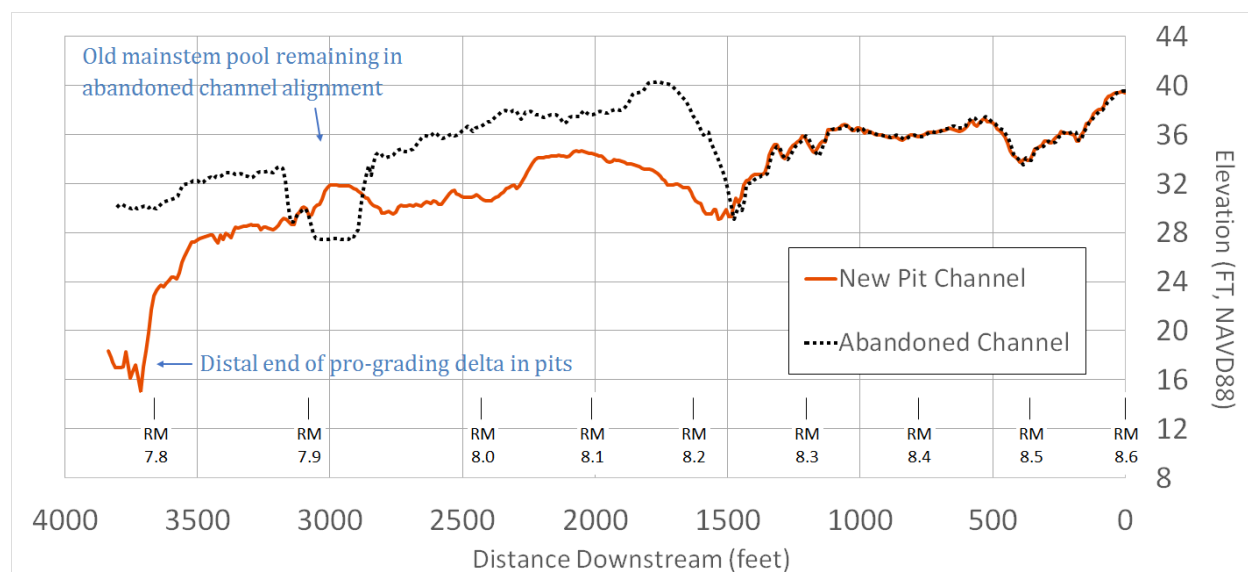
Figure 10. This simple analysis shows that the new channel bed that has formed through the upstream end of the pits is 3-4 feet lower on average than the pre-avulsion channel. The newly formed section of channel has a slope of 0.26%, which matches the reach-average slope upstream and the slope of the pre-avulsion channel from 1977.

Figure 10. Profiles through upstream end of pits. Based on 2018 topographic/bathymetric data.

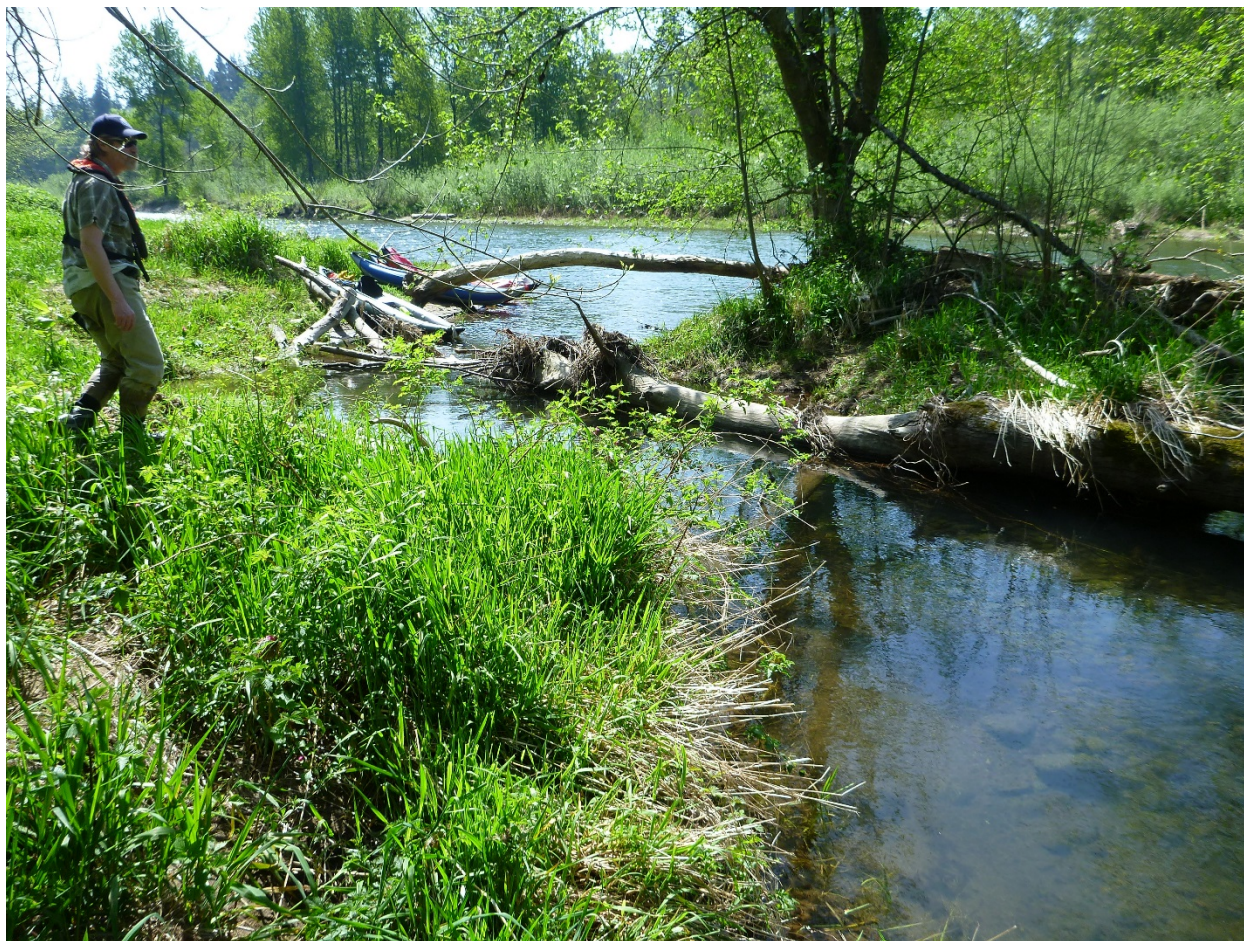
The upstream side-channel was flowing with surface flows from the mainstem during surveys on April 26, 2018 (see Figure 13) and was still barely connected during surveys on May 22, 2018. The downstream side-channel was dry on May 22 (see Figure 14). Based on vegetation and scour features, it is assumed that the downstream side-channel flows during annual high flows and the upstream side-channel flows for much of the year but becomes disconnected from surface flows typically in late spring.

**Figure 13. View from top end of upstream side-channel, looking upstream towards inlet. Near RM 9.45. April 26, 2018.**

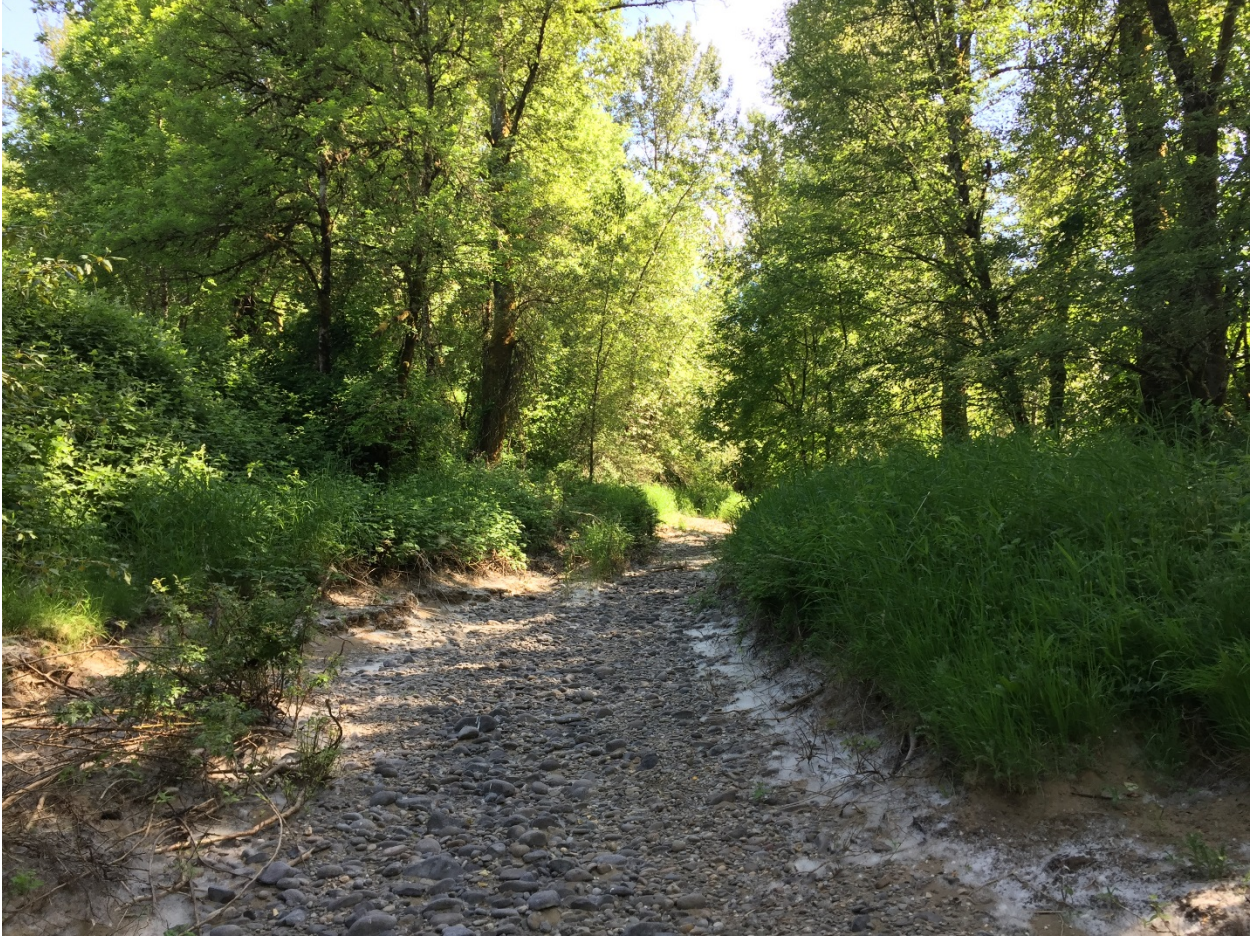
**Figure 14.** *View of downstream side-channel near its upstream end, May 22, 2018.*

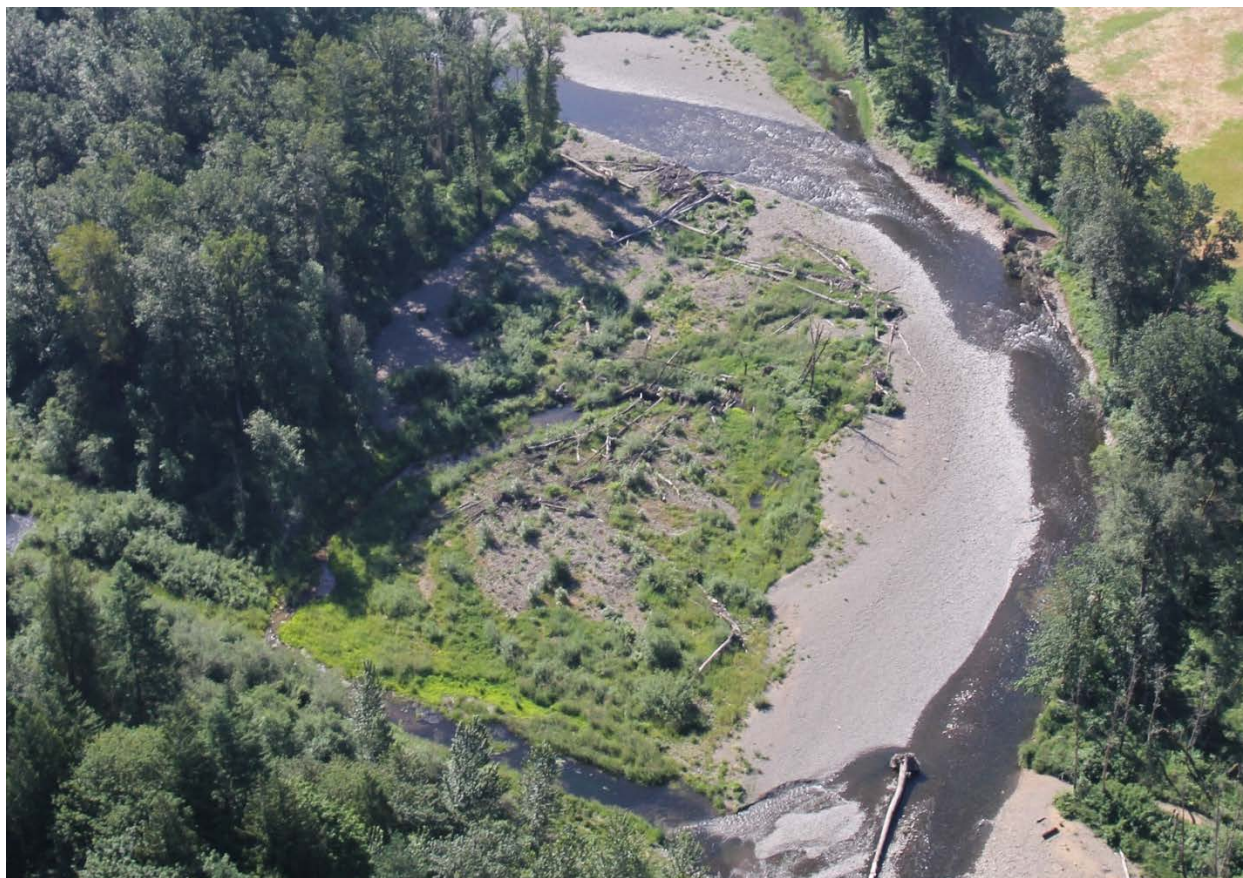
The wood that is present today is primarily concentrated in a few prominent deposition zones that contain high densities of wood. These include above Daybreak Bridge where the channel has recently avulsed near RM 10.5, at the deposition zone near the 2007-8 avulsion near RM 9.1, and at the delta forming in the pits near RM 8.0. These are shown in the map in Figure 16 and in the images in Figure 17 – Figure 19. These are all areas of instability, in various measures affected by human stressors, yet they also exhibit some of the greatest habitat complexity in the lower river.

**Figure 17. Wood accumulation zone near RM 10.5 upstream of Daybreak Bridge. Gardner Johnston photo June 2019.**

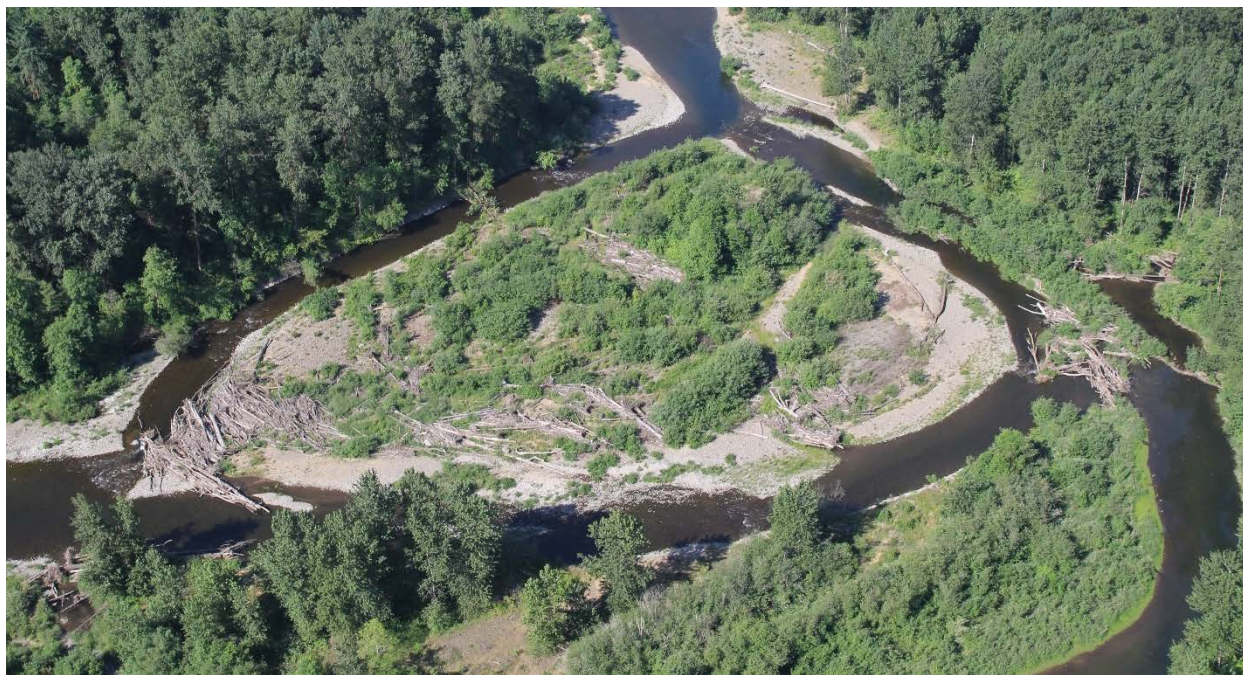
**Figure 18. Wood accumulation zone near RM 9.1. Gardner Johnston photo June 2019.**

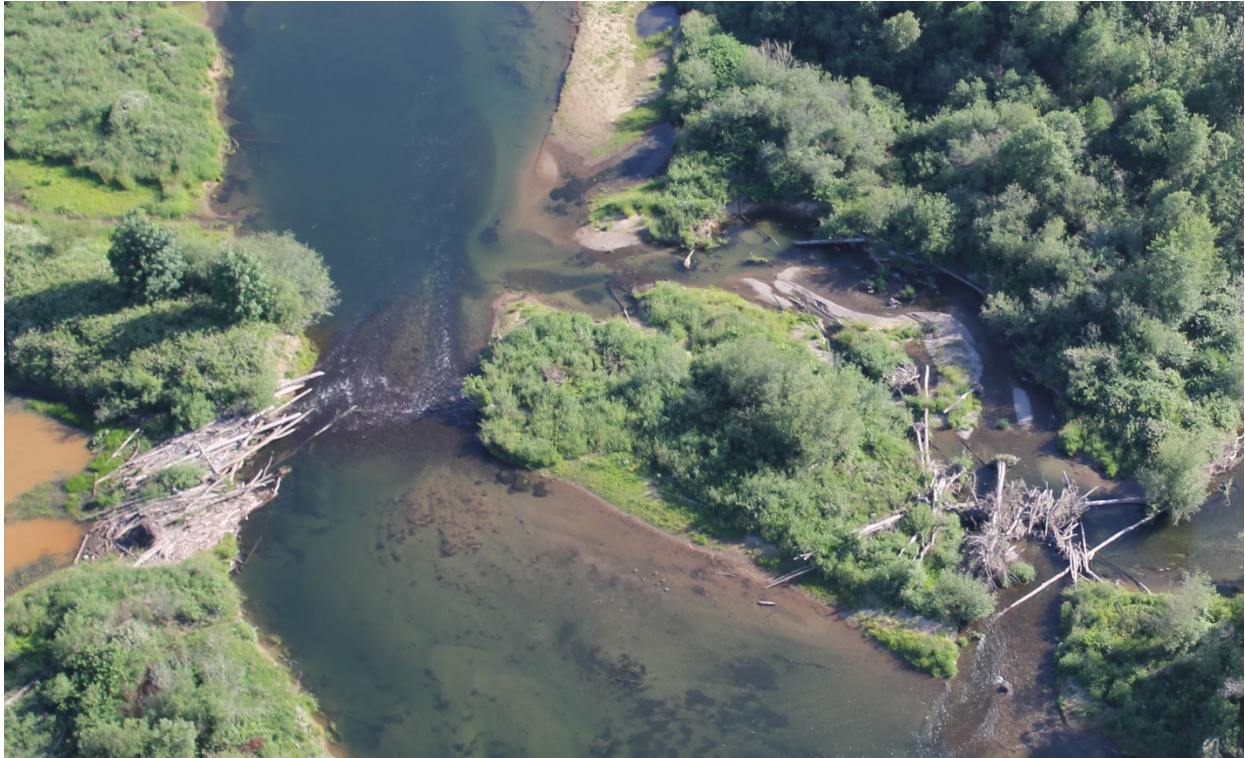
**Figure 19. Wood accumulation in the upstream end of the Ridgefield Pits. Gardner Johnston photo June 2019.**

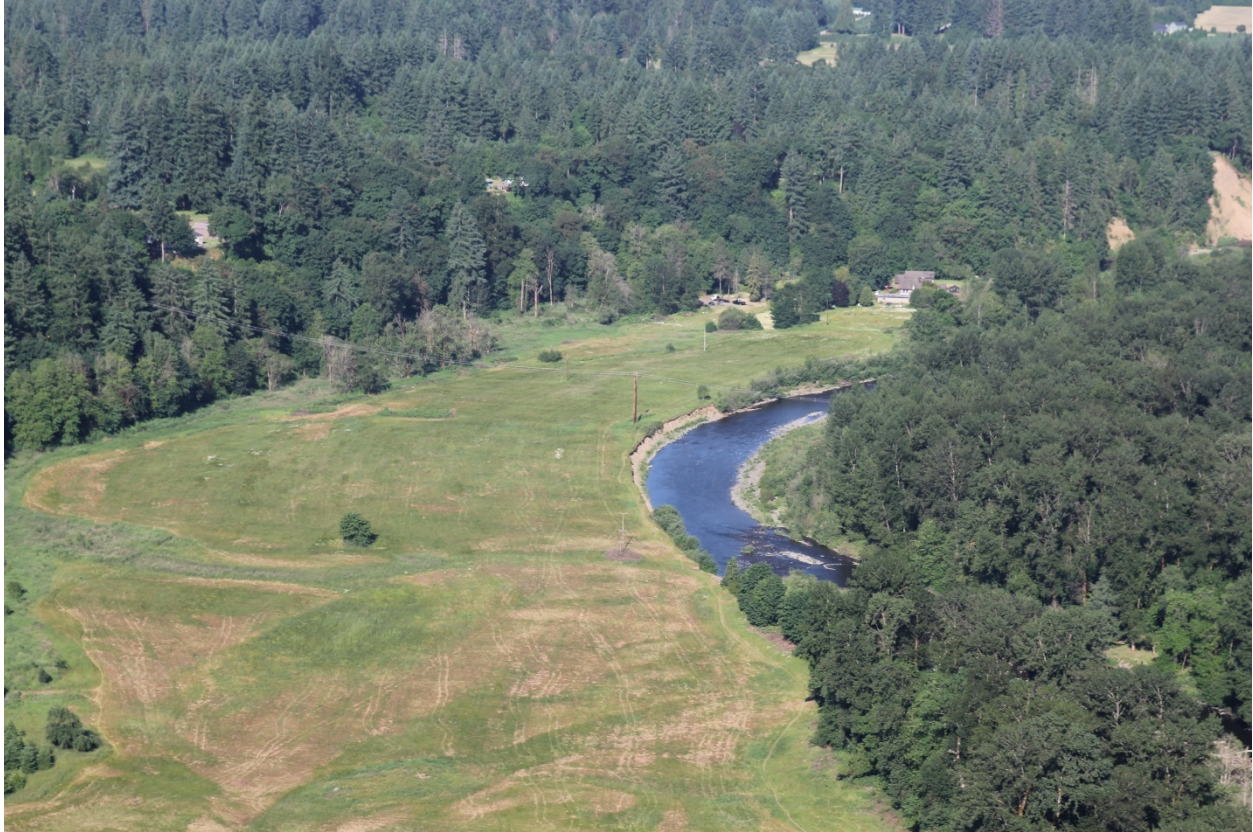
Local riparian and floodplain sources have been heavily impacted by clearing of valley-bottom forests that began prior to 1900 and have continued to today. There are several areas where cleared riparian and floodplain conditions have been maintained. The most notable areas are the left bank near RM 10.9 in Upper Daybreak, the lower Daybreak cut-bank field (~RM 9.7) (Figure 20), throughout the Pits segment, and at the BPA transmission line crossing and along the airstrip on river right in the Mason segment. The La Center segment also has considerable past floodplain clearing that has been mitigated by the creation of new forested riparian buffers by the County and Clark Public Utilities. Even where there are forested riparian and floodplain areas, the timber is second growth and not as large as what would have been present historically.

**Figure 20. Cleared riparian zone and floodplain at the Lower Daybreak cut-bank near RM 9.7. View looking downstream. Gardner Johnston photo June 2019.**

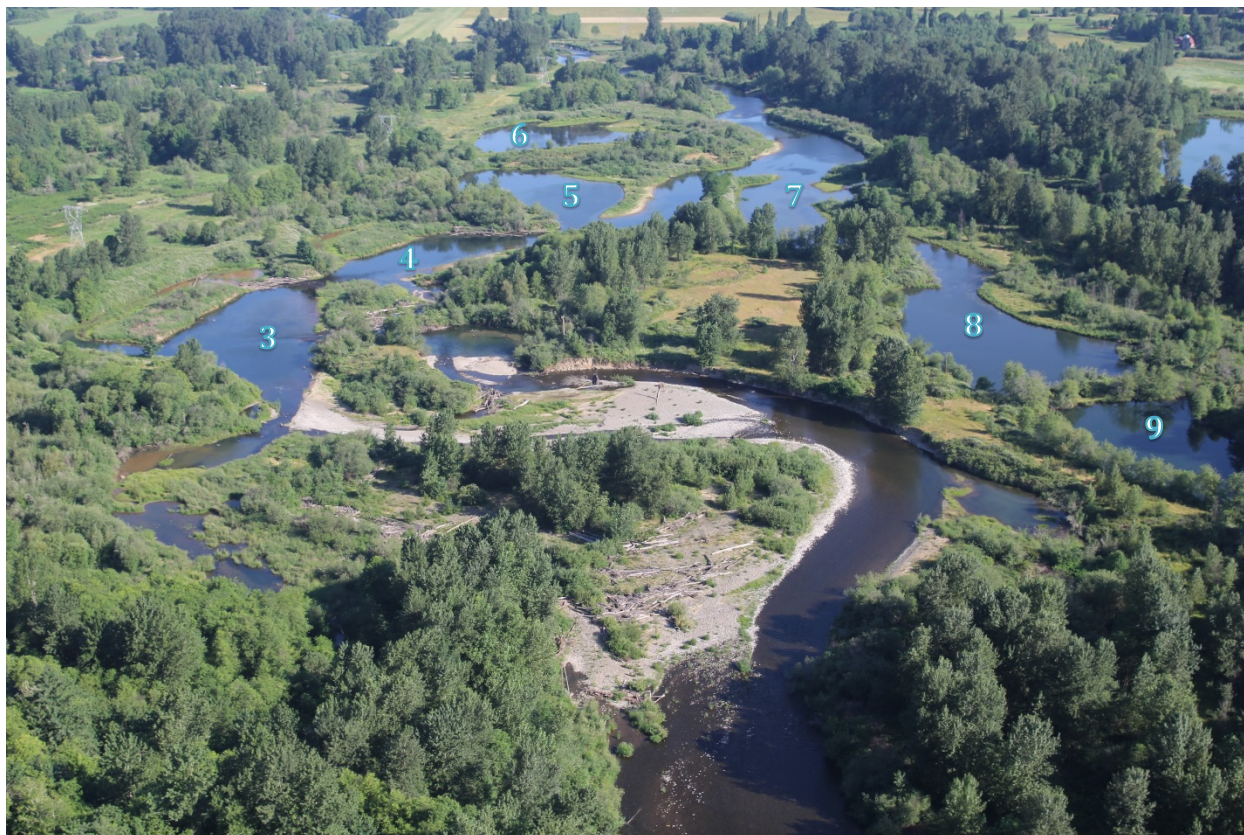
For the Ridgefield Pits reach to be considered geomorphically recovered from the impacts of the 1995-1996 avulsions, it is assumed that all the pits would need to fill with bedload/sediment and that the river channel and active floodplain longitudinal profile would need to return to a similar slope and elevation as the pre-avulsion profile. Previous estimates of recovery time defined geomorphic recovery as “when the channel has returned to an elevation similar to the pre-1996 avulsion channel” (West 2001). However, past estimates did not include the filling of all the pits in this definition; Pits 8 and 9 were excluded, even though current channel dynamics suggest that erosion of the main channel into these pits at some point in the future is likely. For the purposes of this assessment, we consider the filling of all the pits critical to full geomorphic recovery since future channel migration into non-filled pits would result in similar (albeit smaller) pit captures that would have detrimental impacts to river geomorphic function and would result in impaired habitat conditions similar to what is found in the existing pit reach.

*Figure 21. Aerial oblique view looking downstream from near the upstream end of the Ridgefield Pits reach.*
