# Technical Memo

**Name:** Kimball Storedahl  
**Company:** J.L. Storedahl & Sons, Inc.  
**Date:** October 28, 2013  
**From:** Thomas Grindeland, P.E.  
**Subject:** CM-10 Monitoring Report – Ridgefield Pits Bathymetric Survey

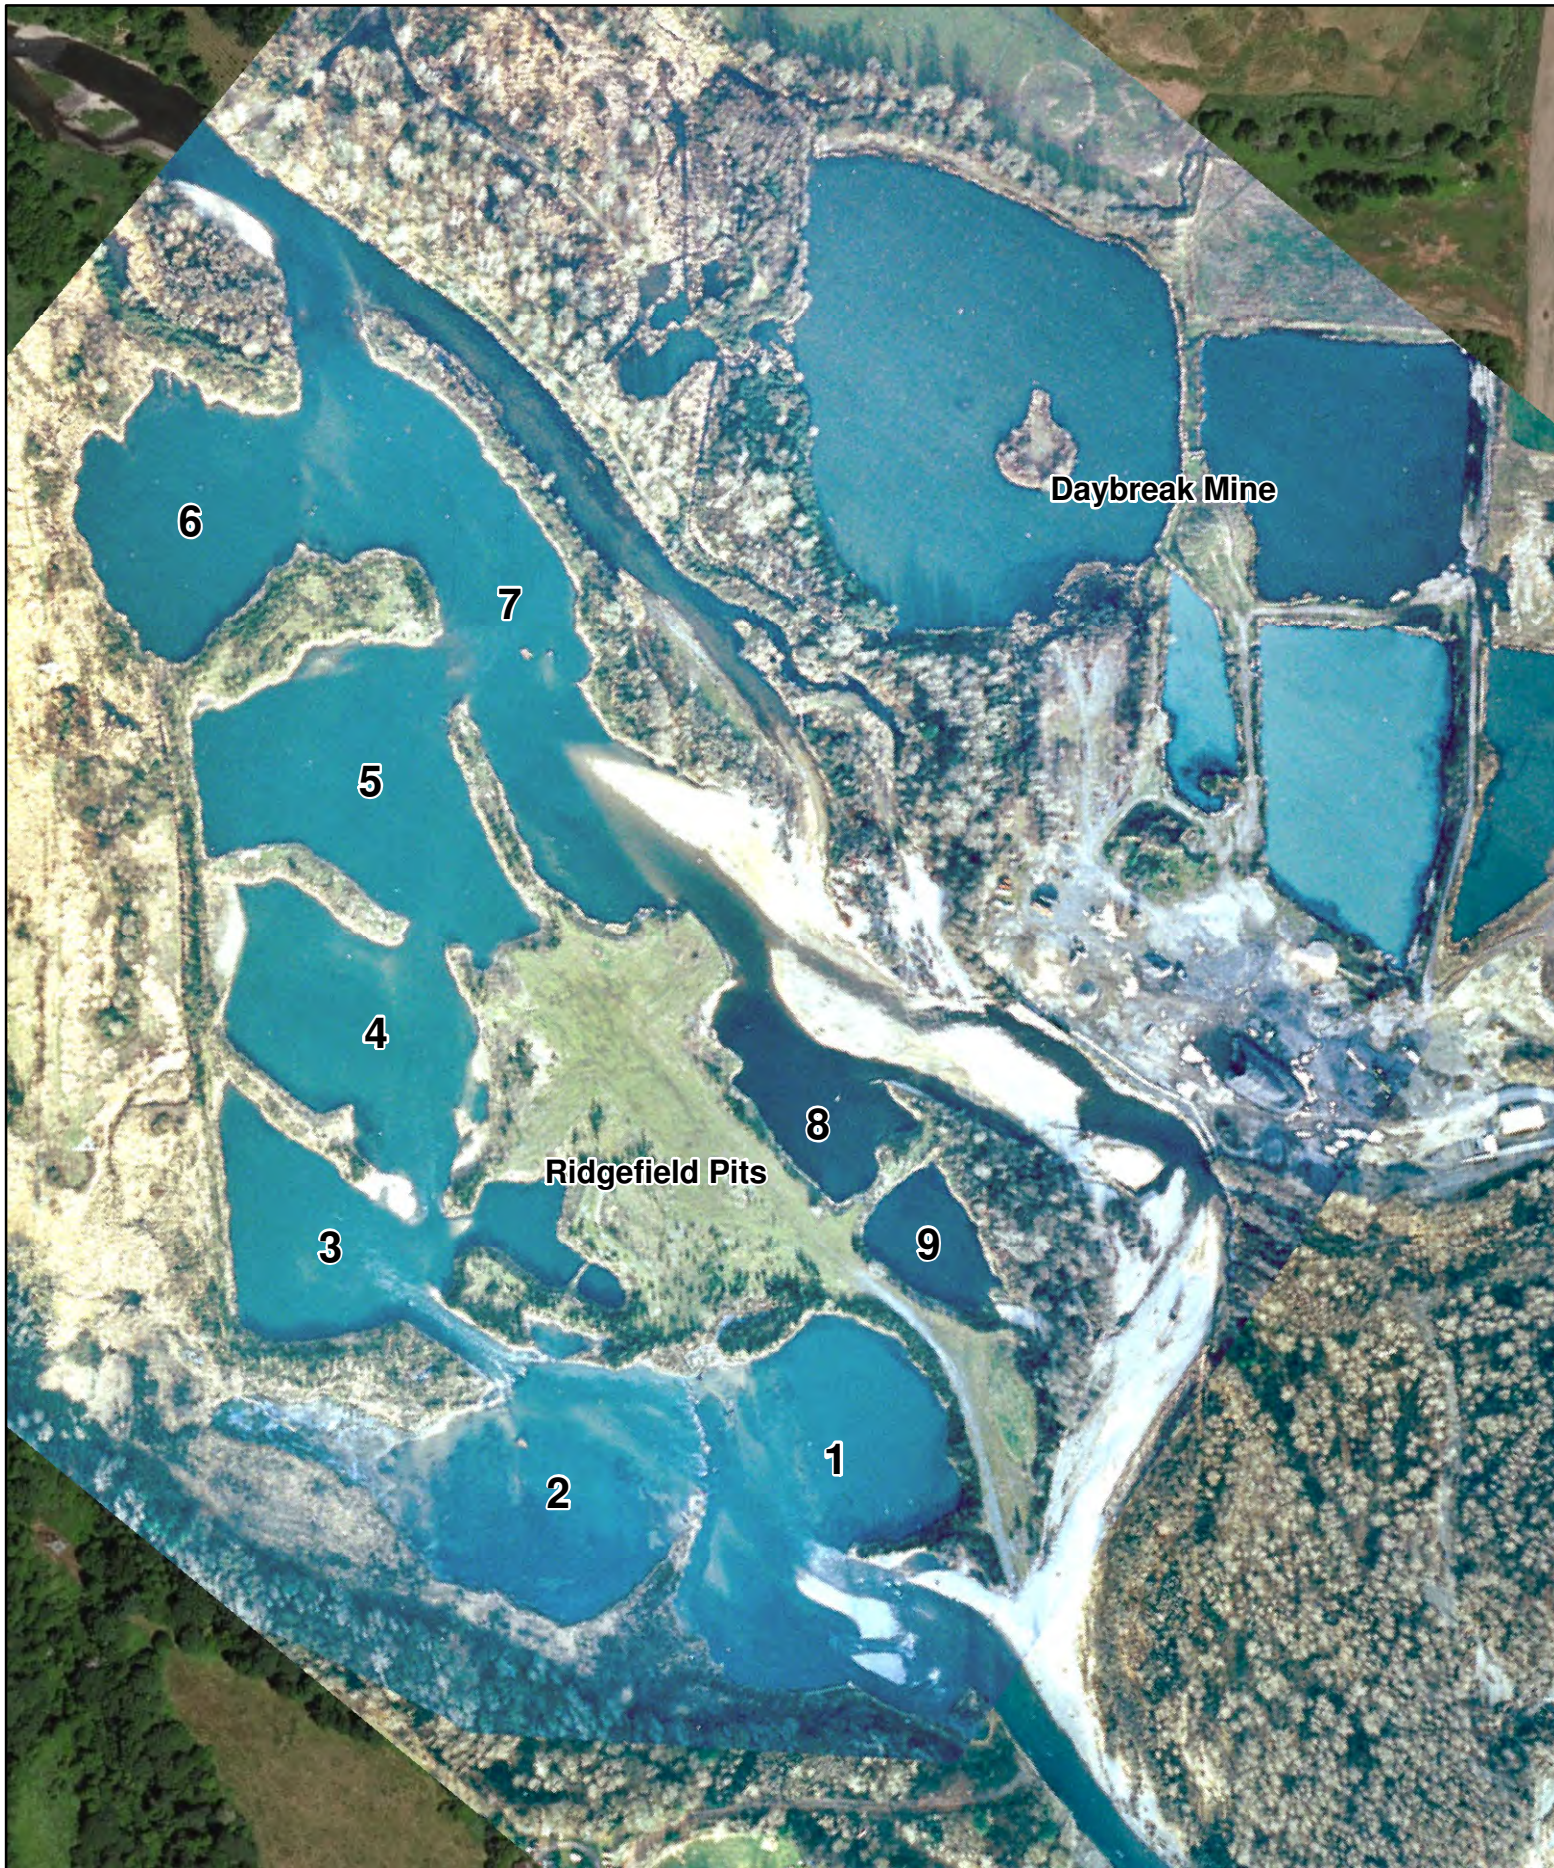
**Figure 2**  
**Ridgefield Pits - EF Lewis River**  
**November 1996**

The East Fork Lewis River avulsed into the abandoned Ridgefield Pits in 1996. Figure 2 shows the path of the avulsion from aerial photography taken in November 1996. Because the river has the potential to avulse into the off-channel Daybreak Pits, the HCP requires an estimate of the amount of time that would be required for geomorphic recovery. Geomorphic recovery of the East Fork Lewis River channel within the Ridgefield Pits will occur when the geometry and hydraulics of the channel return to conditions similar to those that existed prior to the 1996 avulsion. This is assumed to occur when the channel has returned to an elevation similar to the pre-avulsion channel. The avulsion into the Ridgefield Pits that occurred in 1996 provides an opportunity to estimate recovery time.

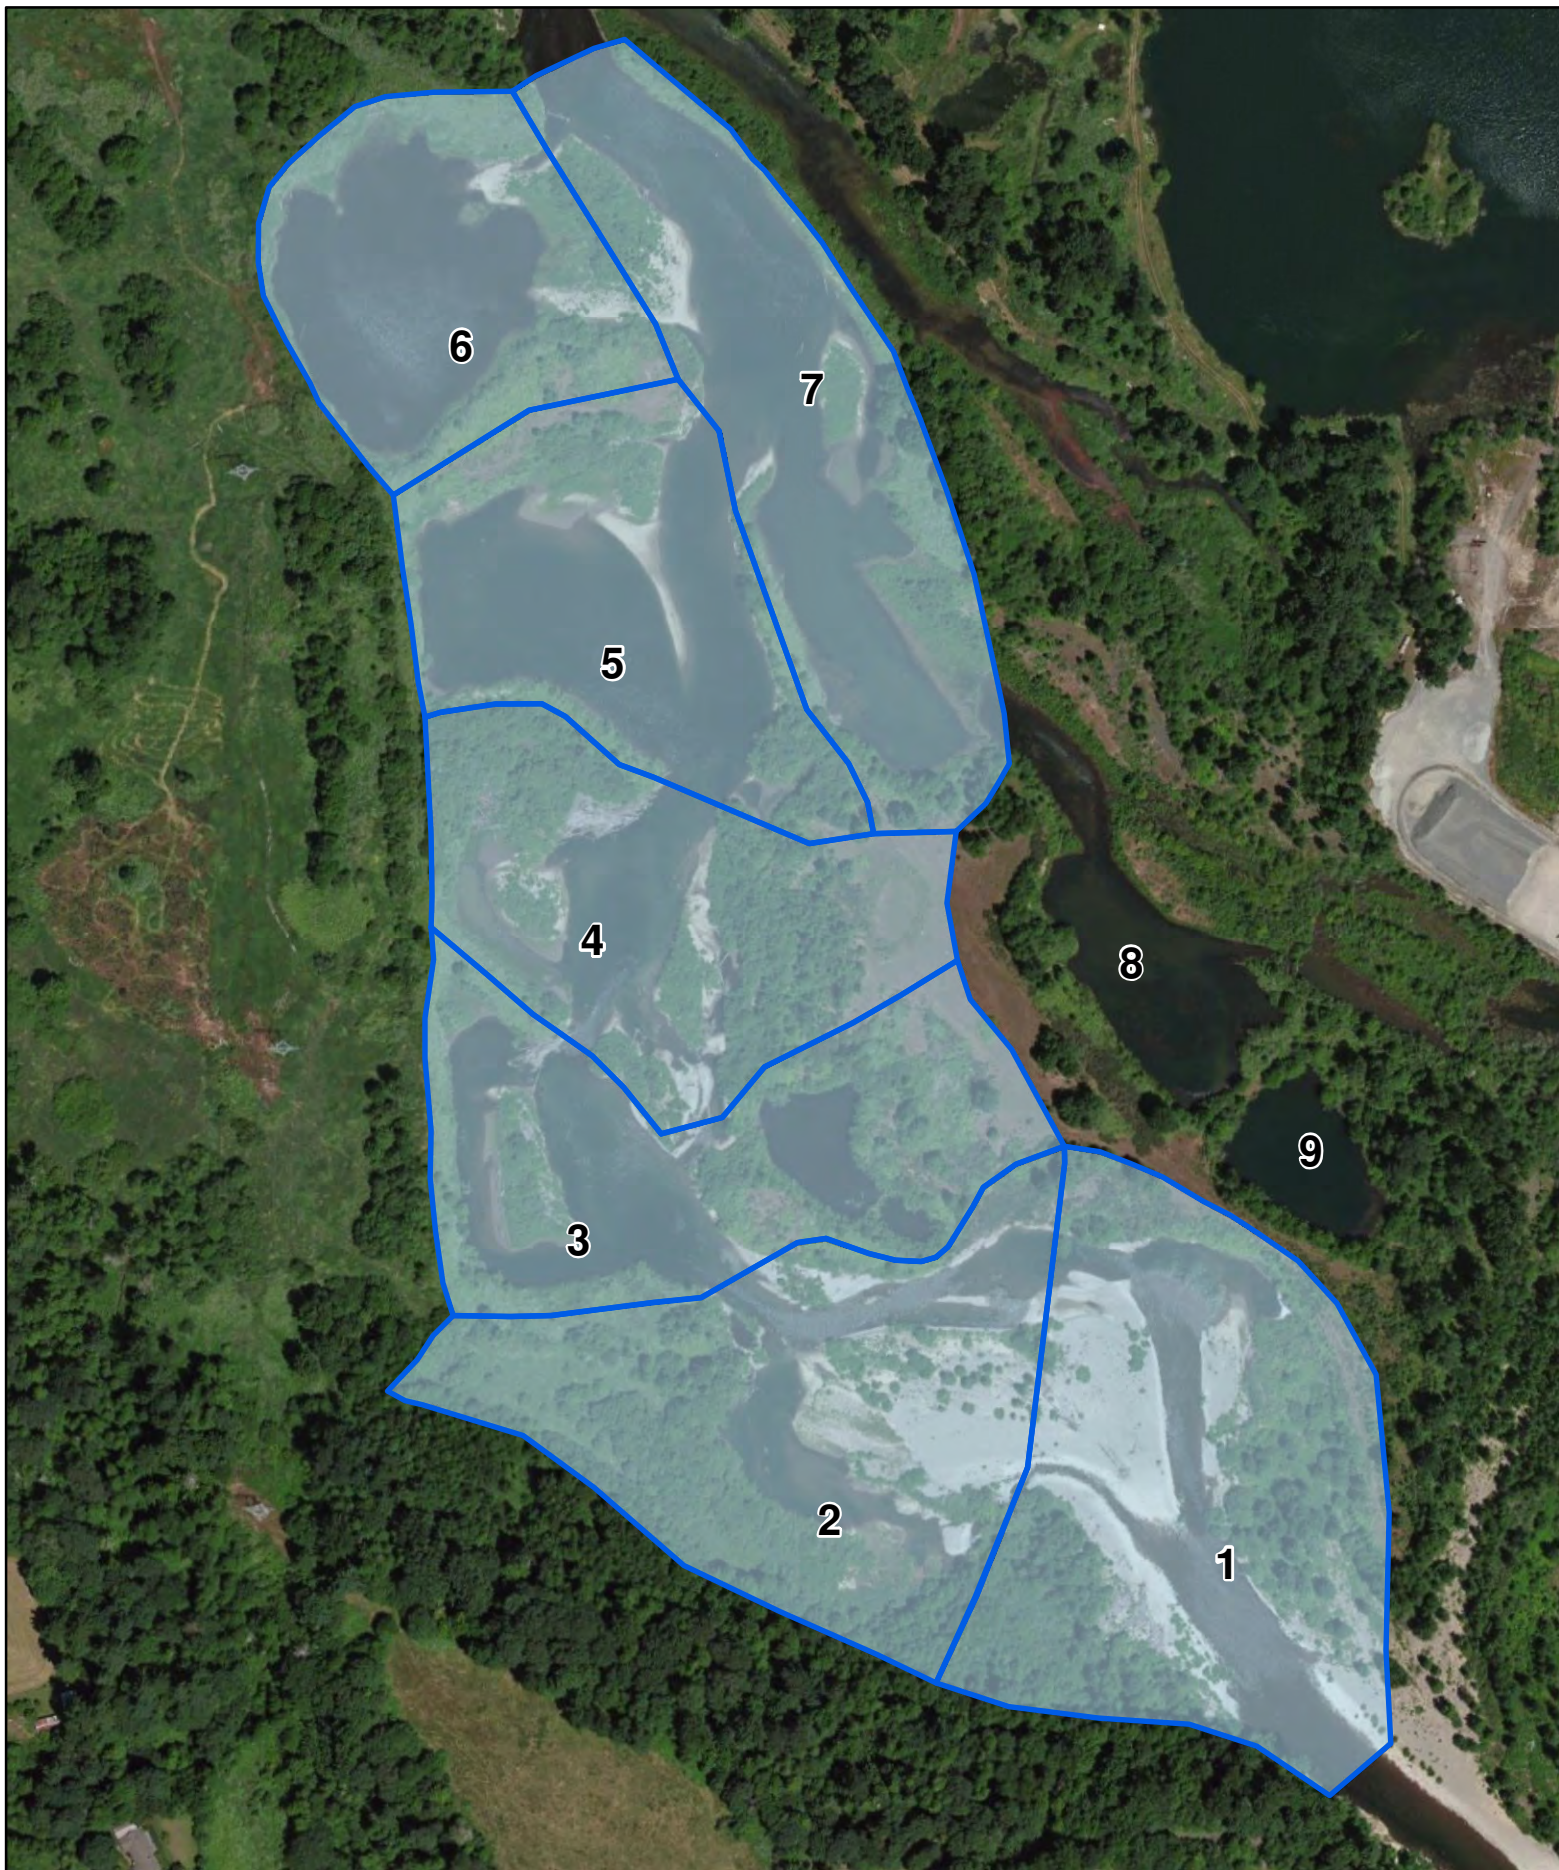
**Figure 5**  
**Pit Analysis Boundaries**  
**Ridgefield Pits - EF Lewis River**

A boundary for each pit was developed to conduct sediment infill calculations. The boundary extends beyond both the historic and current pit area in order to capture potential channel migration. The boundaries for each pit are shown in Figure 5. The volume of the Ridgefield Pits for 1999 and 2013 surveys were estimated using Arc-GIS. The same top elevations were used in the calculation of remaining pit volumes.

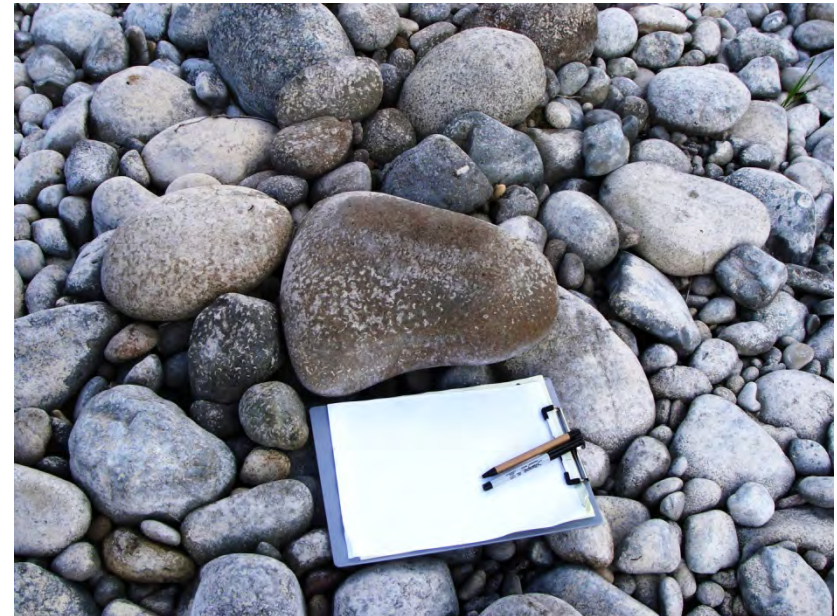
The material deposited in Pits 1 and 2 was observed to be sands, gravels and, cobbles with a median diameter ( $D_{50}$ ) of approximately 2.5 inches. The general characteristic of Pit 1 was riverine in nature and characteristics of a former gravel pit were not evident. The eastern portion of Pit 2 has a geomorphic character similar to Pit 1. The western portion of Pit 2 is more similar

Photo 4: Streambed material, left bank of Pit 1.

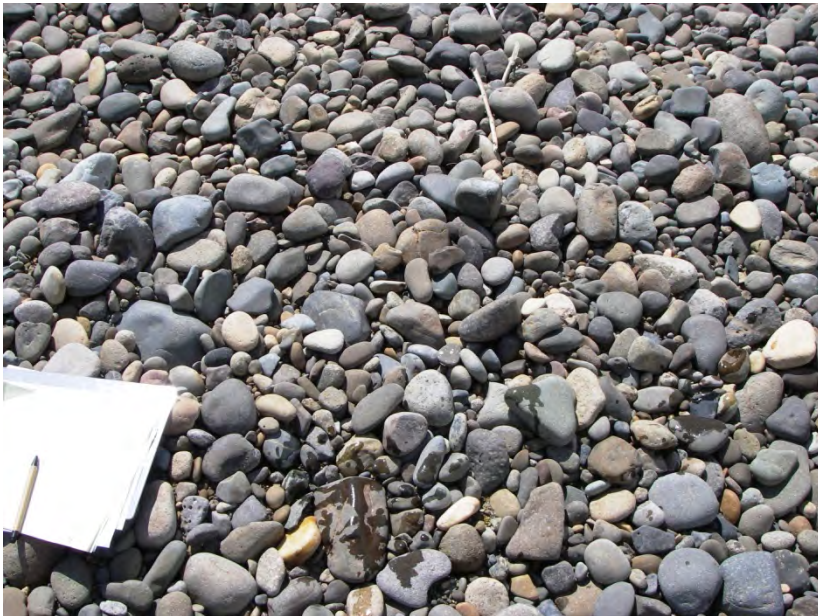
Photo 7: Streambed material, left bank of Pit 2.

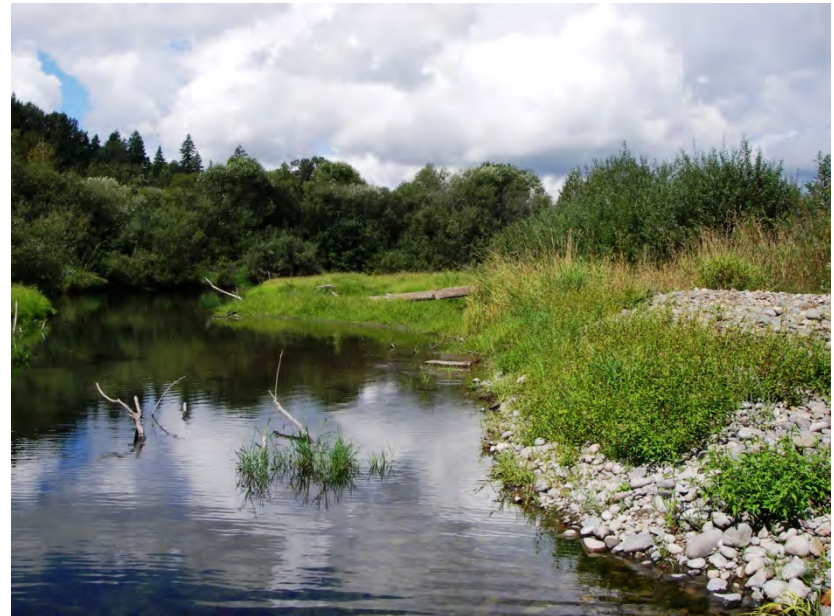
to a back channel environment, with fine sands being the predominant sediment. Historic aerial photography shows the channel was located in this area in 2007 and coarser material may have been deposited under the current sand deposits. Portions of the channel in Pit 3 were observed to have a gravel and cobble substrate, with a  $D_{50}$  of approximately 2.5 inches. Again, the sediment deposits observed in the backwater areas of Pit 3 are primarily sand. Predominantly, sediment deposits in Pits 4 through 7 were observed to be sand.

Photo 8: Looking north, western edge of Pit 2. Note gravel delta deposition on right of photo. Sand deposition is predominant left of the gravel delta.

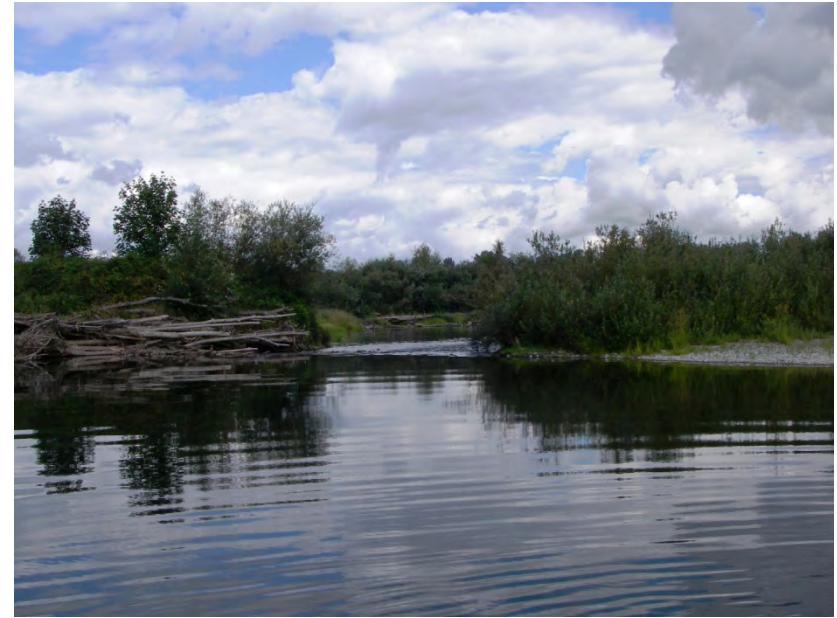
Photo 14: Looking north at the downstream extent of Pit 3. Note the formation of apex log jam on west side of the channel.

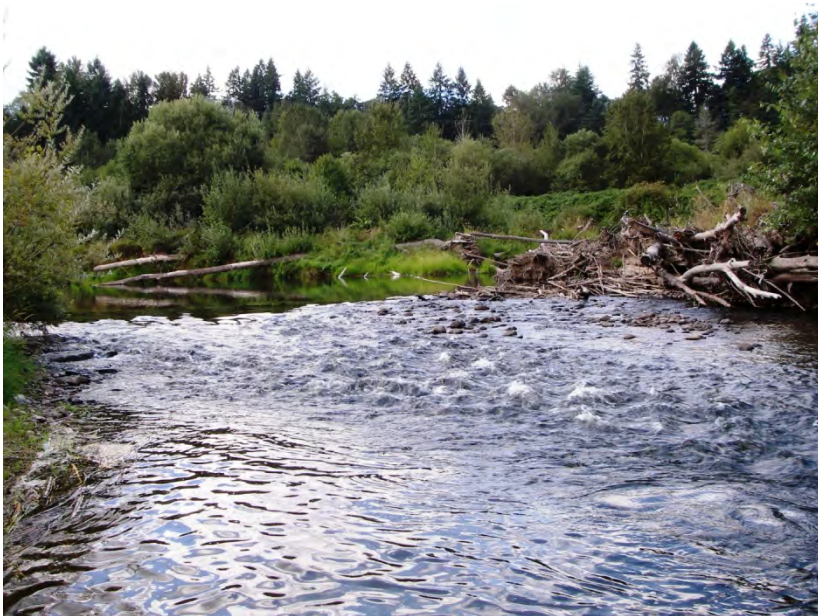
Photo 15: Looking upstream (south) at entrance of Pit 4. Note apex jam on right.

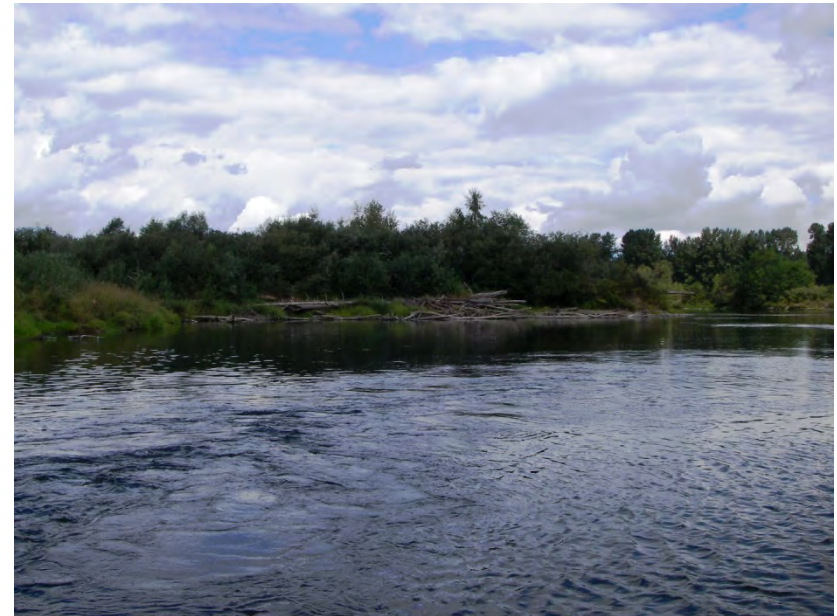
Photo16: Looking downstream from entrance of Pit 4. Note the formation of a second apex log jam on west side of the channel near the exit.

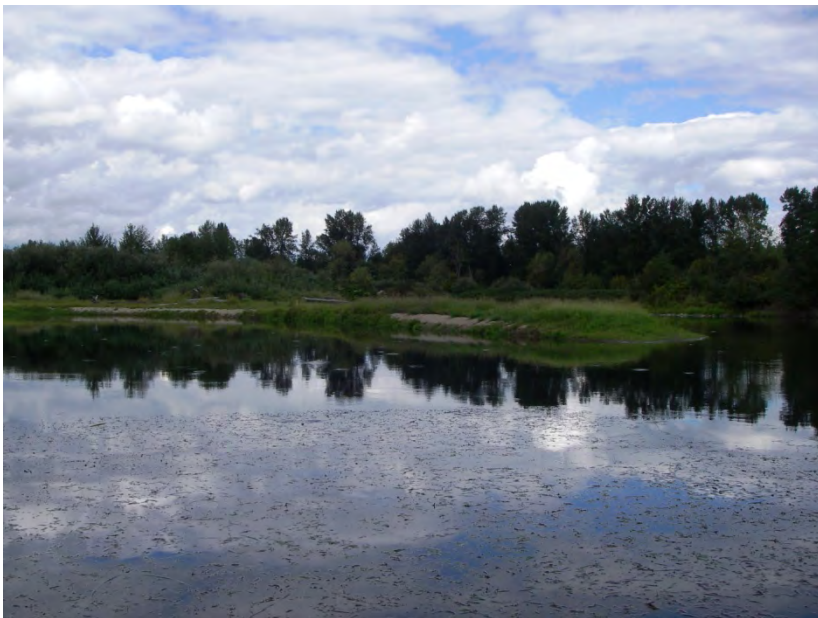
Photo 19: Looking northeast from entrance of Pit 5. Note sandbar formation which separates main channel from the backwater area of Pit 5.

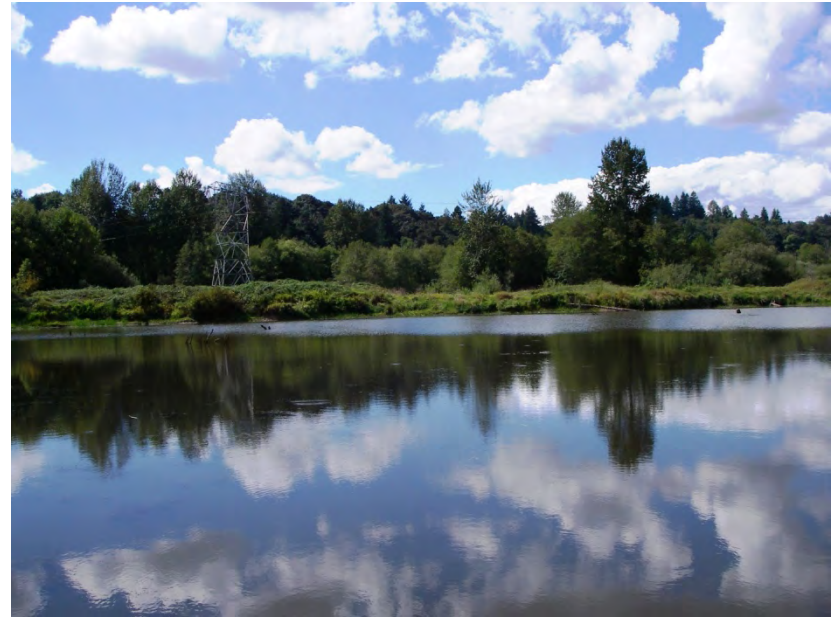
Photo 22: Looking west at Pit 6. Note that Pit 6 is currently cut off from the active channel of the EF Lewis River.

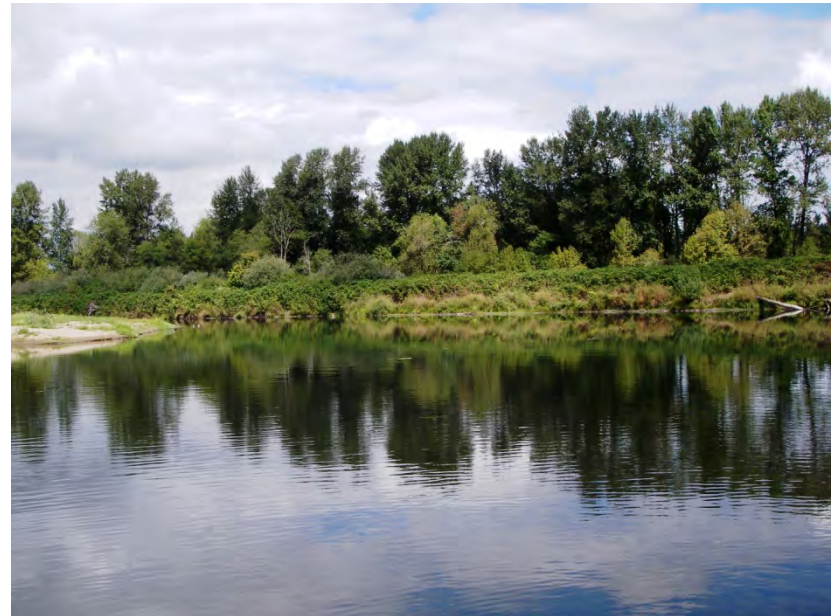
Photo 24: Looking downstream toward the mid section of Pit 7. Note this section is active channel.
