## **Geomorphic Analysis of the East Fork Lewis River**

Geomorphic Analysis of the  
East Fork Lewis River in the Vicinity  
of the Daybreak Mine  
Expansion and Habitat Enhancement Project

May 18, 2001

**WEST Consultants, Inc.**  
**12509 Bel-Red Road, Suite 100**  
**Bellevue, WA 98005**

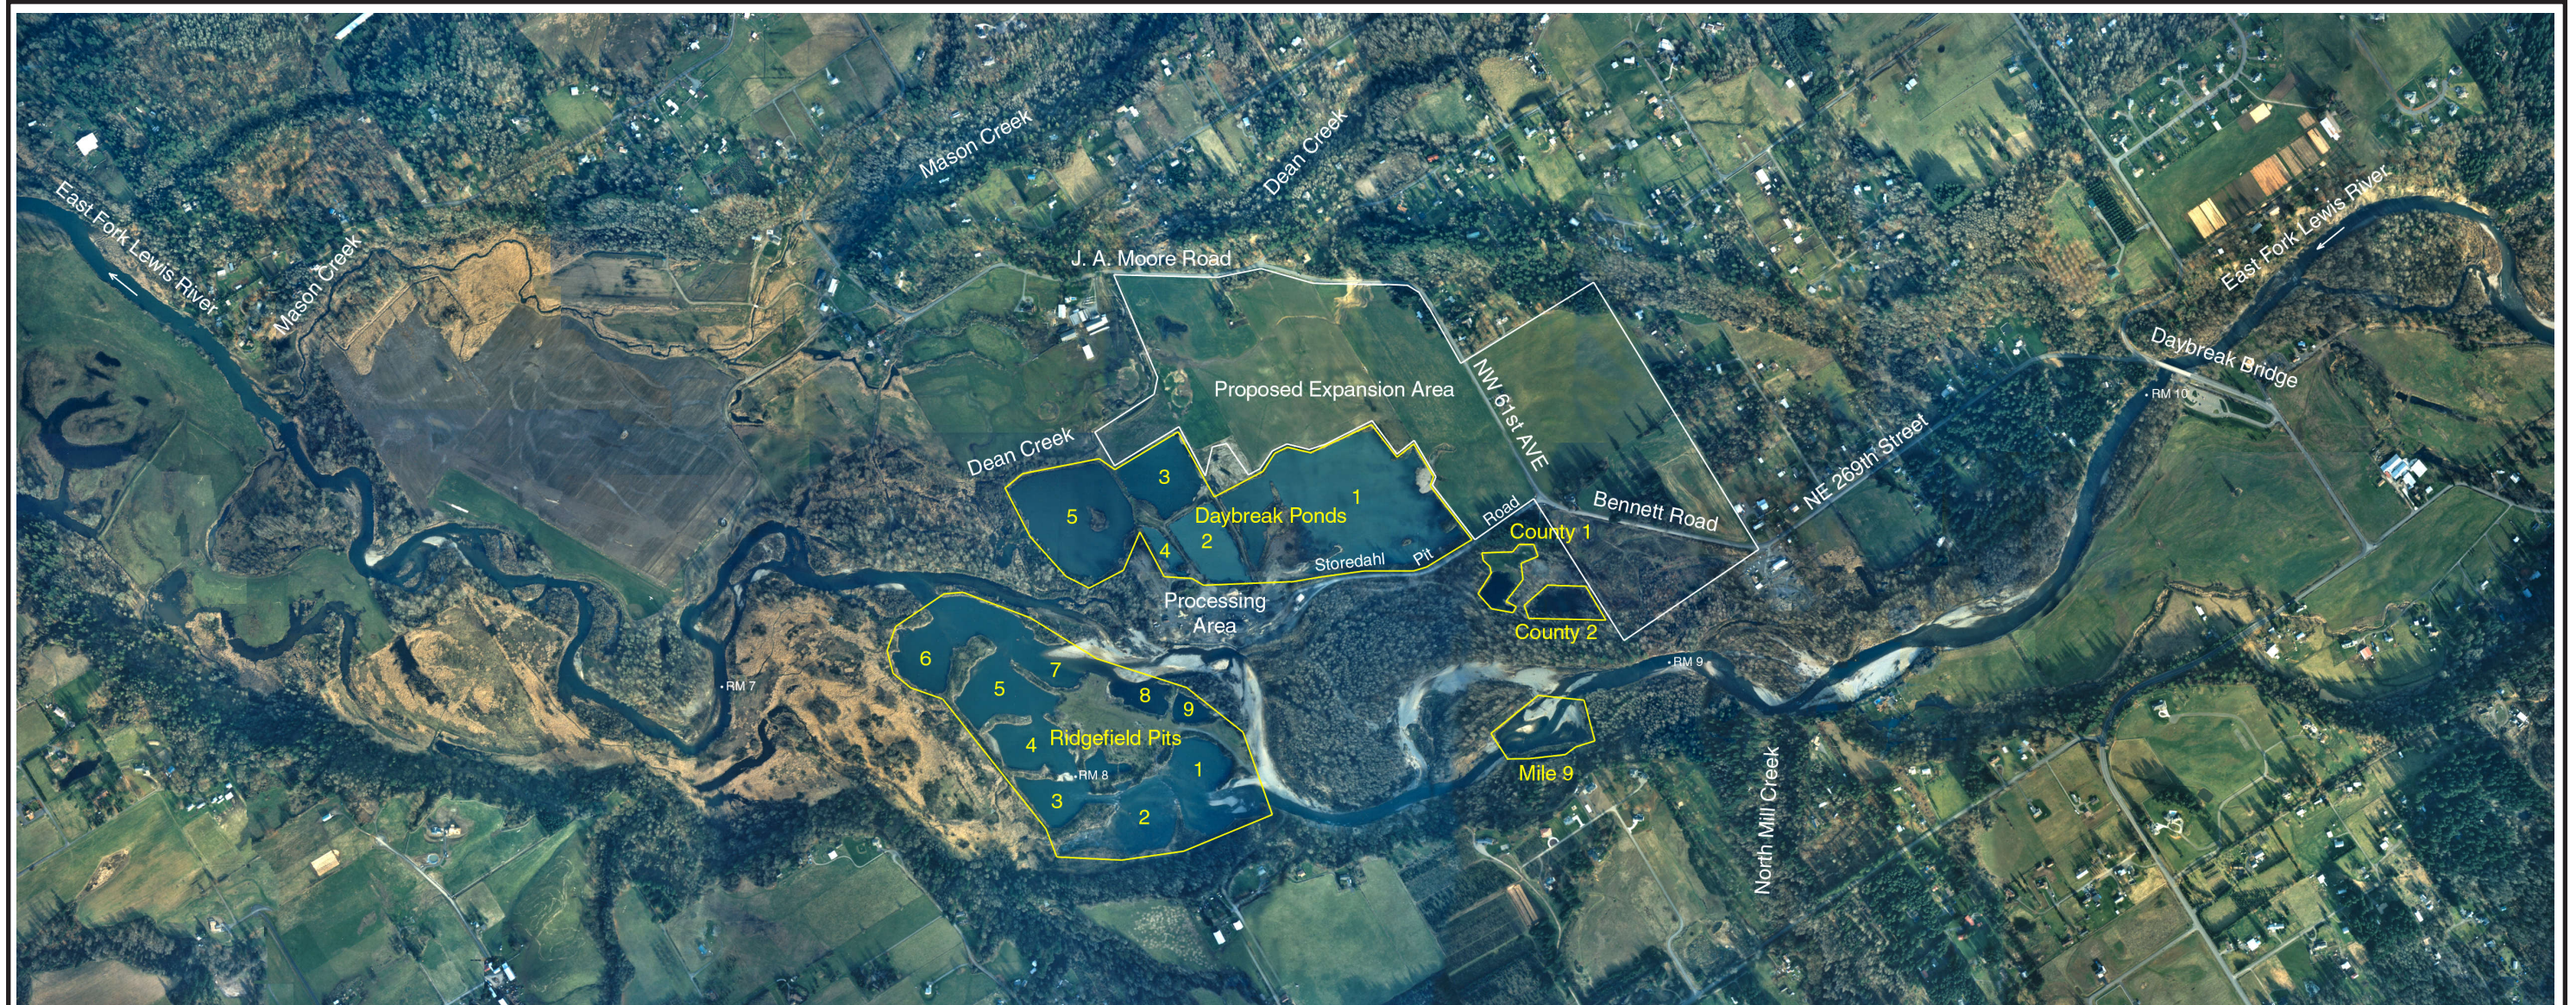
The aggregate resources of the East Fork Lewis River are valuable due to their high quality and close proximity to the Vancouver - Portland metropolitan area. Aggregate from mines along the East Fork Lewis River has been incorporated into a substantial portion of the asphalt and concrete paving of Clark County as well as many public and private projects in the county. It is not known when gravel mining first began in the lower East Fork Lewis River basin. However, it is known that numerous operators have historically conducted gravel mining along the lower East Fork for many years. Mining at the Daybreak site began sometime prior to 1968. A composite aerial photograph identifying the location of various currently operating and abandoned gravel pits along the lower East Fork is shown in Figure 2-4.

The historic gravel mining activities in the vicinity of the Proposed Project have already influenced the morphology of the river (see Figure 2-4). In 1995, the river avulsed in to an abandoned gravel pit (RM 9 Pit) located near RM 9.0. This event caused the abandonment of a large meander bend. During the February 1996 flood, the river broke into the southeast corner of Ridgefield Pit No. 7, flowing back into the channel at its northwestern most point (Miller, 1996). This caused the abandonment of approximately 1,500 feet of channel located southwest of Daybreak Pit No. 5. In November 1996, the river migrated into the Ridgefield Pit No. 1, flowing back into the channel from Pit No. 7 again relocating a section of the main channel of the river. The avulsions into abandoned gravel pits have altered the hydraulic and sediment transport characteristics of the river. Other abandoned or mined out gravel pits exist along the river in the vicinity of the Proposed Project including the Daybreak Pits, County 1 Pit and County 2 Pit, and the remaining Ridgefield Pit No. 9 (see Figure 2-4) and may influence the river in the future. The most significant of these pits are the Daybreak Pits. Consequently, an evaluation of geomorphic impacts must consider both the effects of the Proposed Project individually and cumulatively with other historic gravel mining operations in the area.

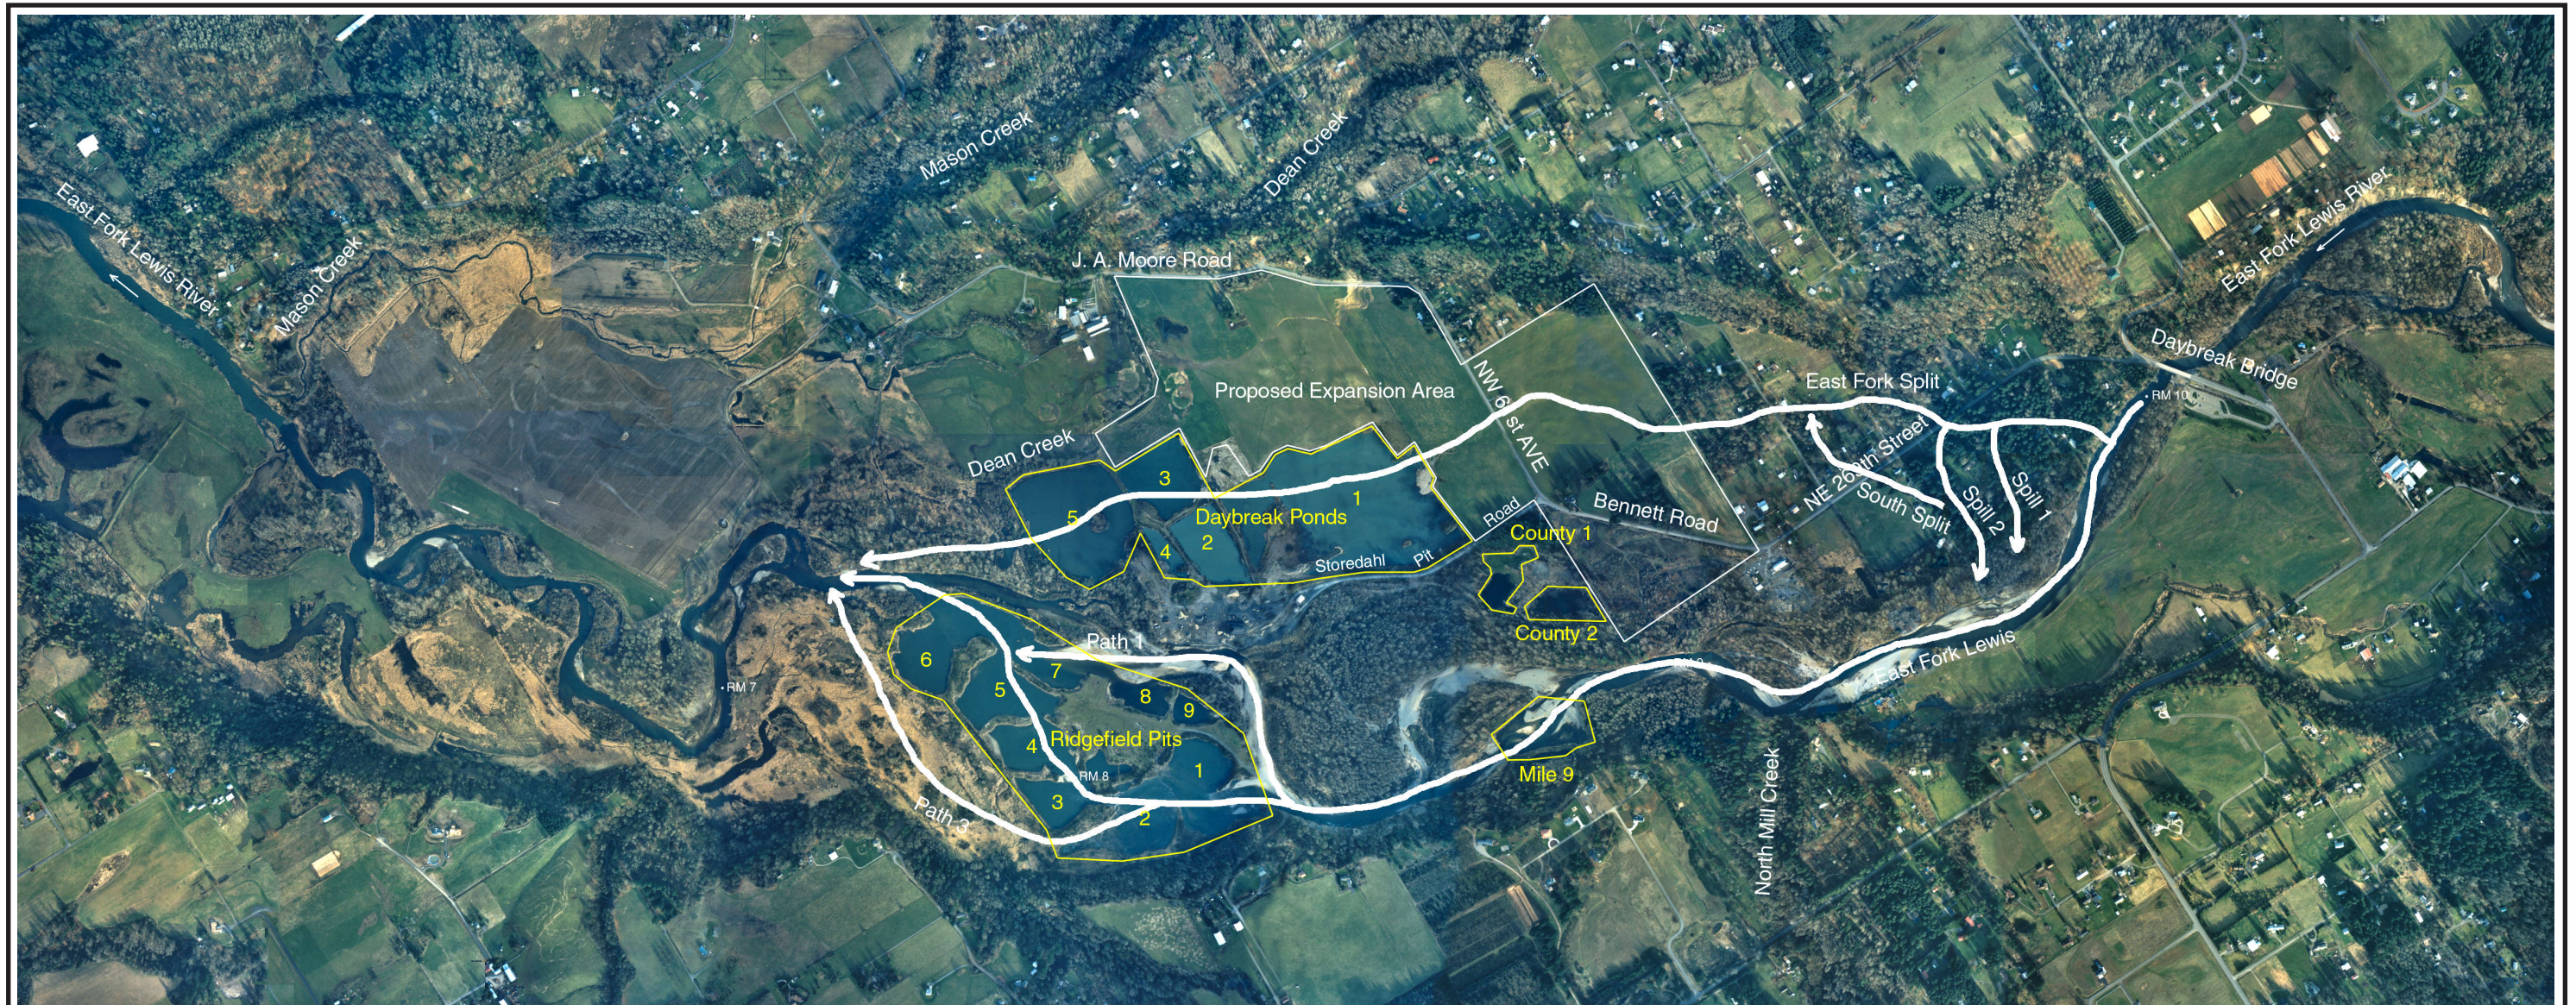
The system was divided into a number of reaches as shown in Figure 4-1. The division of flow at the junction of any two reaches was determined by balancing energy between the upstream most cross-sections of each respective reach. Four locations were identified where flow splits away from the mainstem “EF Lewis” flow path and two locations where flow escapes from the “EF Split” and then returns to the main channel. Initially, water splits from the main channel (flow path “EF Lewis”) along flow path “EF Split”.

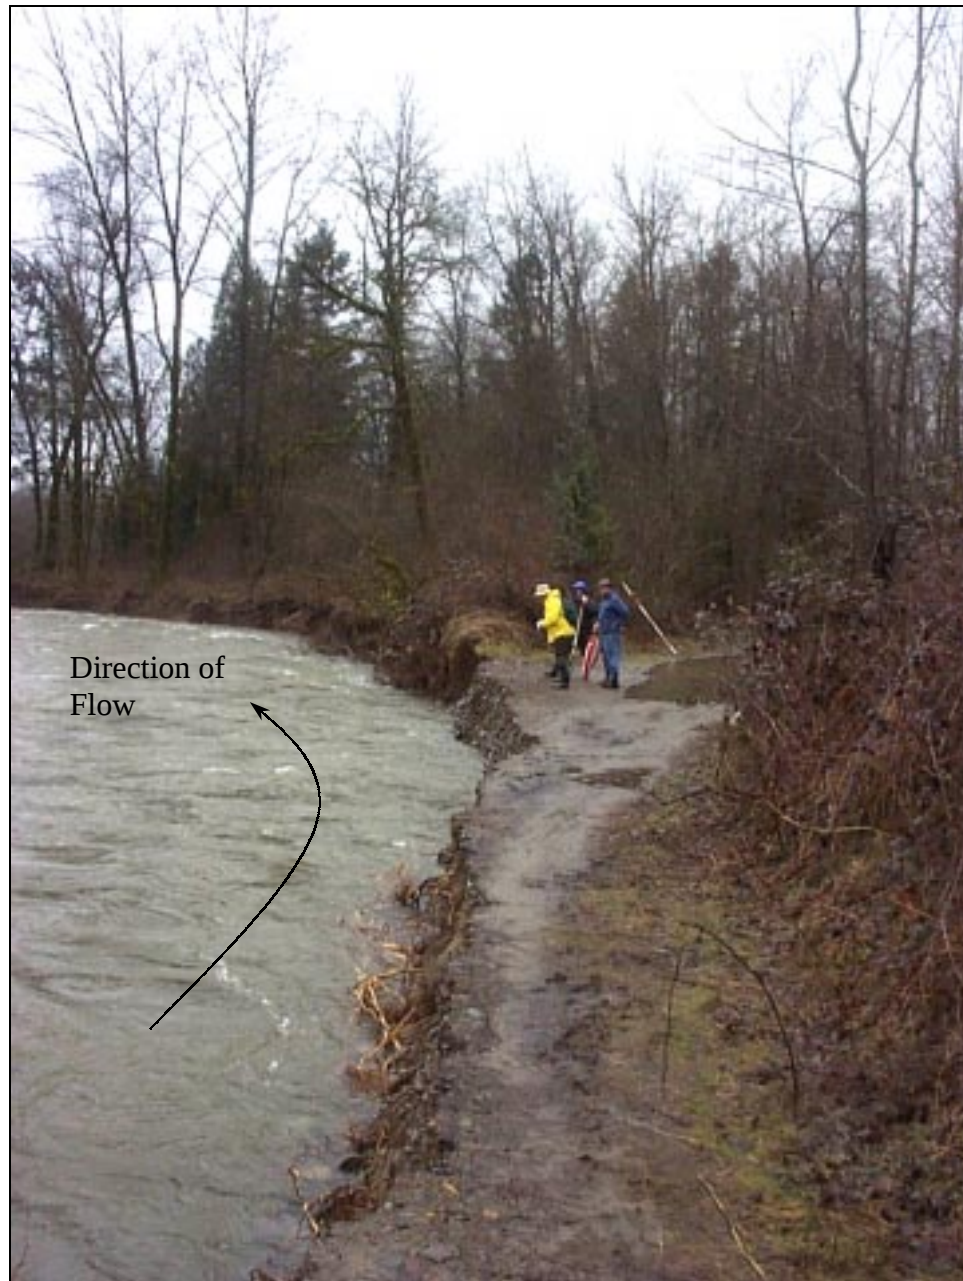
**Figure 7-5. Photo of erosion of north bank just downstream of North Mill Creek at RM 9.**

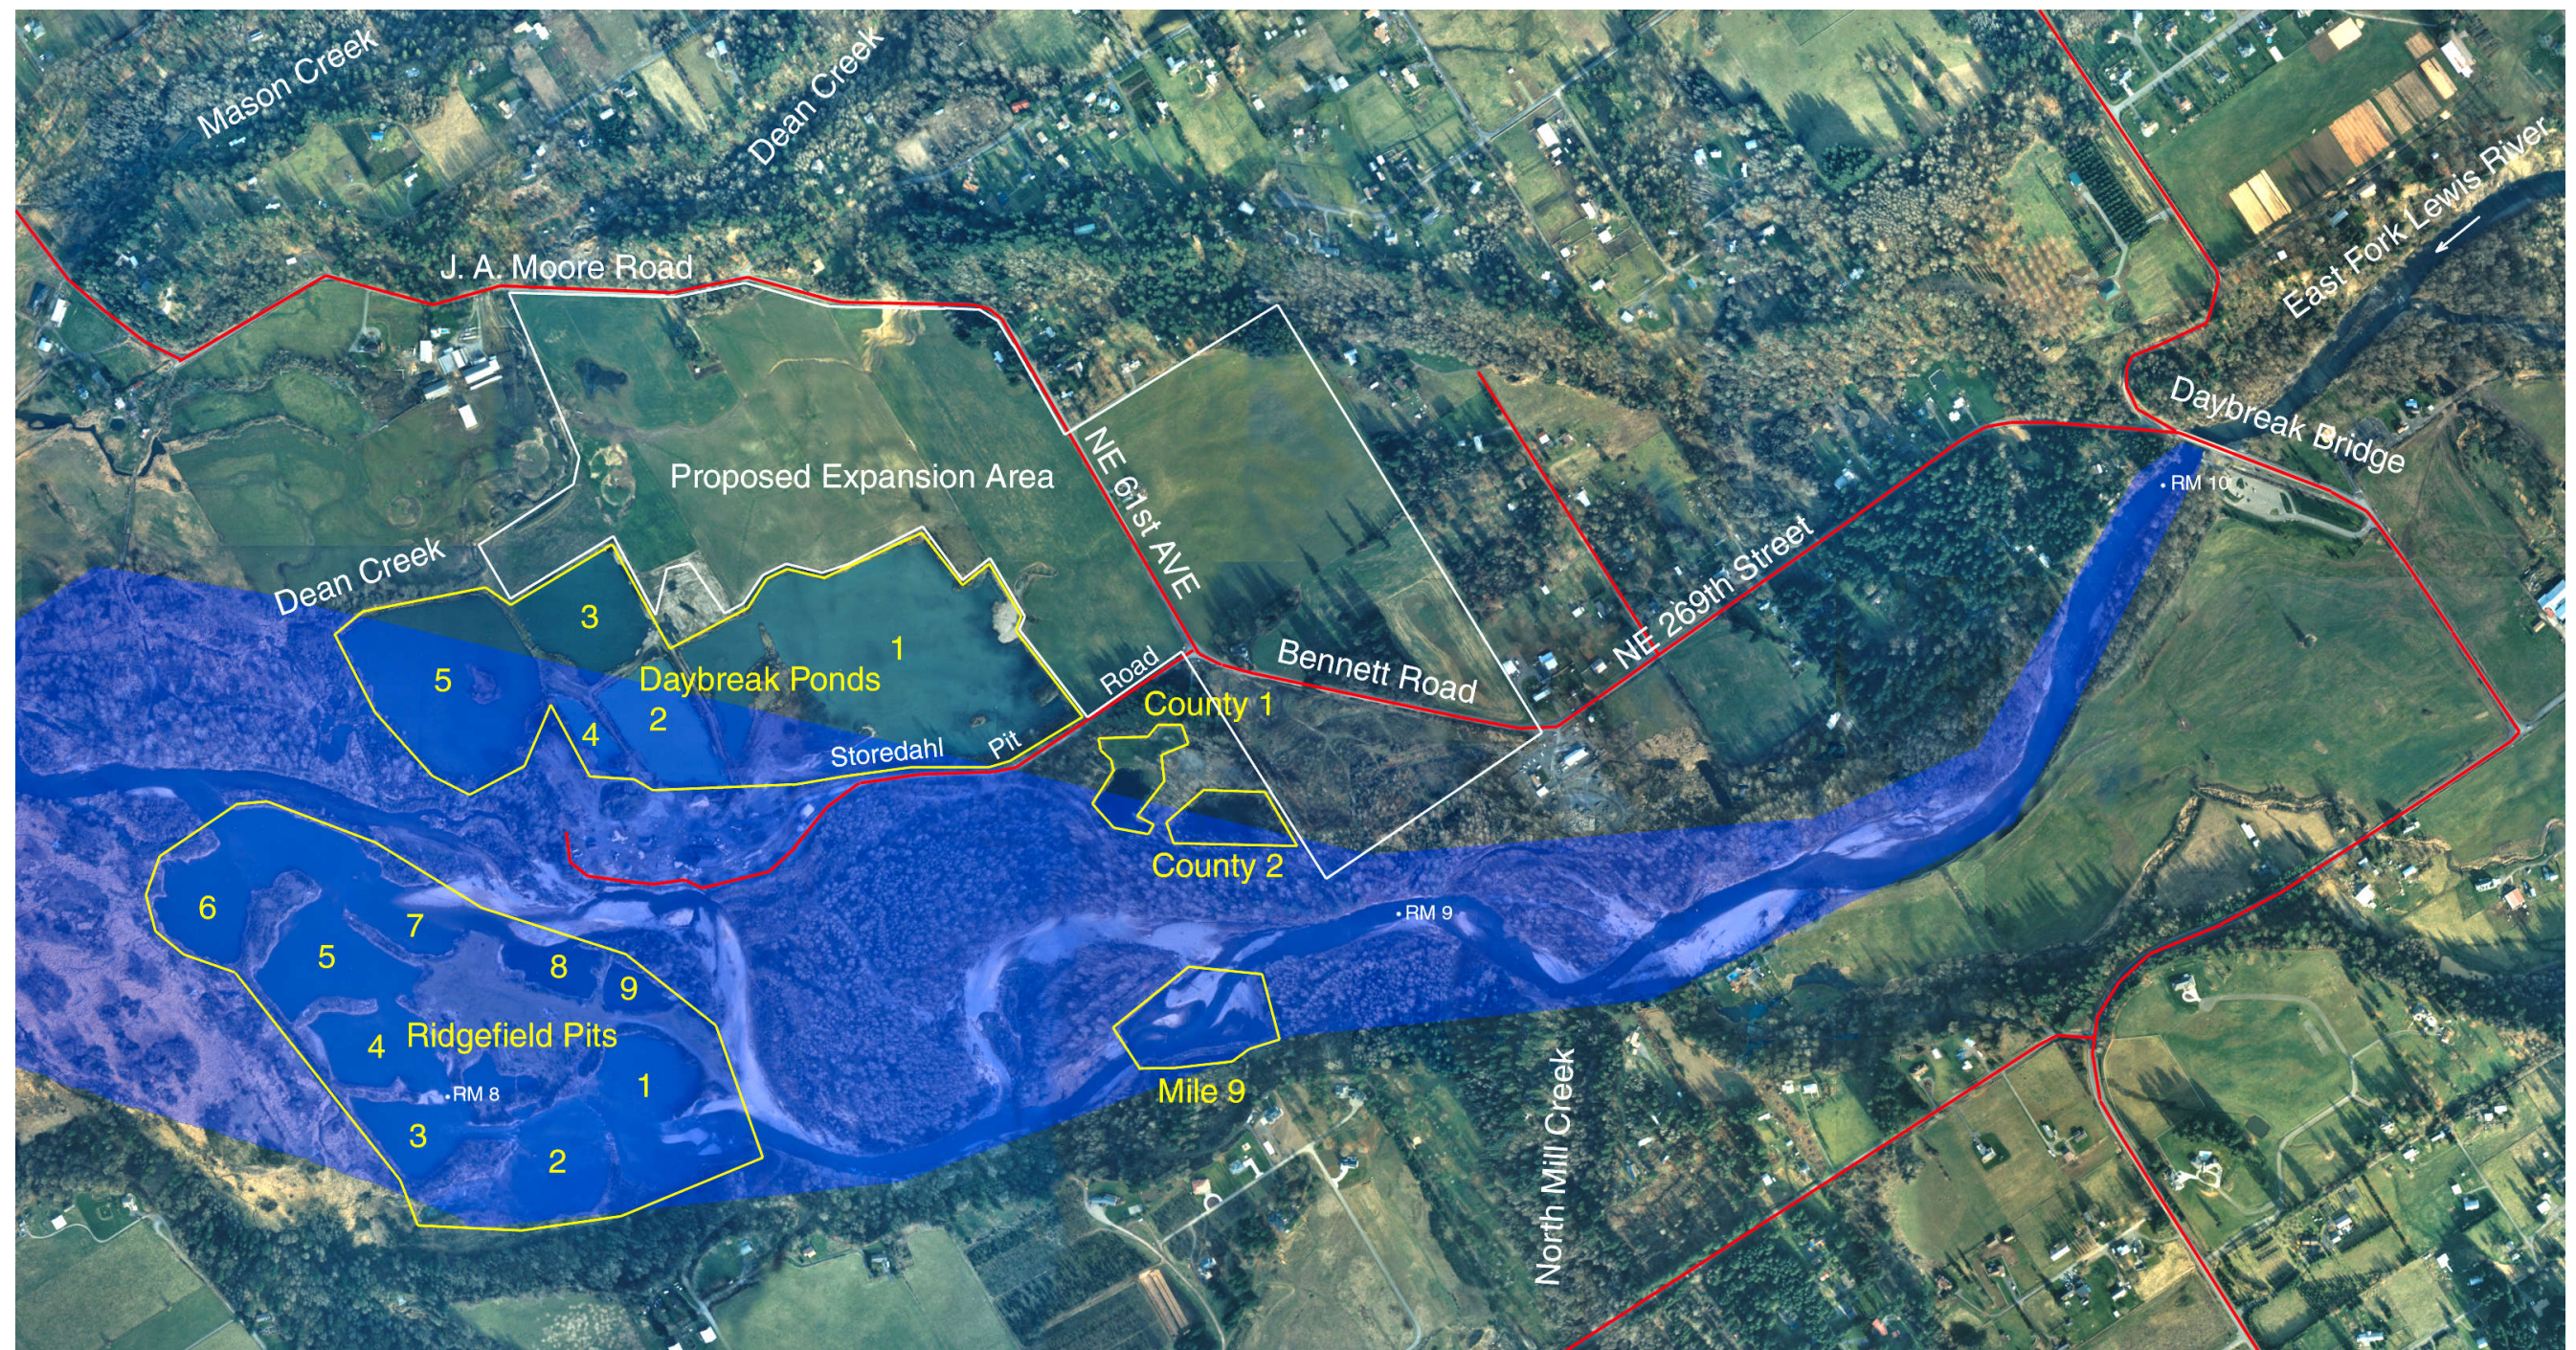
Figure 8-2. Unconfined Meandering Stream (method 1) Channel Migration Zone.
