# East Fork Lewis River Ridgefield Pits Restoration

## Geomorphology Report

Lower Columbia Estuary Partnership

**January 2020**

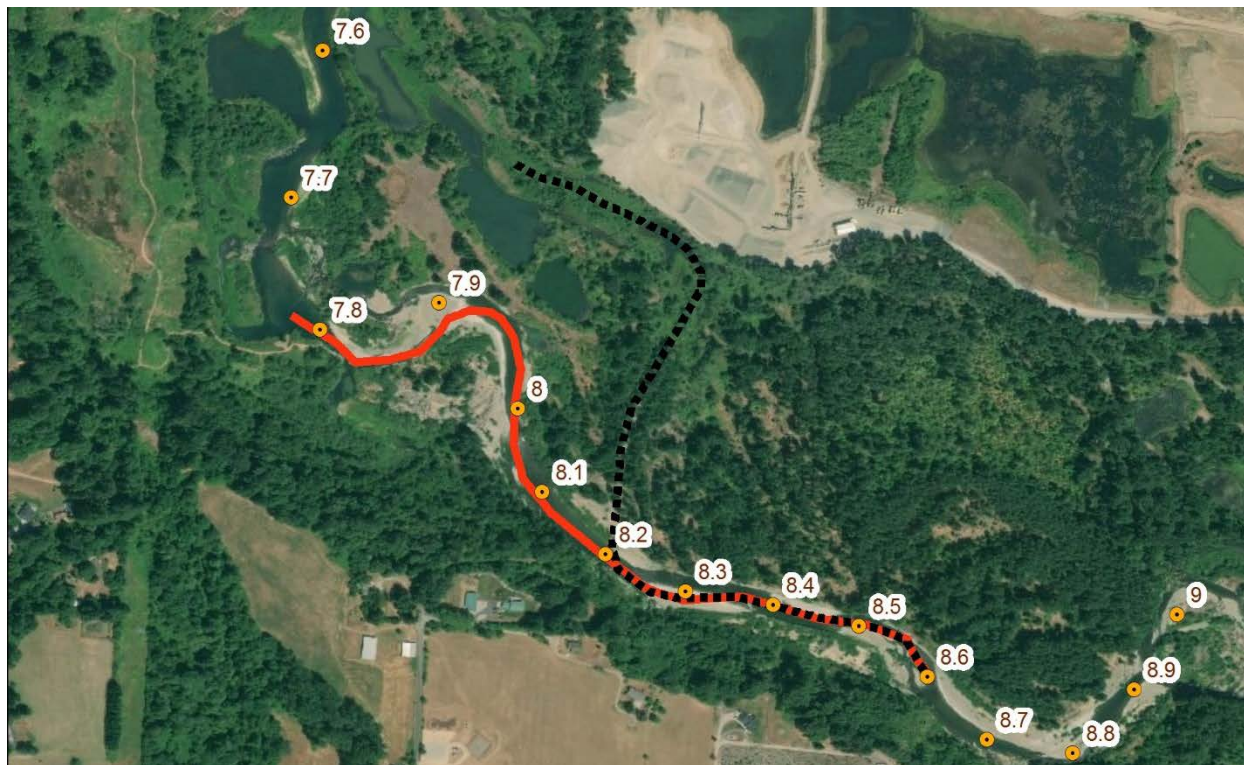
Figure 9. Location of profiles through upstream end of pits.

A longitudinal profile comparison was also made between the abandoned channel and the newly formed channel through the upper end of the pits. This comparison allows for another way to look at changes in the bed profile from the pre-avulsion condition and provides some insight into future trends. The locations of the profiles are shown in Figure 9 and the profiles themselves are shown in

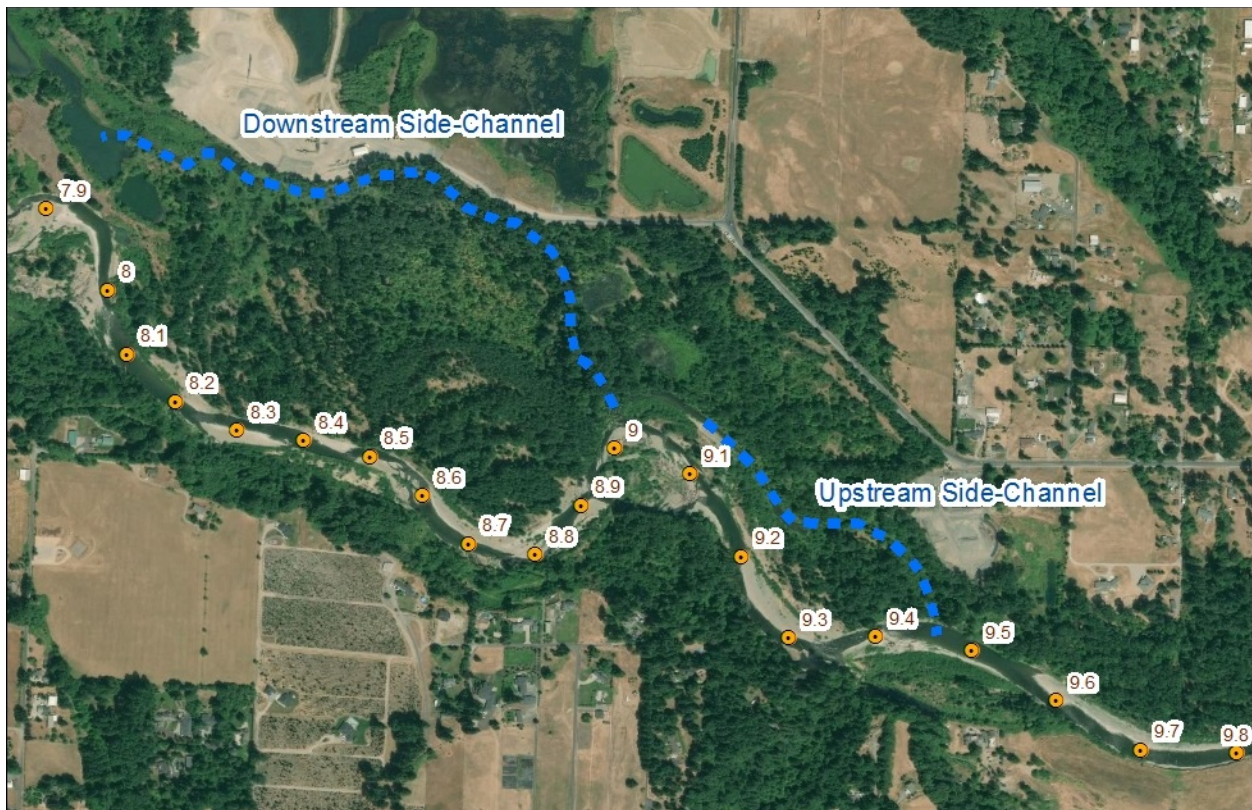
**Figure 12. Location of side-channels being evaluated for enhancement.**

There are two prominent side-channel alignments that are being considered for enhancement. These are located in the Lower Daybreak reach and include the right bank side-channel from RM 9.45 to 9.1 and the right bank side channel from RM 9.0 to the pits (see Figure 12). Both of these side-channels have existing surface flow during high flows, with the upstream side-channel having greater surface water connectivity to the mainstem; however, both side-channels disconnect from surface flow during base flows in the summer.

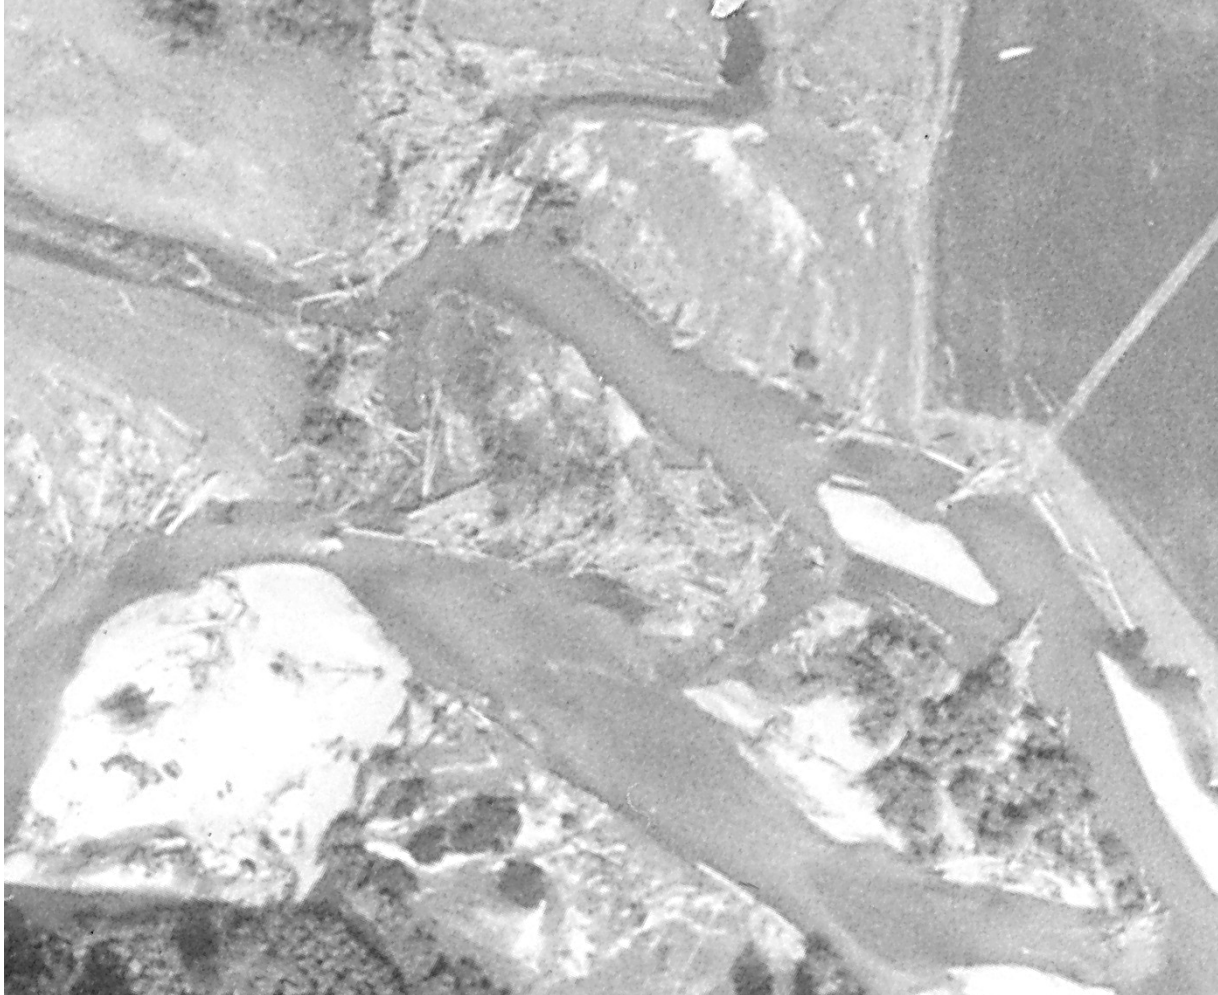
**Figure 15. Large wood accumulations in the Pits segment (near RM 7.4) in 1939.**
