Purpose of Geomorphology Analysis

Analysis of Ridgefield Pit Filling

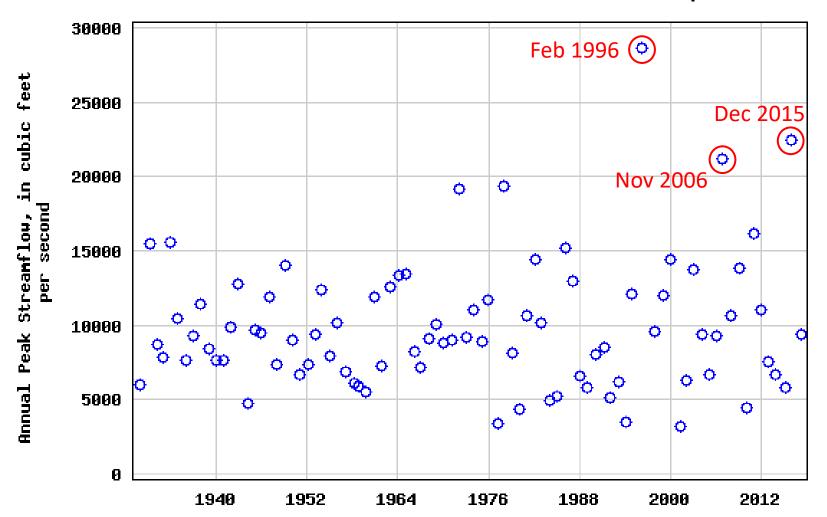
USGS 14222500 EAST FORK LEWIS RIVER NEAR HEISSON, WA

Flood Recurrence Interval	Discharge (CFS)
2-Year	9,160
5-Year	12,900
10-Year	15,400
25-Year	18,500
50-Year	20,800
100-Year	23,100
200-Year	25,300
500-Year	28,300

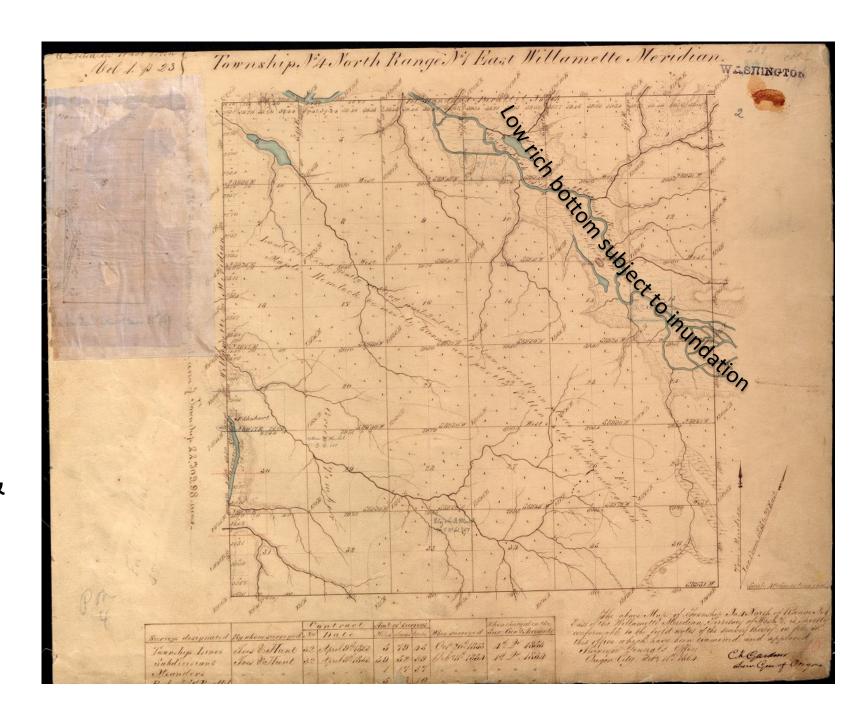
GLO surveys

Braided or anastomosing channel pattern through pits and in lower Daybreak segments

Highly sinuous meandering downstream

Meandering/wandering stream types above

Numerous side channels and wetland areas throughout valley bottom

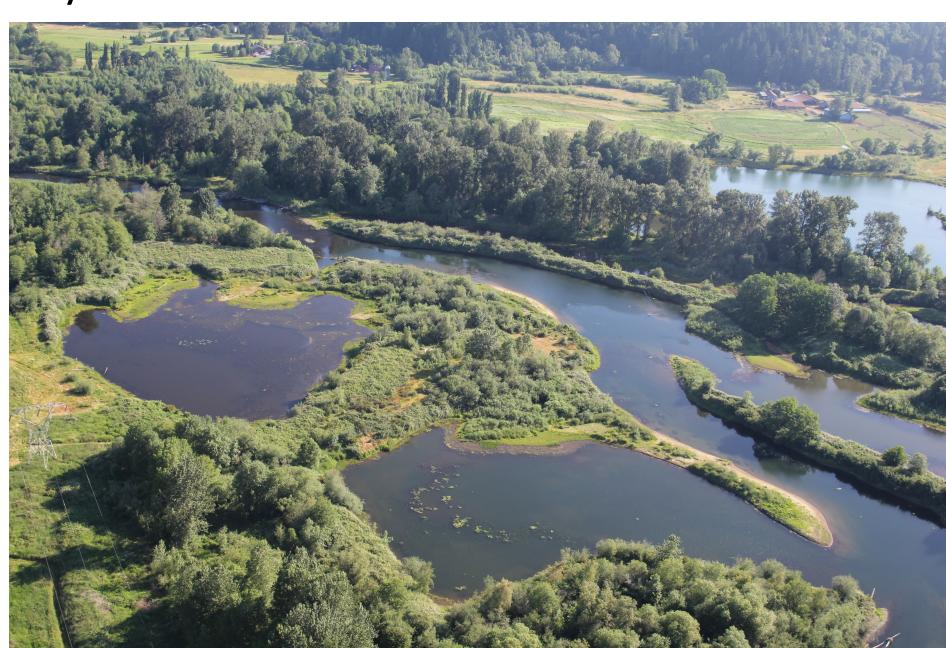
Current Channel Dynamics

Channel change in some areas occurs seldomly or not at all due to confinement from bridges, armoring, fill, or pit capture

Low habitat complexity

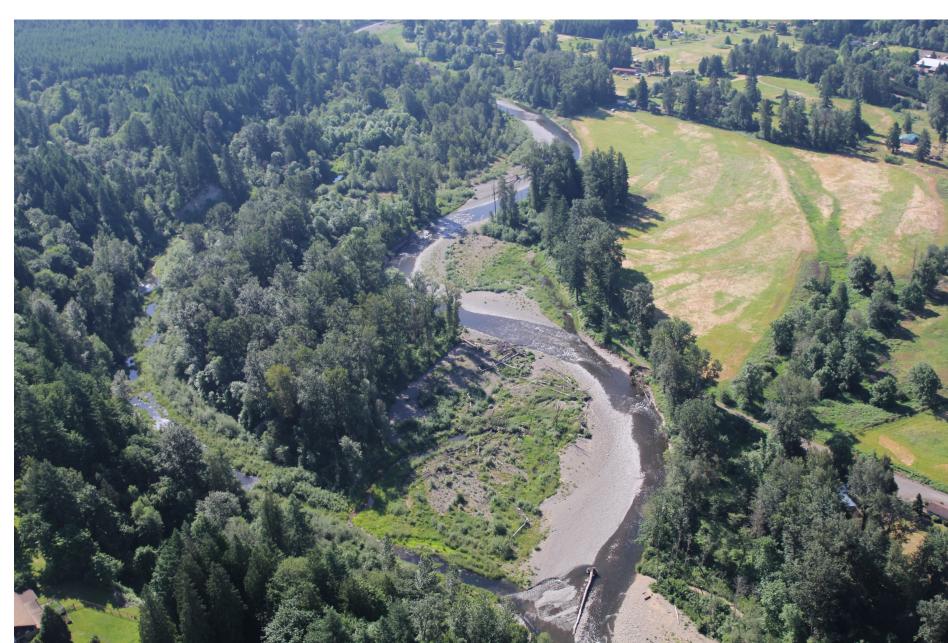
Current Channel Dynamics

Channel change in other areas occurs very frequently (~annually) due to loss of bank vegetation, loss of large forest structure, loss of large instream wood/jams, channel constrictions, or continued adjustment from past pit avulsions.

High habitat complexity
 but possibly redd scour and
 burial issues

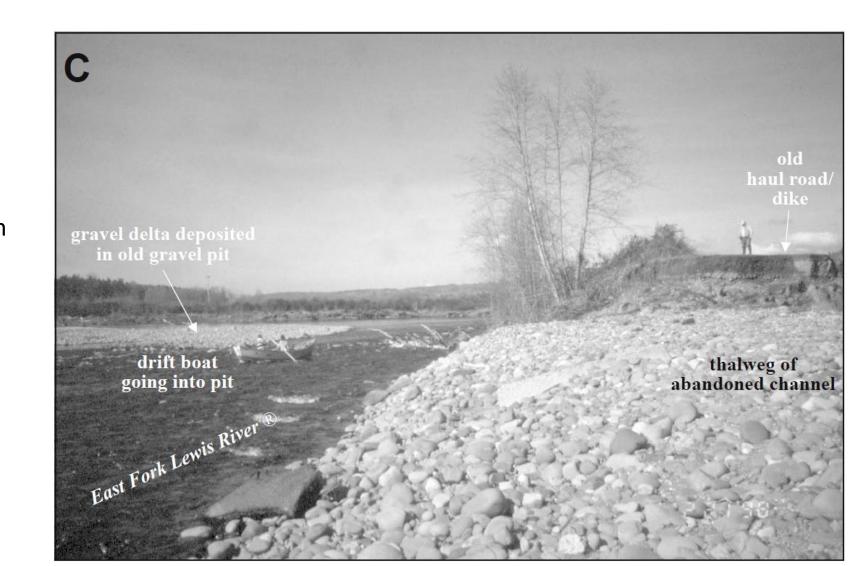
Profile Response

- 5 ft lowering immediately upstream of the pit entrance 1 month following avulsion (WEST 1996 as cited in WEST HCP appendix)
- Slight increase in slope upstream of put avulsion noted by WEST (HCP appendix) immediately following avulsion
- 10 ft lowering immediately upstream of the pit entrance (Norman et al. 1998).

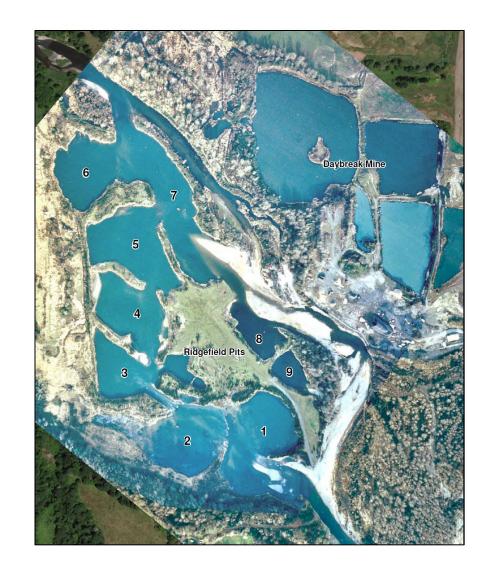
Table 1: Estimated Changes in Volume of the Ridgefield Pits since the 1996 avulsion.

Pit	Pre-1996 Pit Volume (2001 study)	Pre-1996 Pit Depth (2001 study)	Pit Top Elevation (2001 study)	1999		2013	
				Volume	Volume Change	Volume	Volume Change
	(yd³)	(ft)	(ft)	(yd³)	%	(yd³)	%
1	157,700	12	35	118,583	-25%	21,958	-86%
2	102,900	12	34	130,131	26%	54,185	-47%
3	108,500	20	33	124,203	14%	76,290	-30%
4	143,500	20	32	105,176	-27%	51,000	-64%
5	164,800	20	31	160,661	-3%	88,955	-46%
6	204,900	30	31	128,119	-37%	66,211	-68%
7	186,900	20	30	178,981	-4%	96,299	-48%
total	1,069,200			945,854	-12%	454,897	-57%

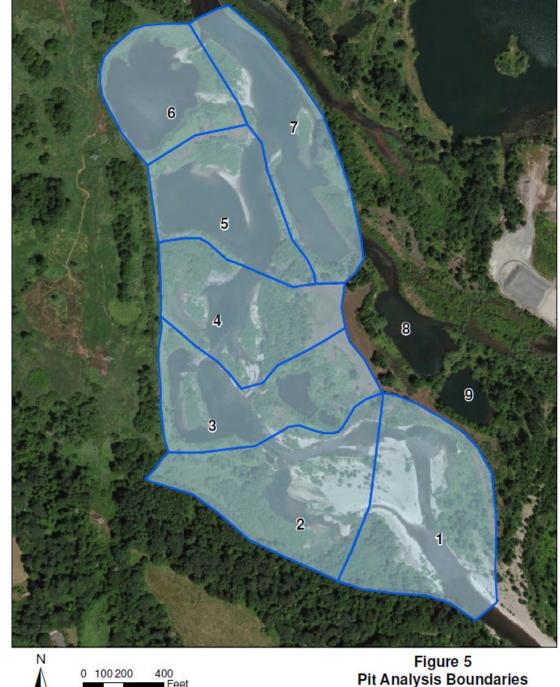
Figure 5 Pit Analysis Boundaries Ridgefield Pits - EF Lewis River

Pit boundaries used for volumetric analysis - from WEST (2014)

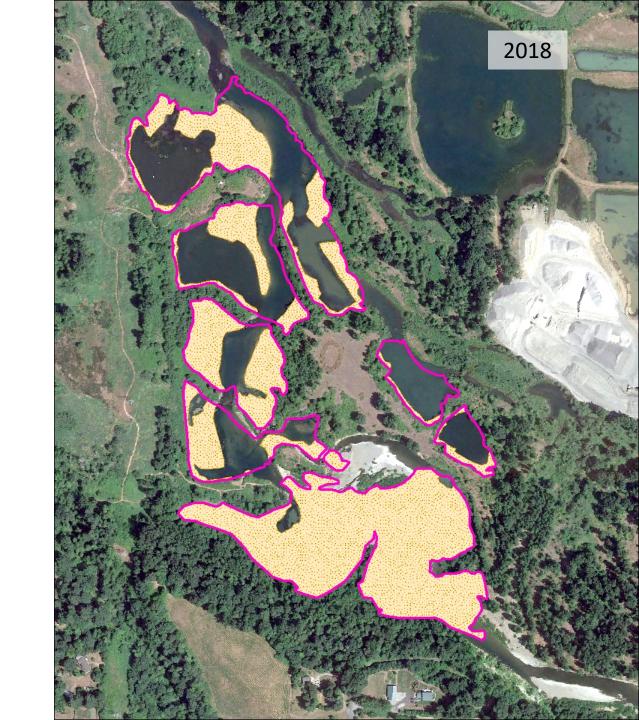
Intervening annu	al peak events
Air Photo Year	Pit Fill Area	Percent Fill	Flow (cfs)	Pate
1996	0.27	0.55%	28,600	8-Feb-96
1996	3.13	6.38%	6,000	19-Nov-96
1998	9.31	18.98%	9,580	30-Oct-97
2000	17.59	35.85%	12,000	27-Dec-98
			14,400	25-Nov-99
2002	18.96	38.65%	3,170	30-Apr-01
			6,330	25-Jan-02
2003	22.2	45.25%	13,700	31-Jan-03
2005	21.09	42.99%	9,420	29-Jan-04
			6,690	18-Jan-05
2006	22.08	45.01%	9,270	10-Jan-06
2007	21.1	43.01%	21,200	7-Nov-06
2009	26.77	54.57%	10,700	3-Dec-07
			13,800	8-Jan-09
2010	26.4	53.81%	4,470	1-Jan-10
2011	27.24	55.52%	16,200	16-Jan-11
2012	27.7	56.46%	11,000	22-Nov-11
2013	28.02	57.11%	7,570	19-Nov-12
2014	27.74	56.54%	6,660	2-Dec-13
2015	26.01	53.02%	5,850	10-Feb-15
2016	28.34	57.77%	22,400	9-Dec-15
2017	27.18	55.40%	9,360	15-Mar-17
2018	29.82	60.78%	6,540	29-Dec-17

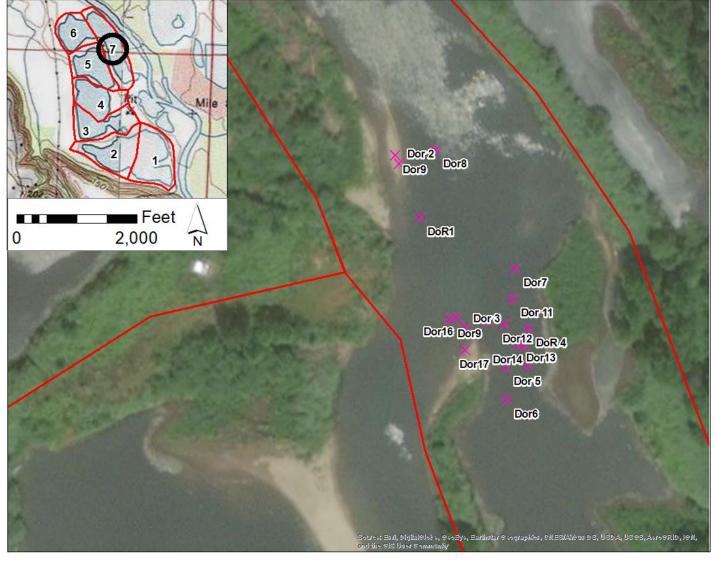
EF Lewis Ridgefield Pits Depth of Refusal
Created Oct 2018

\wedge		×	Depth of Refusal (n=18)				
\rightarrow	0	50	100	150	200	250 Feet	
N

DOR Location #	Depth (ft)	Depth of Refusal (ft)	Thickness (ft)	
1	2.25	4.75	2.5	
2	3.5	9.5	6	
3	4.6	8	3.4	
4	8.5	10	1.5	
5	6.5	8.6	2.1	
6	6.4	11.3	4.9	
7	3.5	10.2	6.7	
8	9.5	14	4.5	
9	3.5	5.5	2	
10	6.25	10	3.75	
11	11.6	13	1.4	
12	9	12.2	3.2	
13	7.9	9.25	1.35	
14	7.8	12.5	4.7	
15	7.8	11.7	3.9	
16	5	7	2	
17	1.7	4.2	2.5	
Averages	6.2	9.5	3.32

Average Thickness (ft)	3.32
Years	23
Avg feet per year	0.14
Avg inches per year	1.7
Range (inches)	0.7 - 3.5
