# Multnomah Channel Marsh Natural Area Floodplain Restoration Project

# Basis of Design Report 60% Design

**November 2023**

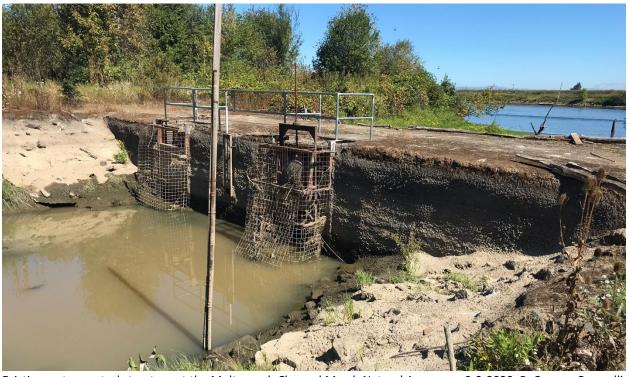
Existing water control structure at the Multnomah Channel Marsh Natural Area

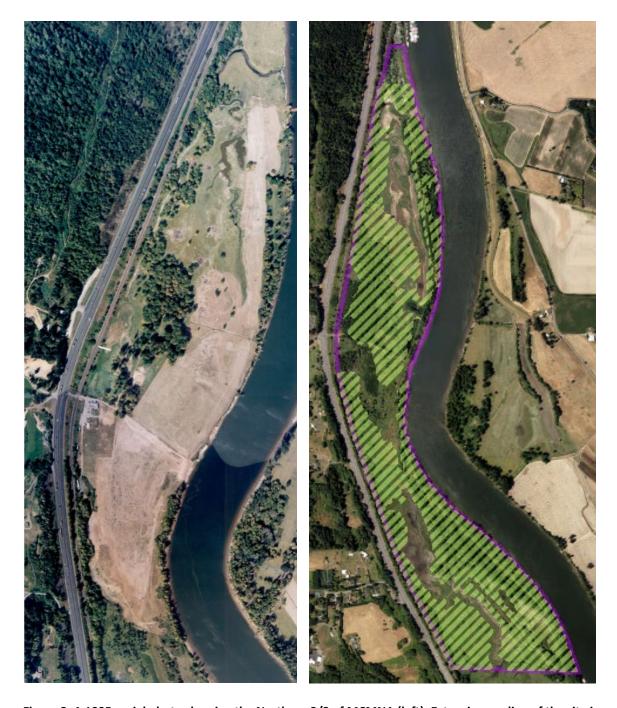
Figure 2. A 1995 aerial photo showing the Northern 2/3 of MCMNA (left). Extensive grading of the site is evident. The site was being scoped for development by the landowner and large areas of the floodplain were graded to dewater the site and redirect water to the western edges of the floodplain. Metro acquired the site a couple years later after the 1996 Flood submerged the entire property.

The image at right shows the heaviest cover of RCG at the site in 2000 (shown in diagonal green hatched shading), as mapped by Adolfson and Associates as part of an ecological inventory of the site.

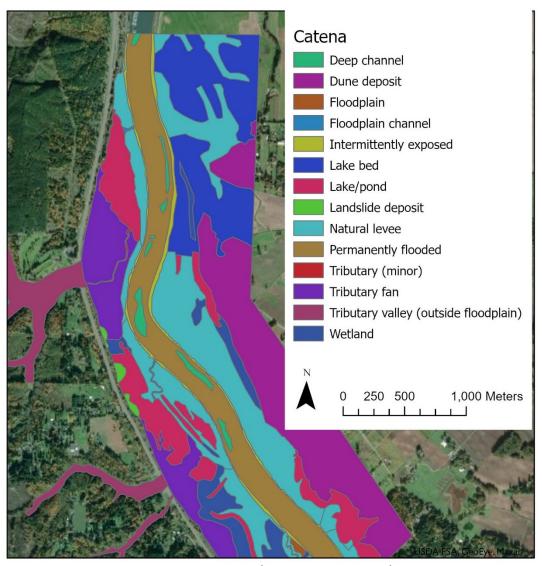
Figure 3. Reach F site scale geomorphic catena (Simenstad et. al., 2011).

Each of the Catena classifications (Figure 3) reflects the dominant geomorphic character in the corresponding coverage area, which in turn correspond with the landforms present at the site (Figure 4). The two large lake beds and flanking tributary fans associated with Crabapple Creek and the unnamed stream to the South of the site are dominant geomorphic features at MCMNA.

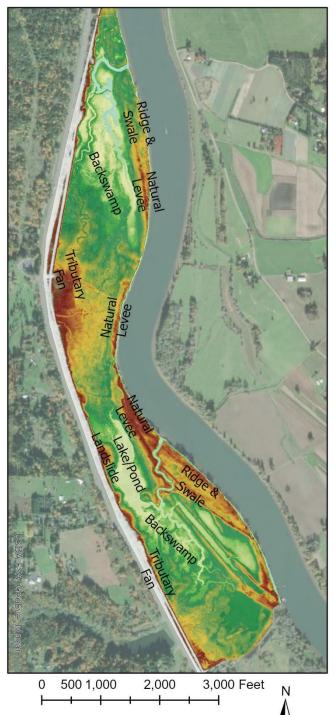
Figure 4. MCMNA fluvial geomorphic features.

Backswamps form between the natural levees and the terrace. Natural levee formation and deposition of fine sediment hinders floodplain drainage. The MCMNA parcel (Figure 4) is a backswamp bounded to the east by a natural levee running along Multnomah Channel and to the west by the valley wall. These areas often have the lowest topography, resulting in ponding of freshets. In addition, tributary streams flowed onto the floodplain behind the natural levees and flowed parallel to the main river until they found a topographic break in the natural levees, which enabled them to join the main river. Tributary creeks provide more constant inflow to the lakes and so they may be more persistent than floodplain lakes found on Sauvie Island. At MCMNA these floodplain lakes may have formed in the relict course of a side channel created as point bars formed on the inside of the bend in the Multnomah Channel, which would explain their elongated shape.

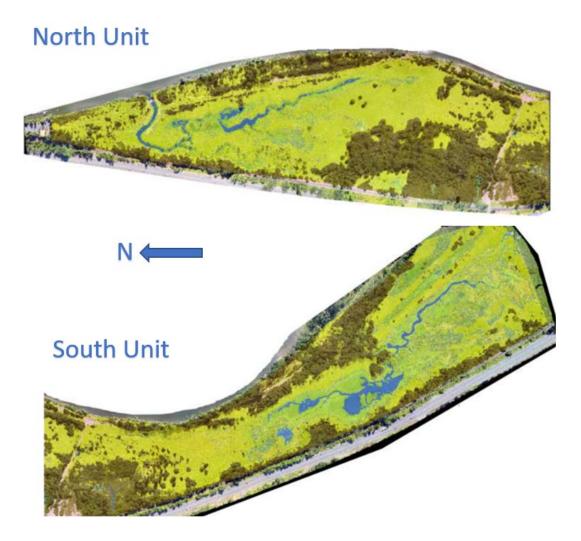
Figure 6. Drone-Based Vegetation Analysis (EP, Personal Correspondence, 2018).

Existing plant community elevation ranges (color-coded and corresponding to Figure 6 (above)) were also derived from EP's vegetation analysis and are included in the table below. The elevations EP identified at the site are further compared to elevations identified by a recent study of wetland vegetation associated within the lower Columbia River and estuary floodplain (Borde et al., 2020). The elevation data presented in this

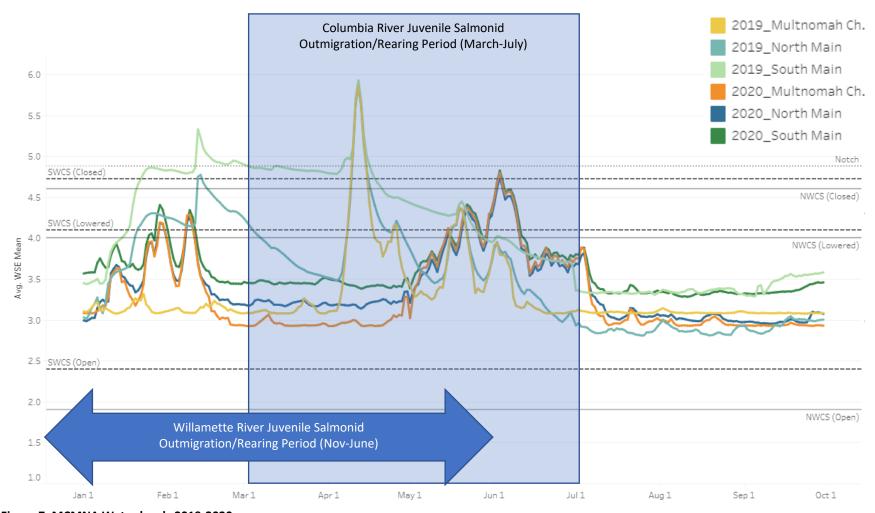
Figure 7. MCMNA Water levels 2019-2020.

the steep rise in late February of 2019 (Figure 7) which is associated with a rainfall event, not a rise in the Multnomah Channel, so it appears that closure of the North structure is insufficient for impoundment of water in the site. Also contributing to reduced flows into the North, are the effects of a large beaver dam just upslope of the central bridge, which has been diverting much of flow from Crabapple Creek away from the North basin and into the South basin, counteracting the effects of the 2008 hydrologic modification.

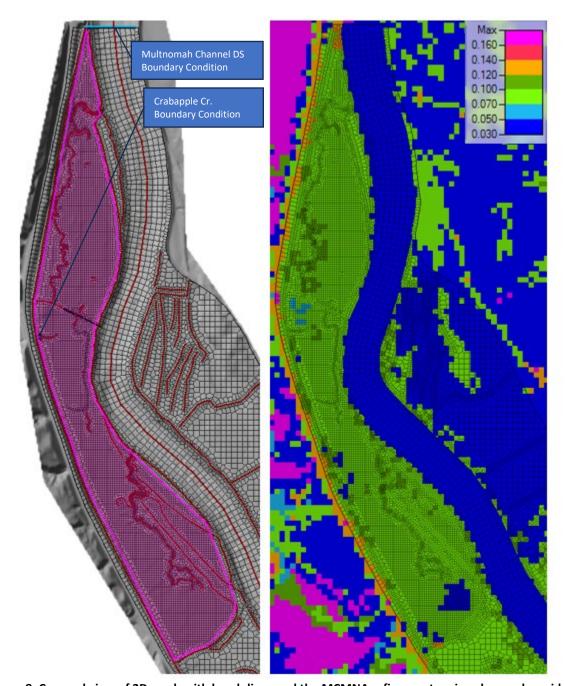
Figure 8. Cropped view of 2D mesh with break-lines and the MCMNA refinement region shown alongside the final Manning's n value raster. The Multnomah Channel upstream boundary condition is located at the Sauvie Island Bridge (not shown).

The model geometry consists of a 2D mesh overlain on a composite LiDAR surface created from the 2019 METRO LiDAR, 2014 METRO LiDAR, and Multnomah Channel Bathymetric Survey from 2010 (EP, 2010). The model extends from the Sauvie Island Bridge (RM 19.9) downstream to the Skyline Moorage & Marina (RM 14.4). The project site itself extends from RM 14.4 to RM16.5 (See Figure 8). This extended model domain is important to properly model the 1% ACE flood event due to the complex floodplain interactions occurring throughout this reach. The model geometry and roughness coverages are displayed in Figure 8 below. A range of cell sizes was used to limit complexity in areas beyond the project site and improve detail around key design elements and areas of concern. Within the project site a higher resolution mesh is created with a refinement region and break-lines to delineate high ground barriers and improve resolution along defined channels.

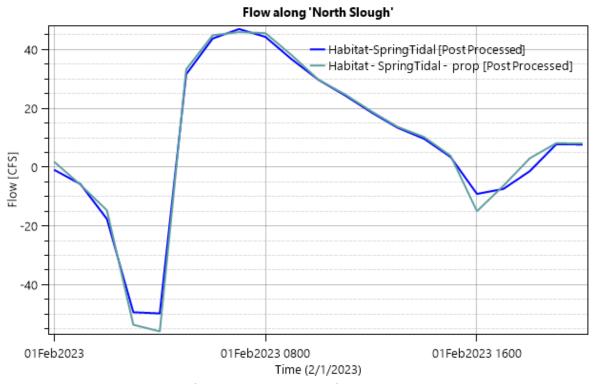
Figure 9. Existing versus proposed flow rates at the mouth of the North Slough. The negative values represent influx and positive represent efflux from the site.

The removal of the water control structures was not shown to significantly impact drainage patterns from either slough, compared with present day operation (structures left fully open). The results of the unsteady spring tidal simulation, which also contains a moderate flood pulse from Crabapple Creek, showed how timing and magnitude of flow in the North Slough was affected, with the tidal influx at peak tide increasing by an average of 5.1 cfs (10%) during peak tide.

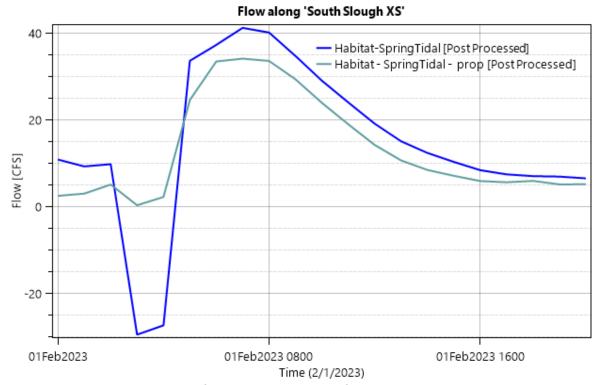
Figure 10. Existing versus proposed flow rates at the mouth of the South Slough. The negative values represent influx and positive represent efflux from the site.

Conditions in South Slough showed a greater change in flow rates. The proposed conditions show slight decreases during periods of both influx and efflux. This reduction is likely attributable to the BDAs in the terrain reducing the cross-sectional area of the slough by raising the bed. While the BDAs beneficially retain interior site water levels, they may reduce tidal mixing between the wetlands, slough, and Multnomah channel during periods of low water when the site hydrology is driven by tidal fluctuation. The assumption that the BDAs are impermeable should be considered in interpretation of these results as it exaggerates both the retention of water and the reduction of tidal mixing. There will, however, likely be variability in permeability of BDAs over the site profile.

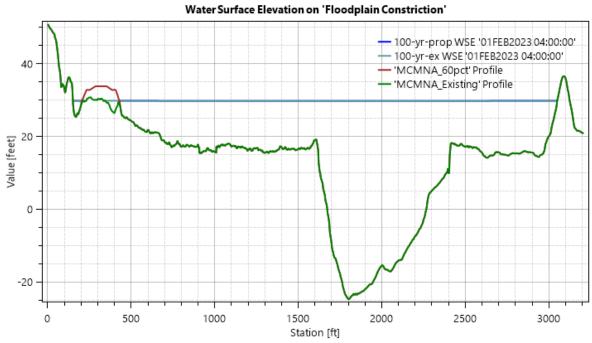
Figure 11. Cross-section of 1% ACE water surface elevations and terrain at the location of the Upland Habitat Enhancement fill placement.

A slight reduction in wetted area during the modeled 1% ACE event is caused by the Upland Habitat Enhancement Area located adjacent to the entrance road. This reduction is located on the floodplain fringe far from the floodway boundary and does not result in any reduction of cross-sectional conveyance or a rise in the BFE. A cross-section displaying the existing versus proposed terrains and water surface elevations is shown below in Figure 11.

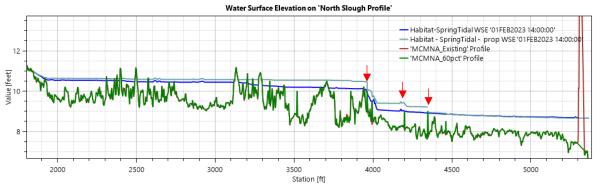
Figure 12. Modeled profile of the North Slough with BDAs at low-tide. The existing conditions WSE is shown in dark blue and the proposed condition in light blue. Red arrows identify BDA locations.

In combination with marsh plain Grading, the modeling suggests that well-constructed BDAs are an important action that would significantly benefit site hydrology. The benefit of these structures is highly dependent on their initial construction and permeability, as well as their continued maintenance and/or whether beaver move into the reaches, taking over maintenance of some of these structures and constructing their own dams. The potential benefits to storage from these structures is shown below in Figure 12.

The modeled condition assumes that the BDAs are impermeable and as such shows the maximum potential benefit they may provide, but also a condition which may develop naturally if beaver colonization continues to expand throughout the site. Due to the temporary nature of BDAs, it is important that these structures be implemented alongside extensive riparian planting and invasive species management efforts to create conditions that are attractive for beaver colonization.
